INSPECTION REPORT: GREENS CREEK MINE

Date of Inspection: Wednesday, March 22, 2023
Date of Report: Tuesday, April 27, 2023
USDA Forest Service Inspector: Casey Loofbourrow

Ranger District: Admiralty National Monument, Juneau Ranger District
Weather Conditions: Overcast. Temperature: Mid 30's (°F).

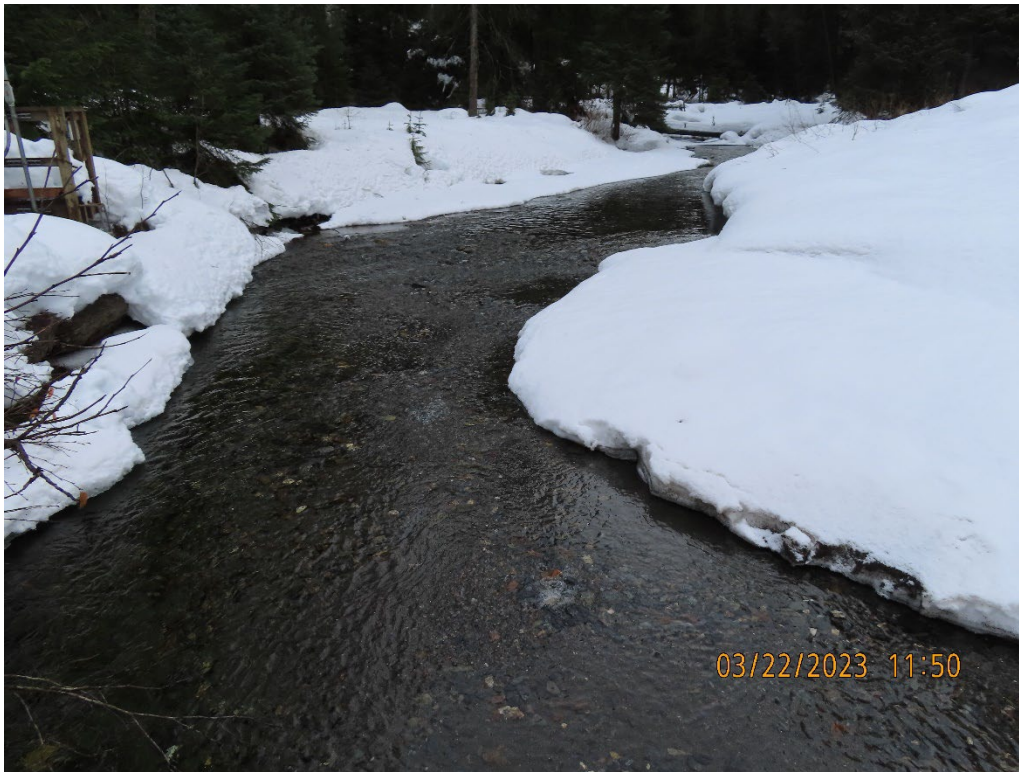
The Greens Creek discharge was 7.3 cfs (Photos 1-2) and 1.3 cfs was being withdrawn for operational use.

Photo 1. Greens Creek looking upstream from the 920 weir.

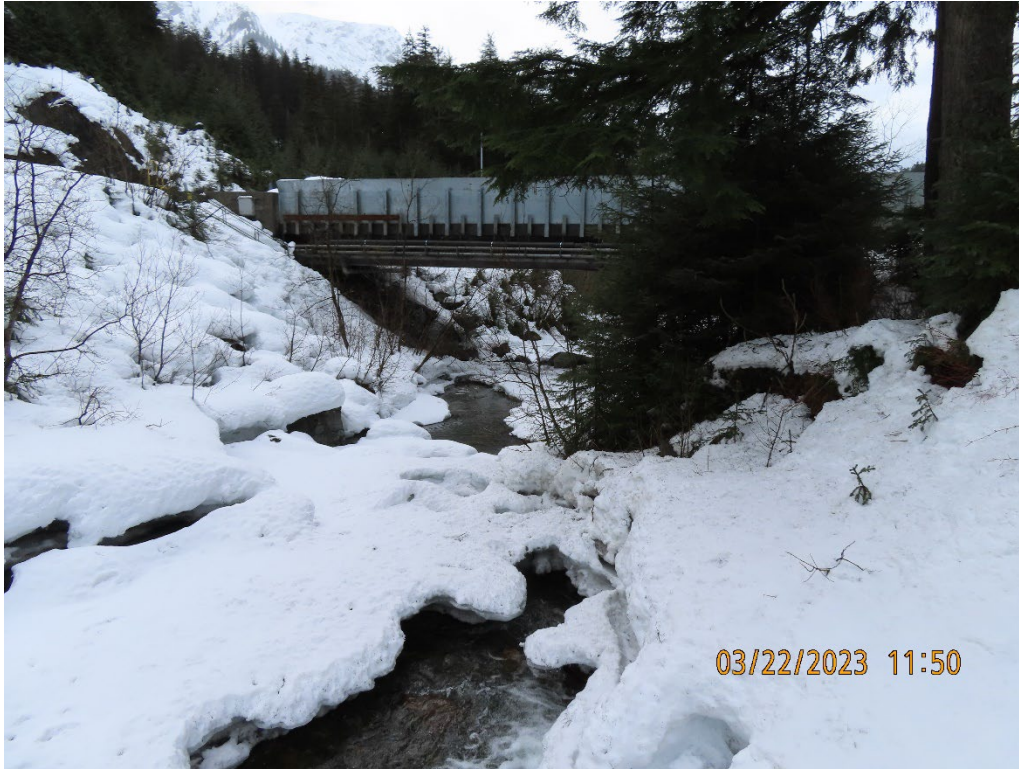
Photo 2. Greens Creek looking downstream from the 920 weir.

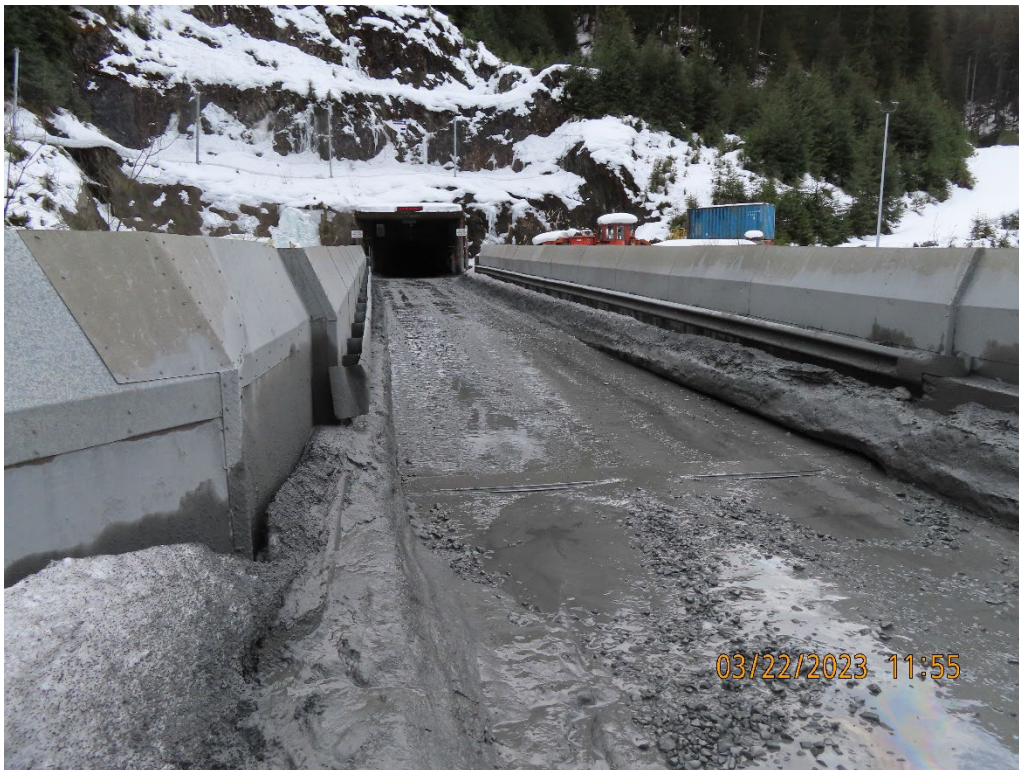
The Greens Creek bridge appeared in good condition, with sediment deflection concrete barriers preventing sediment from reaching bridge abutments, and metal splash guards preventing sediment from being transported over the bridge edge due to traffic (Photo 3).

Photo 3. Greens Creek bridge and 920 portal.

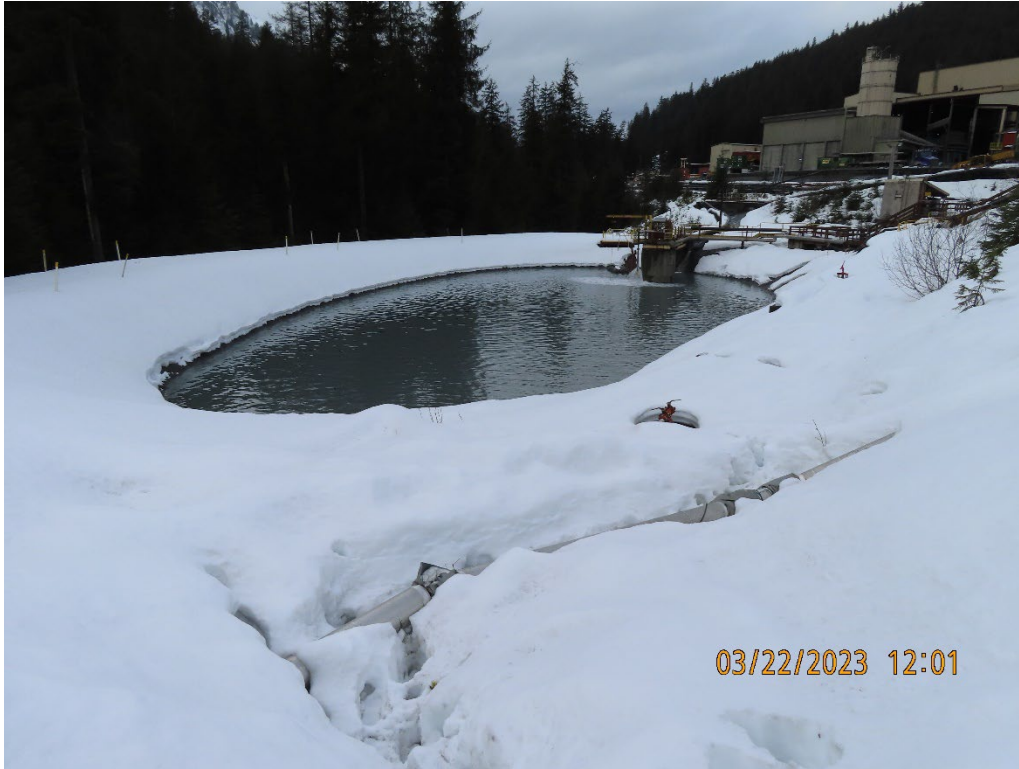
Pond A was in good condition with substantial surge capacity (Photo 4).

Photo 4. Pond A, below the 920 area.

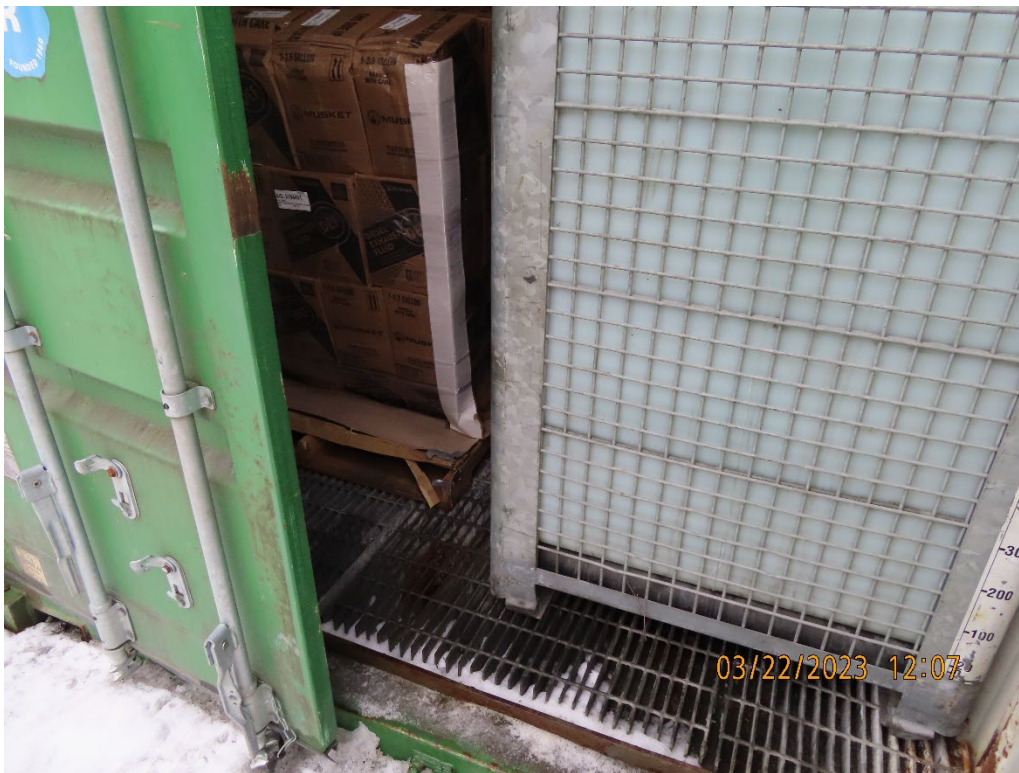
Good housekeeping practices were observed at the 920 warehouse (GPO, Appendix 5 BMP Plan, page 39). All petroleum/chemicals observed were properly stored within secondary containment (Photo 5).

Photo 5. Chemicals stored in appropriate secondary containment at the 920 warehouse area.

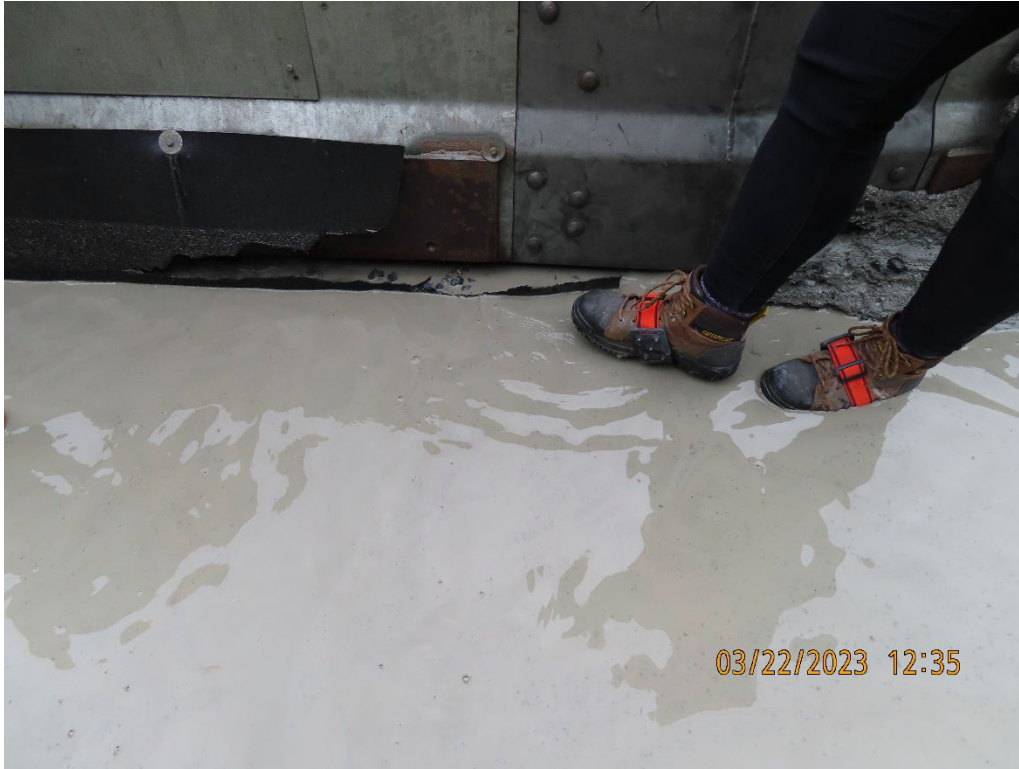
429-1: Ponded turbid water on Killer Creek Bridge was leaking through damaged bridge liner.

NEW ACTION ITEM 429-1: Turbid water was ponding on the Killer Creek Bridge was leaking through damaged bridge liner (Photo 6).

Photo 6. Killer Creek Bridge liner damaged, allowing turbid water to infiltrate.

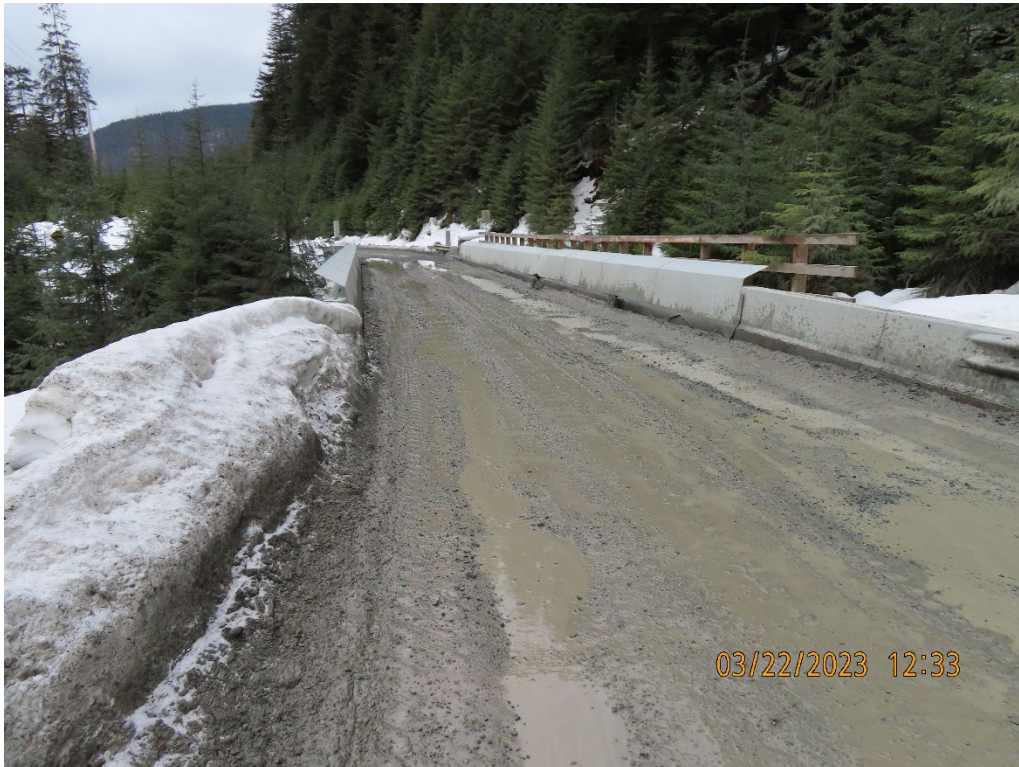
The Killer Creek Bridge otherwise appeared in good condition (Photo 7), with sediment deflection concrete barriers preventing sediment from reaching bridge abutments. Due to winter conditions the abutments were not able to be inspected.

Photo 7. Killer Creek Bridge.

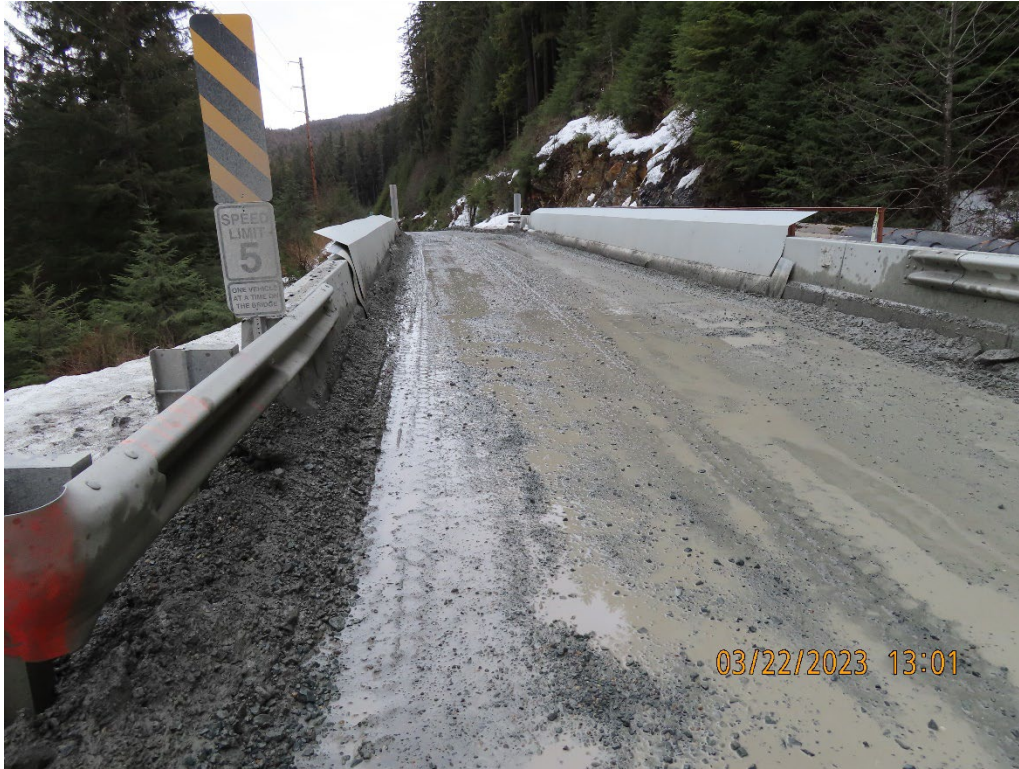
The bridge surface appeared in good condition with functioning sediment deflection barriers and no ponding water (Photo 8).

Photo 8. Falls Creek Bridge surface.

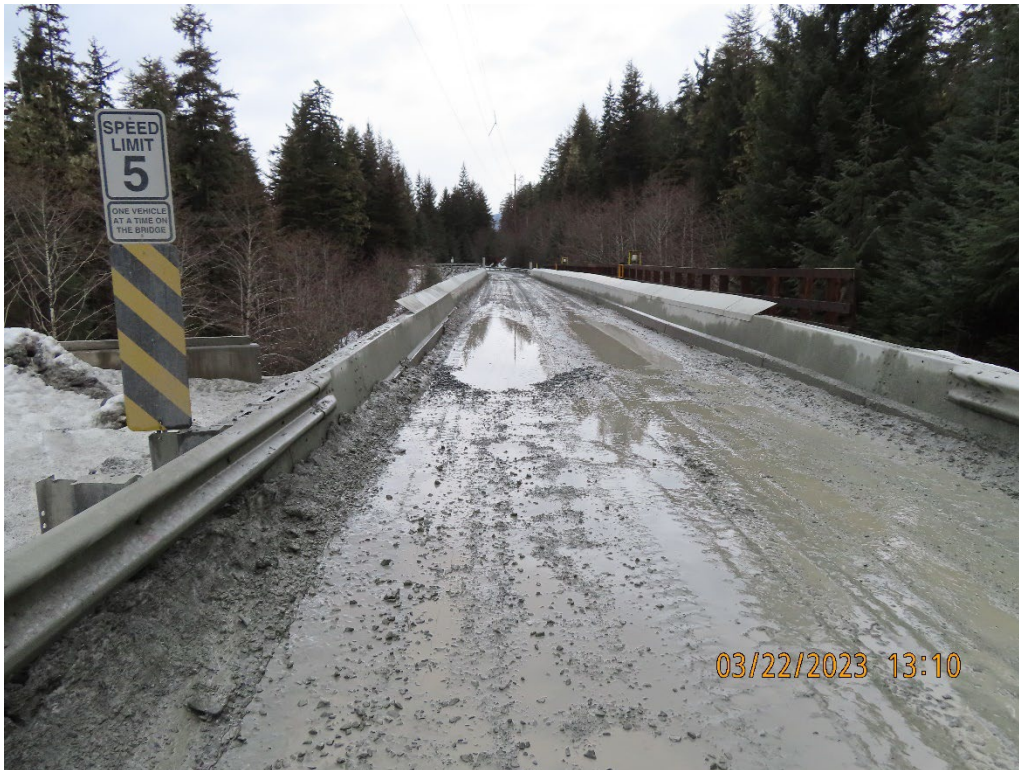
The Zinc Creek bridge appeared in good condition, with sediment deflection concrete barriers preventing sediment from reaching bridge abutments (Photo 9).

Photo 9. Zinc Creek Bridge.

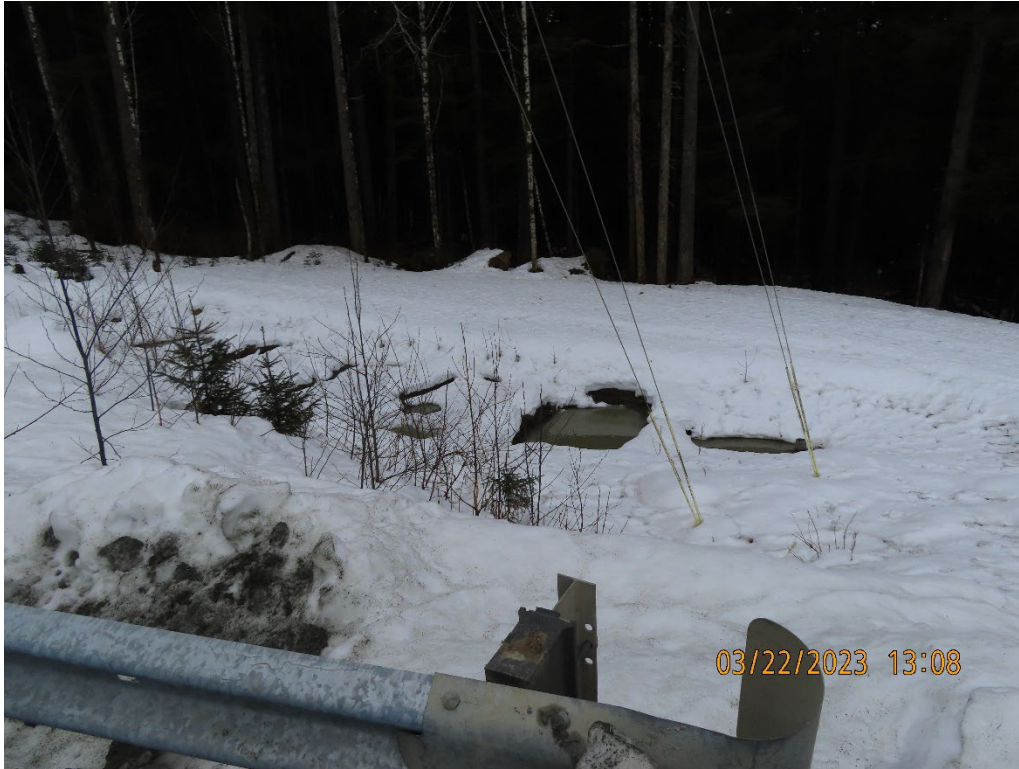
Turbid water was previously observed discharging from the stormwater BMP colloquially known as the “Gnome Pond” (Report 423). The “Gnome Pond” was observed covered in snow and ice with reduced inflow from runoff (Photo 10). This location will be closely monitored in future inspections.

Photo 10. "Gnome Pond" stormwater ponds.

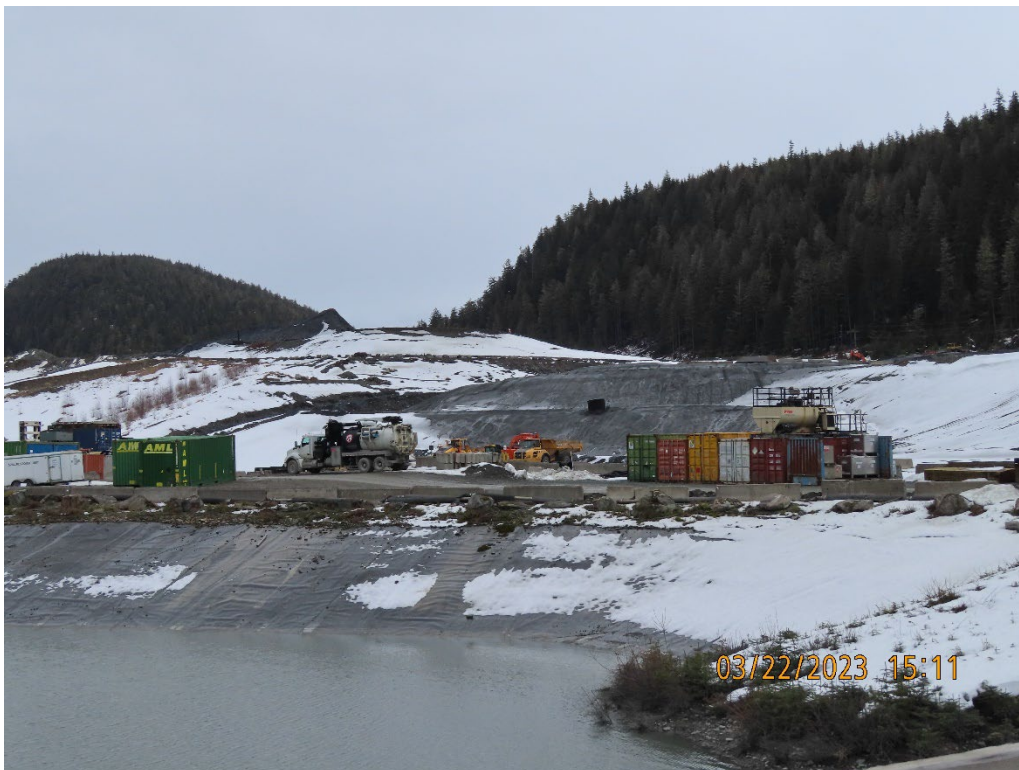
The current active tailings deposition location is just south of the center of the tailings pile (Photo 11), approximately adjacent to 1.0 mile of the B-Road.

Photo 11. Tailings disposal facility.

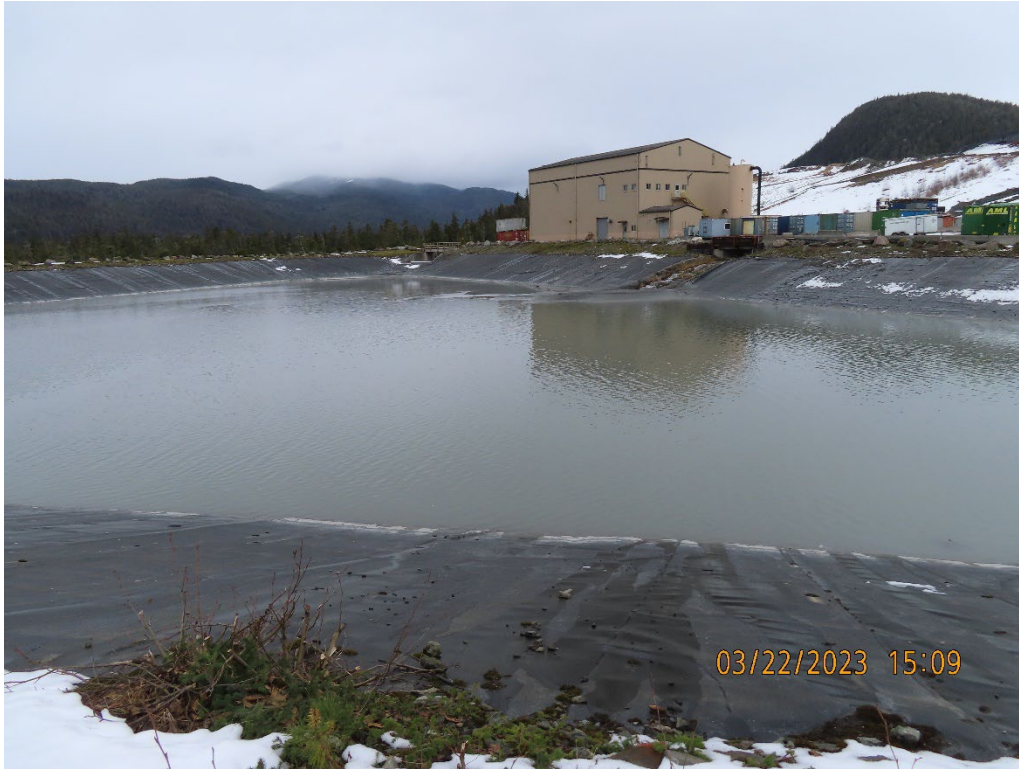
Photo 12. Pond 7.

At the time of the inspection, Pond 7 (Photo 12) was collecting contact and process water, and Pond 10 (Photo 13) was not receiving water.
