## INSPECTION REPORT: GREENS CREEK MINE

Date of Inspection: Wednesday, July 19, 2023  
Date of Report: Monday, August 28, 2023  
USDA Forest Service Inspector: Richard Dudek

The site inspection included: The B access road, 920 area, Site 23, Pond A, 7.4-mile B-Road Bridge (Killer Creek Bridge), 3.4-mile B-Road bridge (Falls Creek Bridge), 3.0-mile B-Road bridge (Zinc Creek Bridge), and the Tailings Disposal Facility (TDF).

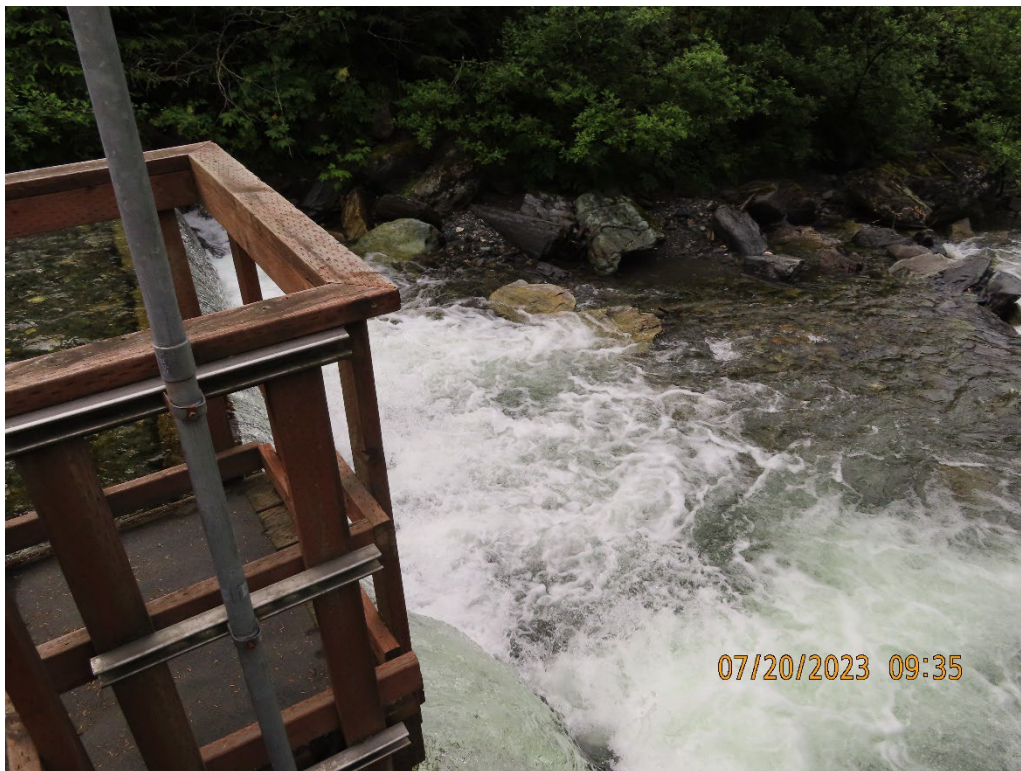
The Greens Creek weir discharge was 41 cfs (Photo 1), and 1.5 cfs was being withdrawn for the 920 facilities.

**Photo 1. The Greens Creek Wier.**

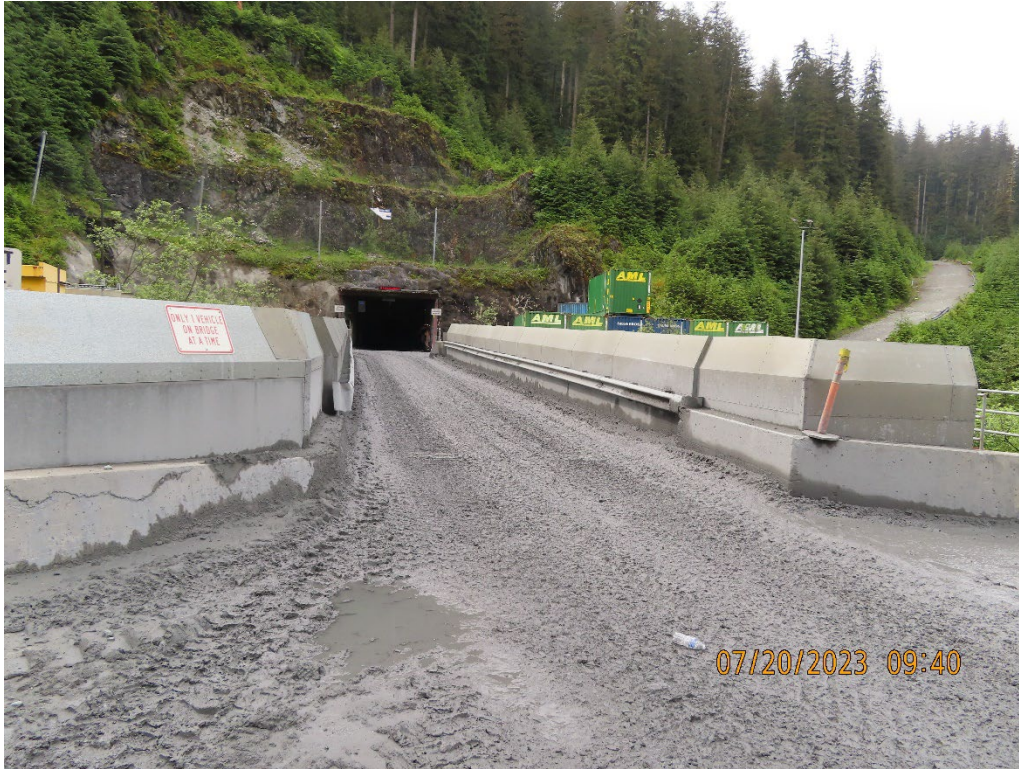
The 920 bridge was in good condition, and the splash guards were functioning as intended (Photo 2).

**Photo 2. The 920 Bridge.**

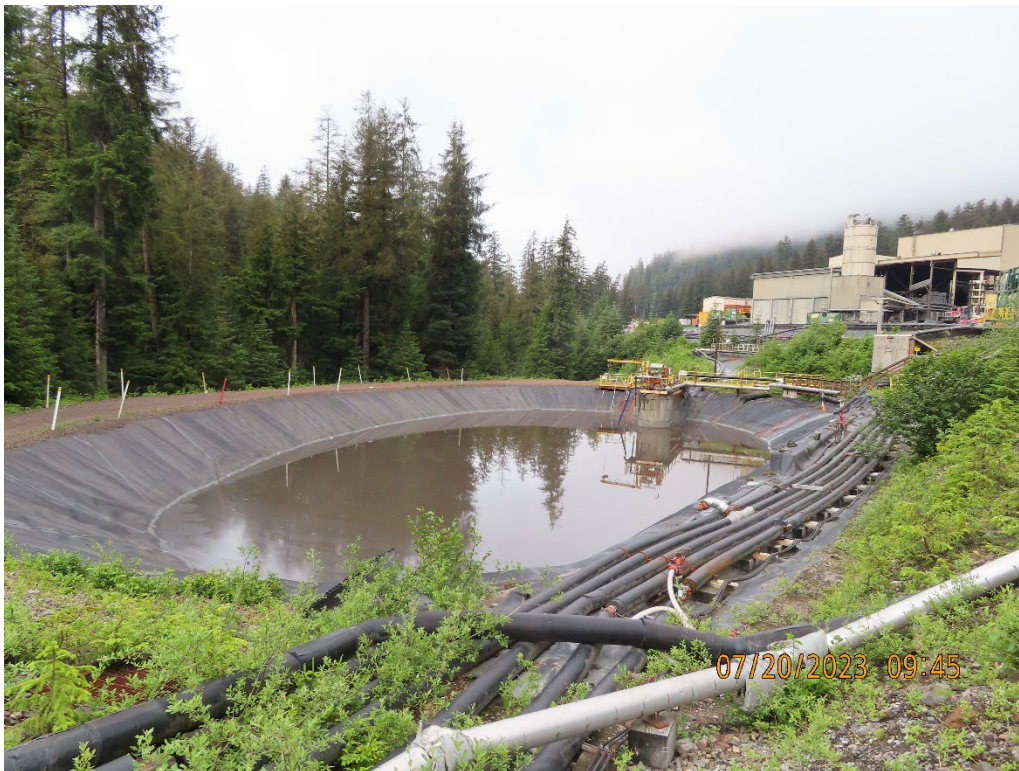
Pond A was in good condition and was receiving mine site contact water (Photo 3).

**Photo 3. The 920 Area Pond A.**

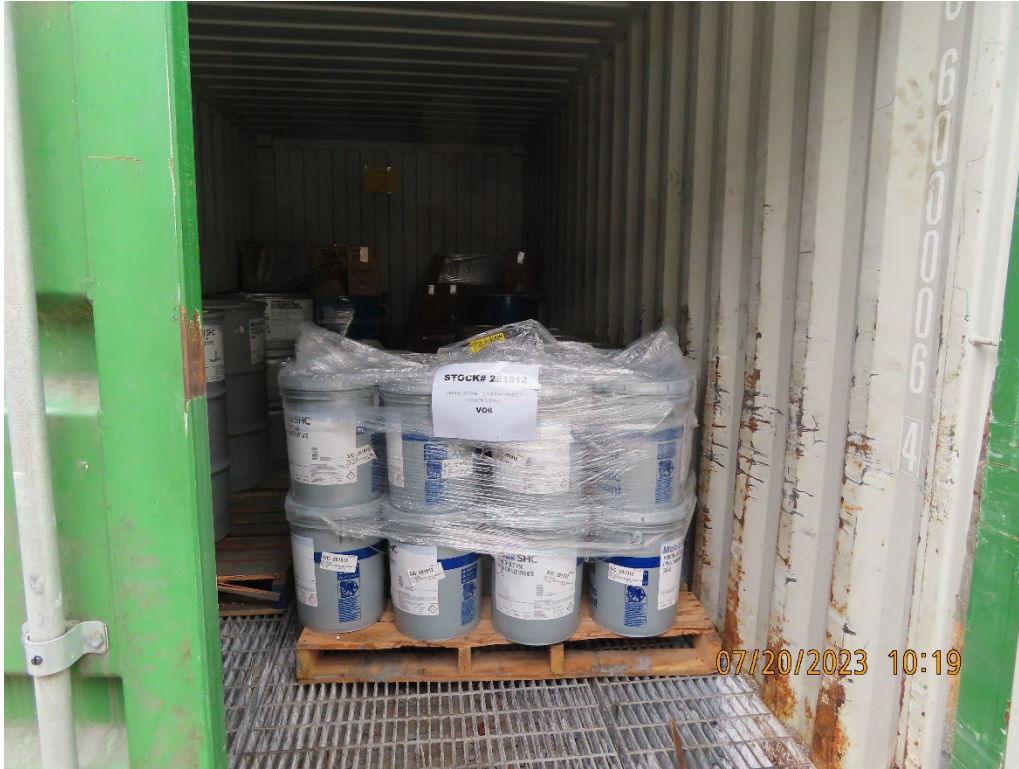
Good housekeeping practices were observed at the 920 warehouse (Appendix 5 BMP Plan, page 39). All petroleum/chemicals were stored adequately within secondary containment (Photo 4).

**Photo 4. The 920 warehouse storage container with secondary containment.**

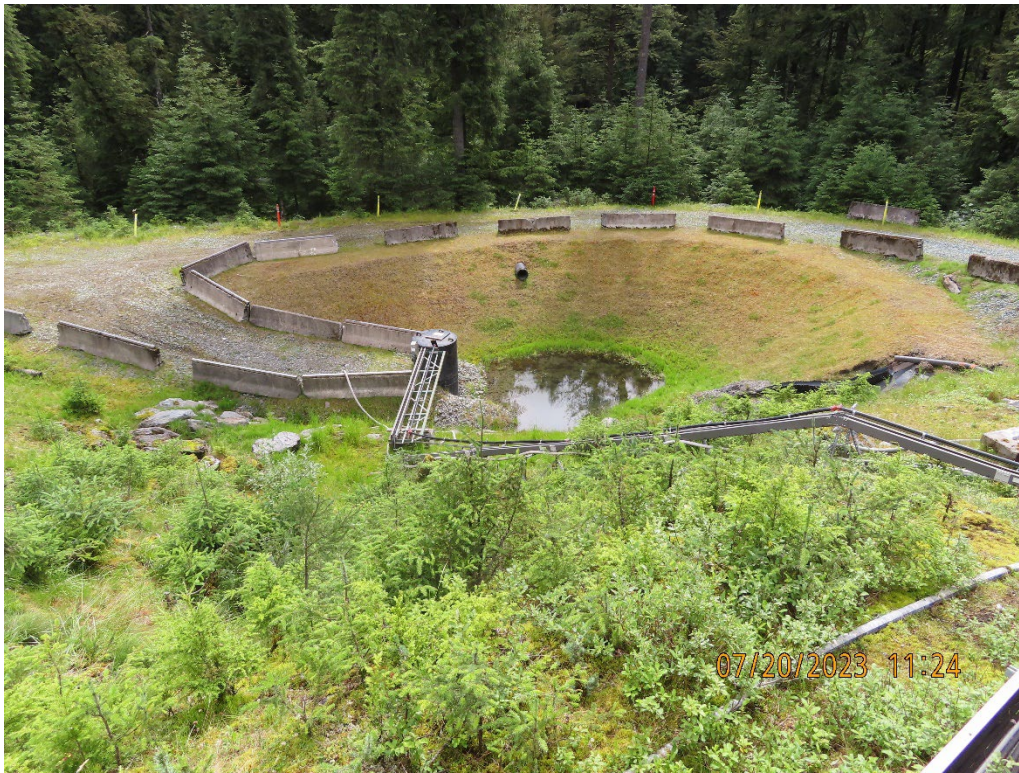
Both upper and lower C ponds were in good condition with enough capacity for stormwater runoff (Photos 5-6).

**Photo 5. The 860 Area Lower Pond C.**

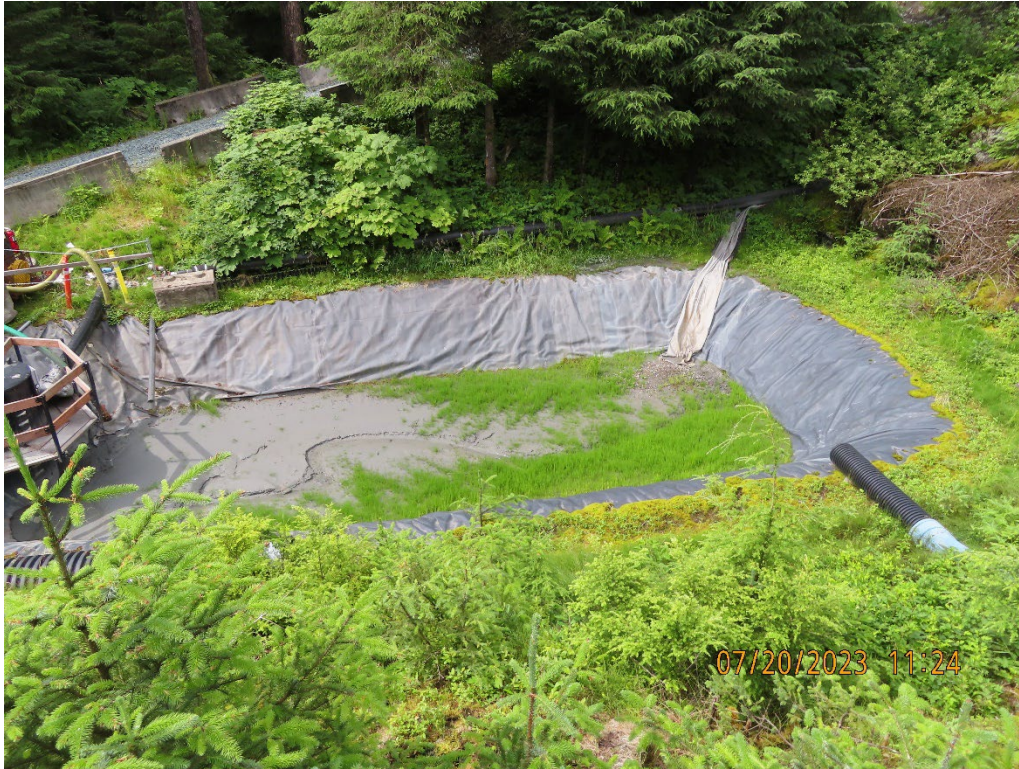
**Photo 6. The 860 Area Upper Pond C.**

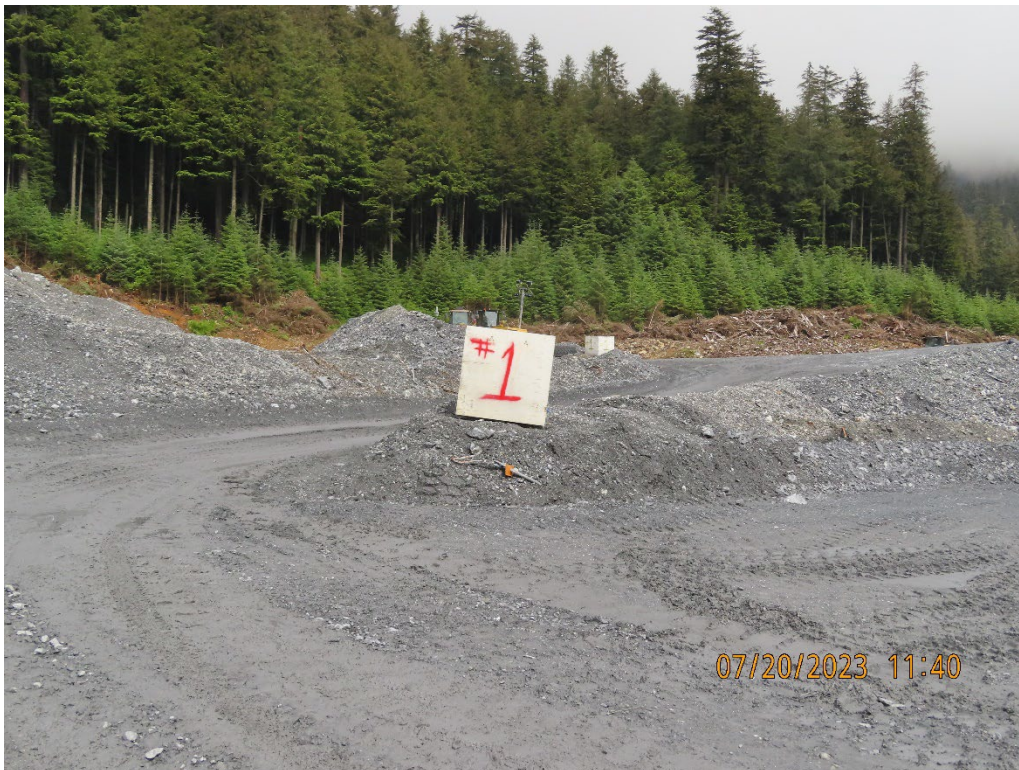
HGCMC continues to stage Class 1, 2, and 3 waste rock at this location (Photos 7-8). Class 4 waste rock is kept underground and disposed of underground (Appendix 11 Waste Rock Management Plan, page 11).

**Photo 7. Waste rock storage area Site 23. Class 1 waste rock is separately staged from class 2/3 waste rock.**

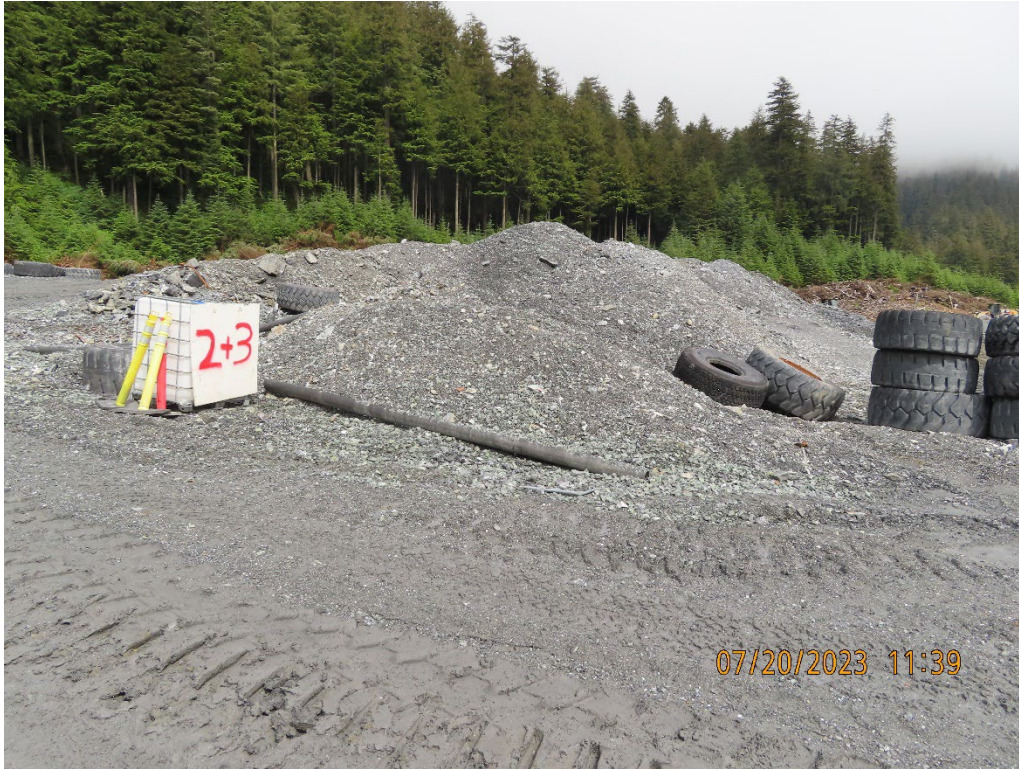
**Photo 8. Site 23 class 2/3 waste rock.**

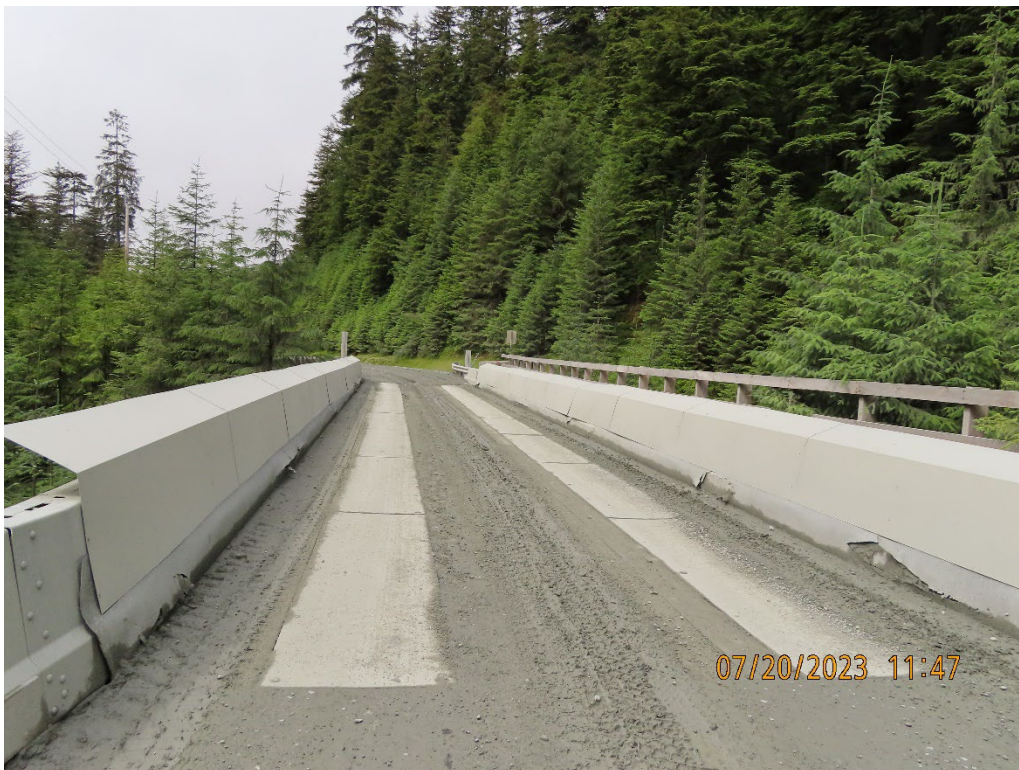
The Killer Creek Bridge was in good condition, and the associated BMPs were functioning as intended (Photo 9).

**Photo 9. The 7.4-mile marker B Road Bridge (Killer Creek Bridge).**

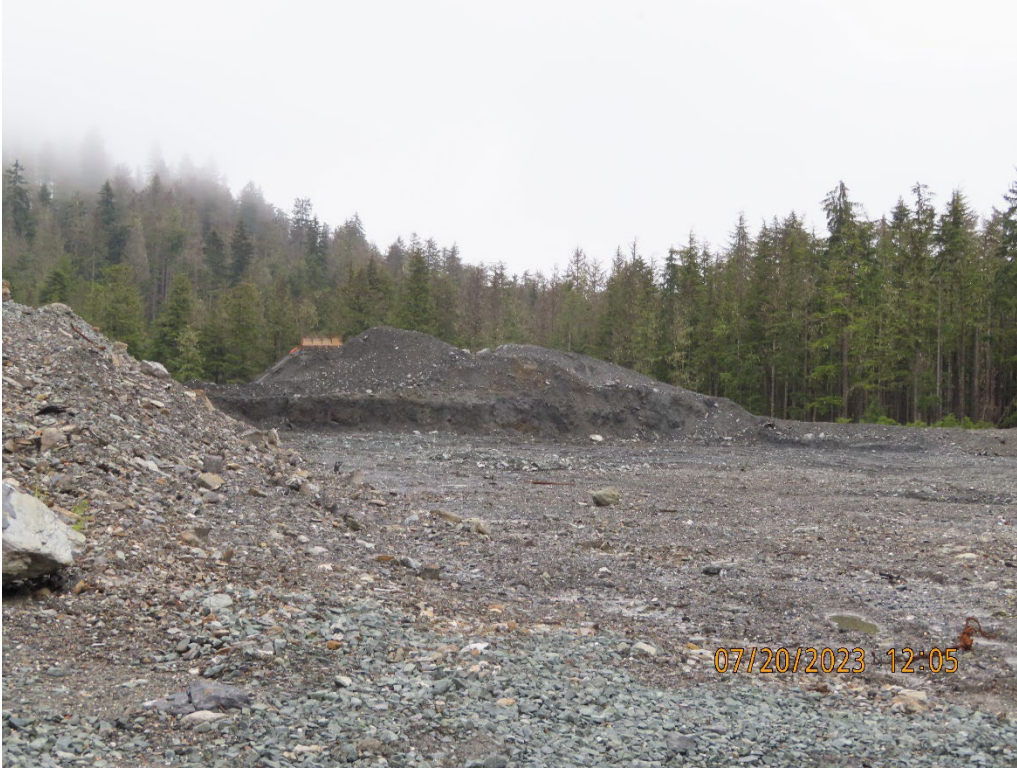
FY 2023, HGCMC has removed 17,000 cubic yards of waste rock from this location and disposed of it in the TDF (Photo 10).

**Photo 10. Site E. The waste rock removed from this site is disposed of in the TDF.**

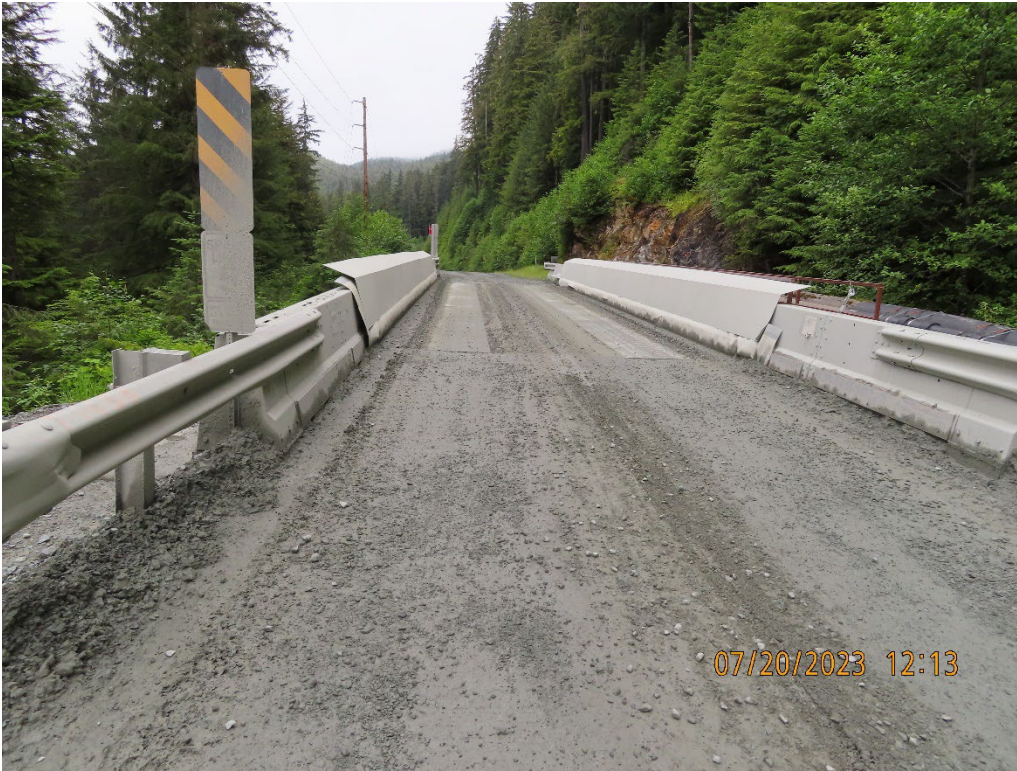
The bridge surface or wear layer was in good condition, and the splash guards worked as intended (Photo 11).

**Photo 11. The 3.4-mile marker B Road Bridge (Falls Creek Bridge).**

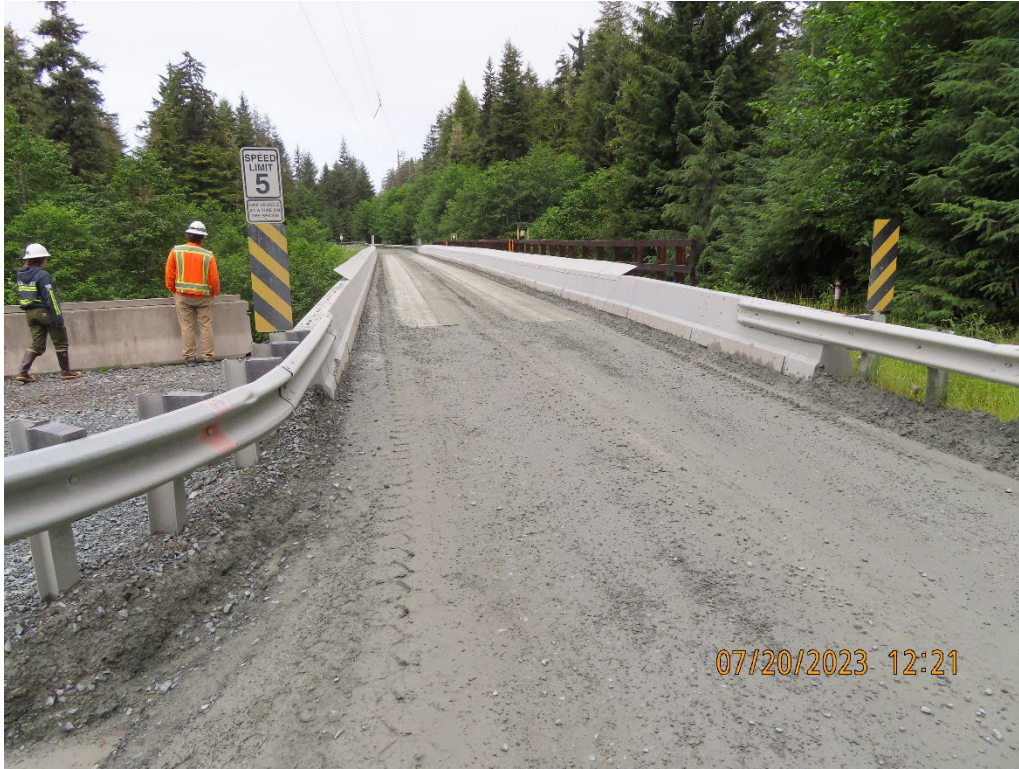
The Zinc Creek bridge was in good working condition, and HGCMC plans to modify/upgrade the gnome pond's outlet (Photos 12-13).

**Photo 12. The 3.0-mile marker B Road Bridge (Zinc Creek Bridge).**

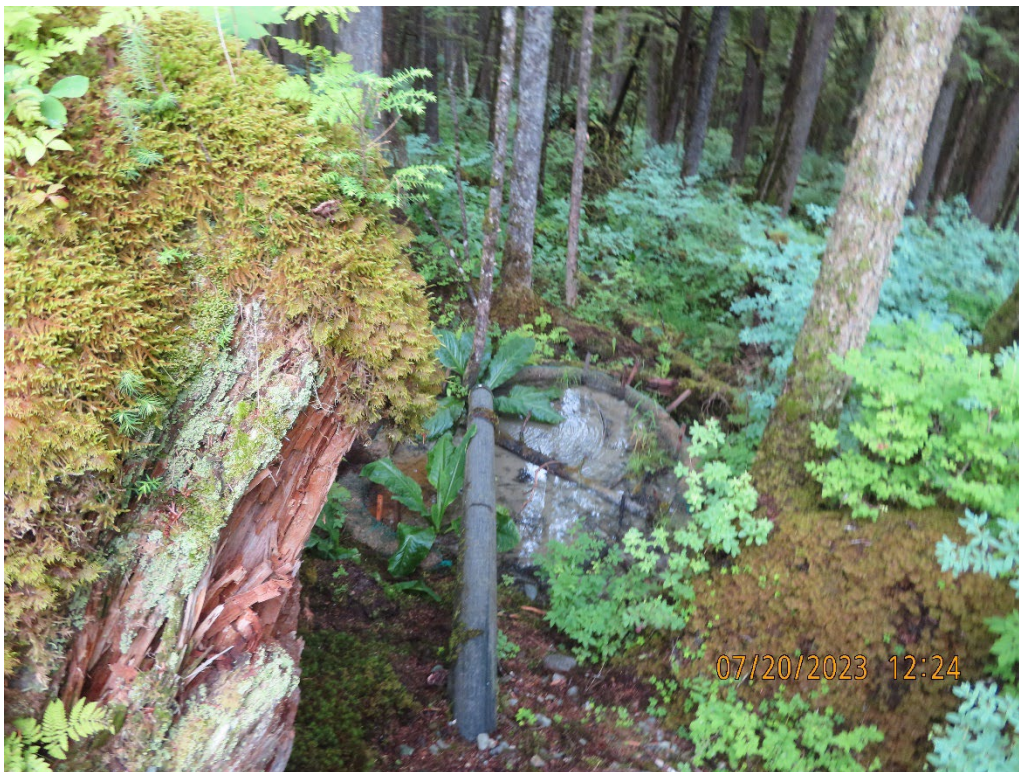
**Photo 13. The Gnome Pond outlet pipe.**

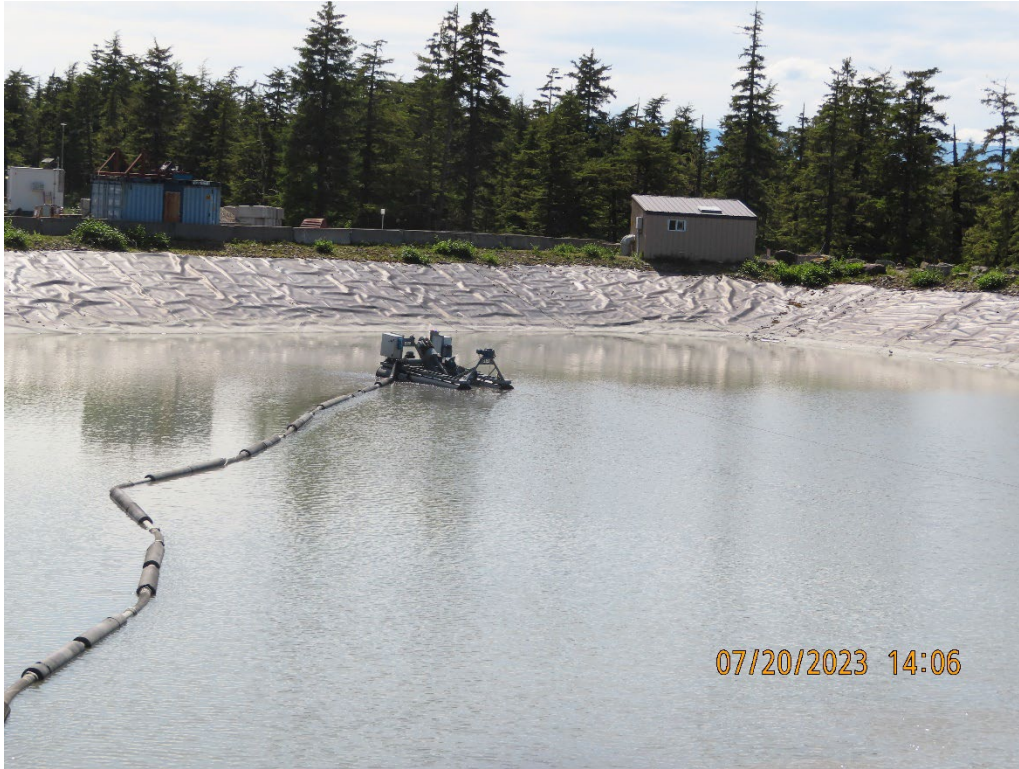
The current active tailings placement location was in the eastern section of the TDF's S3P1 area. At the time of the inspection, Pond 7 was receiving mine site water, and HGCMC personnel were conducting routine pond dredging to increase its capacity (Photo 14).

**Photo 14. Pond 7, with a dredge, is seen in the background.**

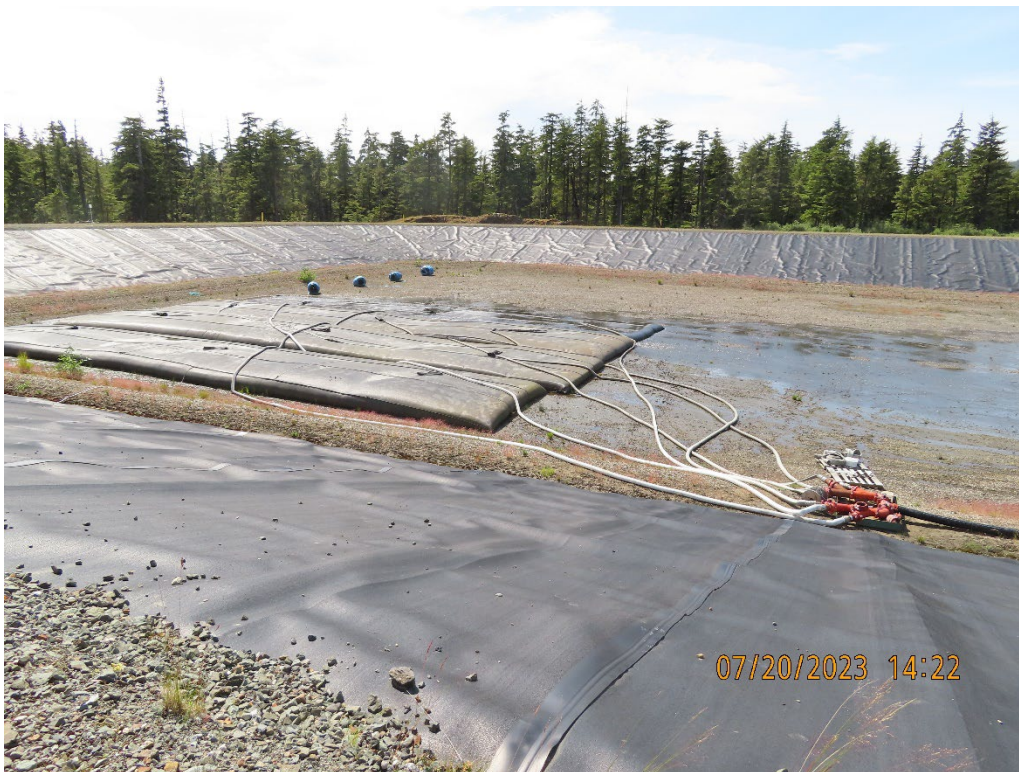
The dewatering bags staged in Pond 10 are for collecting sediments from the dredging activities at Pond 7 (Photo 15). The sediments collected in the bags will be disposed of in the TDF.

**Photo 15. Pond 10 with dewatering bags temporarily staged inside.**

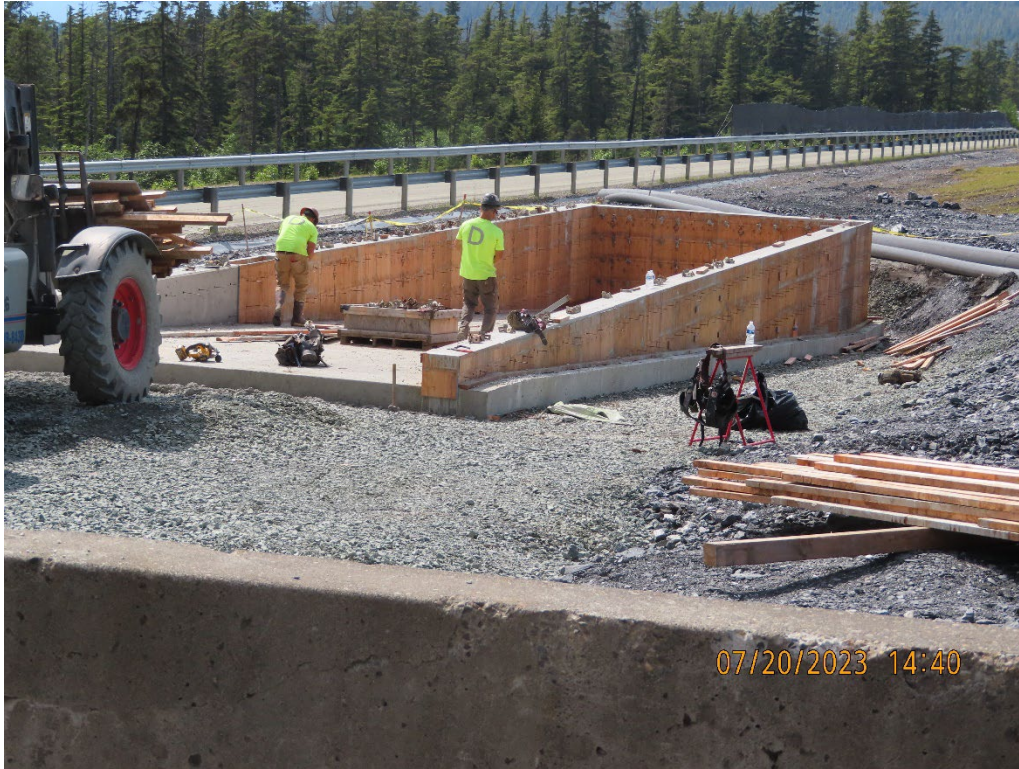
During the inspection, contractors were constructing a new degrit basin in the TDF's S3P1 southwest area to help capture sediment-laden water from entering Pond 7 (Photo 16).

**Photo 16. The construction of the TDF degrit basin.**
