PEBBLE PROJECT

2020 Reclamation Report

MLUP No. 6118

**PREPARED BY:
PEBBLE LIMITED PARTNERSHIP**

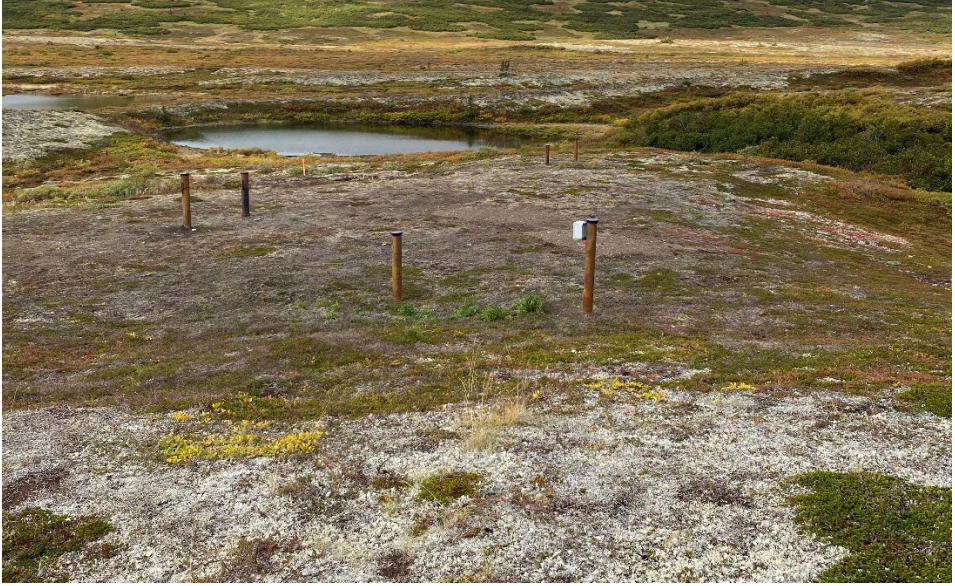
<p>1. 2019 Drill Sites & Sump Areas Date: 9/9/2020</p> <p><i>P-19-90/1/2/3, PW-19-11/12 and sump areas following final reclamation.</i></p>

Similar touch-up reclamation work was performed at nested boreholes drilled in 2019 (PW-19 and P-19 series). These boreholes were fully reclaimed in 2019 but remain active for potential use during future hydrogeological testing. Sumps were recontoured to promote better surface drainage and minimize erosion potential.

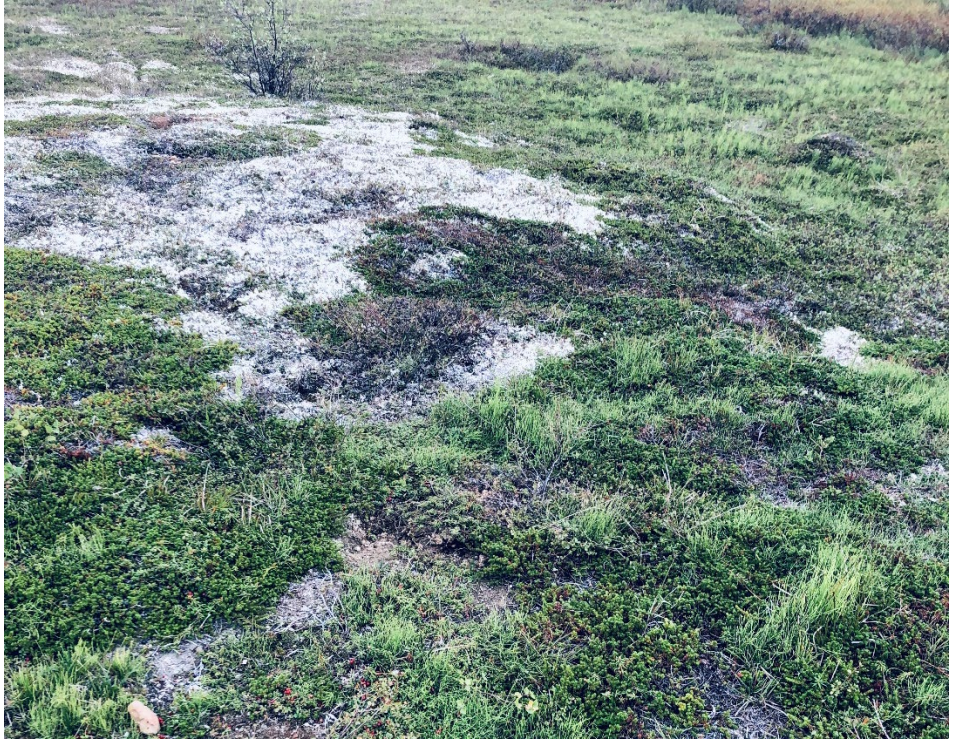
<p>2. Borehole 9475 & Sump Area Date: 8/24/2020</p> <p><i>Area following final reclamation.</i></p>

Stockpiled soil was spread across the area and contoured to approximate the site topography and minimize the potential for erosion. Salvaged vegetation was replaced on top of disturbed areas to further stabilize the ground surface.
