APMA A20166118 and A20142788 – Field Monitoring Report

Amended November 3, 2016

APMA A20146118 and A20142788 - FIELD SUMMARY REPORT

Inspection Date: 26 July – 27 July 2016
Weather: Overcast Skies with Moderate Ceiling, Intermittent Rain Squalls, Variable East Wind at 5-10 kt, Air Temp. Approx. 58° F
Time of Inspection: 26 July: 0930-1630, 27 July: 0830-1230
Agency Personnel: Hollie Chalup (Mining Section), Marty Lentz (Mining Section), David Schade (Water Resources Section)
Operator Contact: Tim Havey, Env. Manager, Pebble Limited Partnership
Pilot: John Baechler, Jr.
Inspection Objectives: Annual Inspection and Follow-Up Compliance Inspection

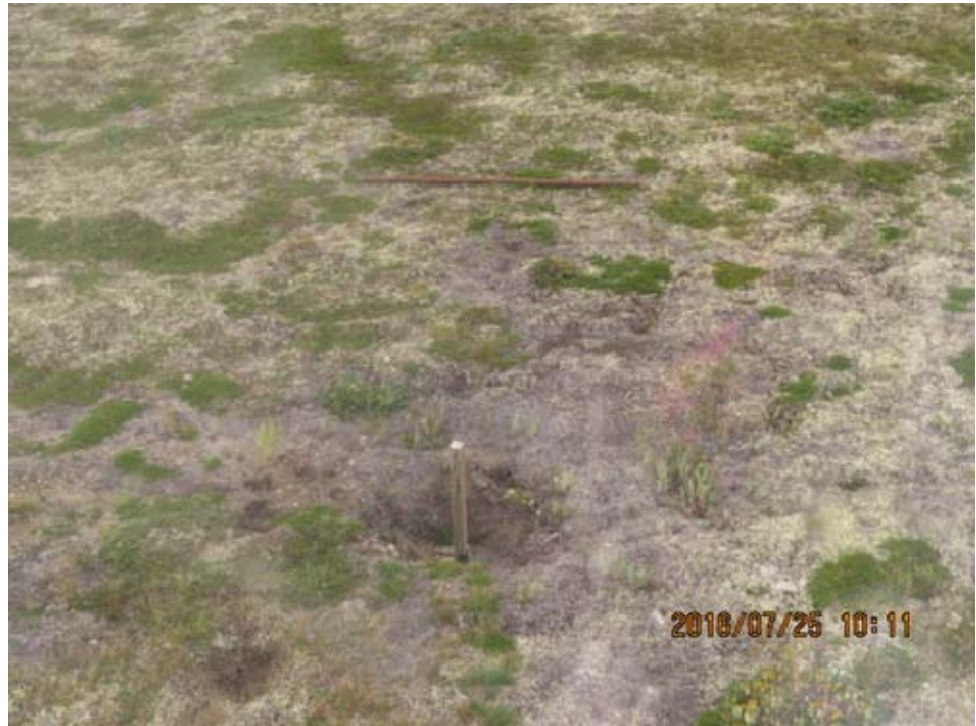
1. Borehole 12561

Borehole 12561 was inspected by PLP in 2015, who documented subsidence at the casing. ADNR staff observed continued subsidence of approximately 36" wide by 20" deep. ADNR requests PLP to measure and report any difference in subsidence from 2015. If the site continues to subside, ADNR requests that PLP investigate the cause and propose a corrective work plan.

Subsidence of an unknown origin is observed.

Subsidence extends approximately 36" W x 20" D.

Determine measured change from 2015 if any and devise work plan for resolution, which may simply include infilling.

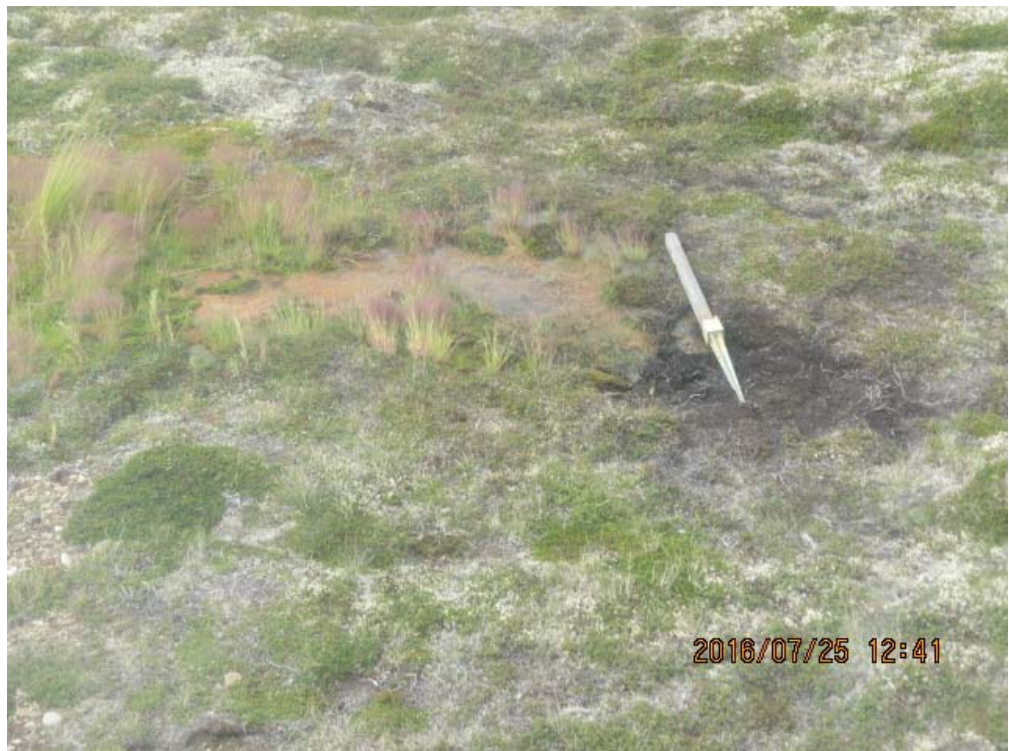
2. Borehole 8433M

Shallow groundwater appears to be daylighting at borehole 8433M. There is no casing structure at this site. PLP attempted to stop water flow in spring 2016 by packing bentonite pellets to 8'. The repair was unsuccessful. Minor iron bacteria growth and iron staining was observed at the site. ADNR requests PLP to continue to investigate the water production and submit a corrective work plan to stop the flow.

Water appears to be daylighting at the borehole.

There is no casing structure at this location. Minor iron bacteria growth.

Attempt to stop flow was made in Spring 2016 by packing bentonite pellets to 13'. The repair was unsuccessful.

Construct work plan for resolution.

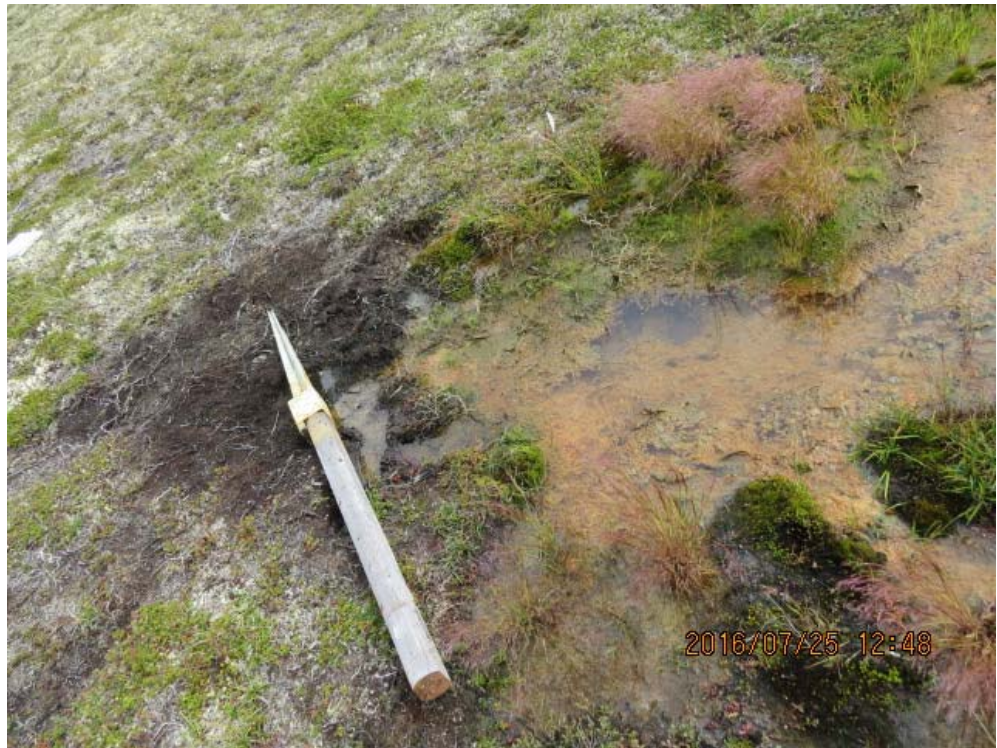
3. Borehole 8433M
26 July 2016

Standing water depth is an average of 3" with maximum depth approximately 8". Flow dissipates approximately 15' from borehole location.

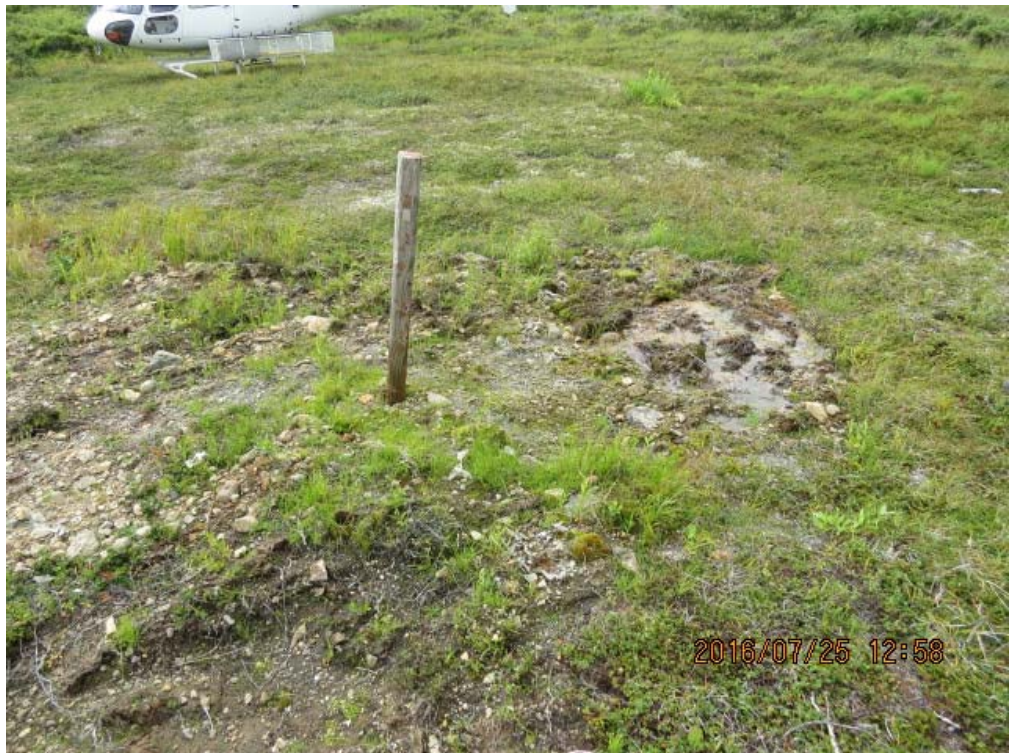
4. Boreholes 3131 and 3132
26 July 2016

Borehole 3132 shows evidence of a minor weep. The weep is no more than approximately 24" from the borehole and standing water is less than two inches deep. Nearby, Borehole 3131 was repaired by regrouting to 40' in fall 2015. This repair could potentially have generated the issue at 3132. ADNR requests PLP to continue investigating this site to determine if regrouting 3132 would be successful and to submit a corrective work plan.

Borehole 3131 was regouted in 2015 and appears to be successful (stake at left).

Borehole 3132 (right) shows evidence of a minor weep. Continue to monitor or create work plan to resolve.

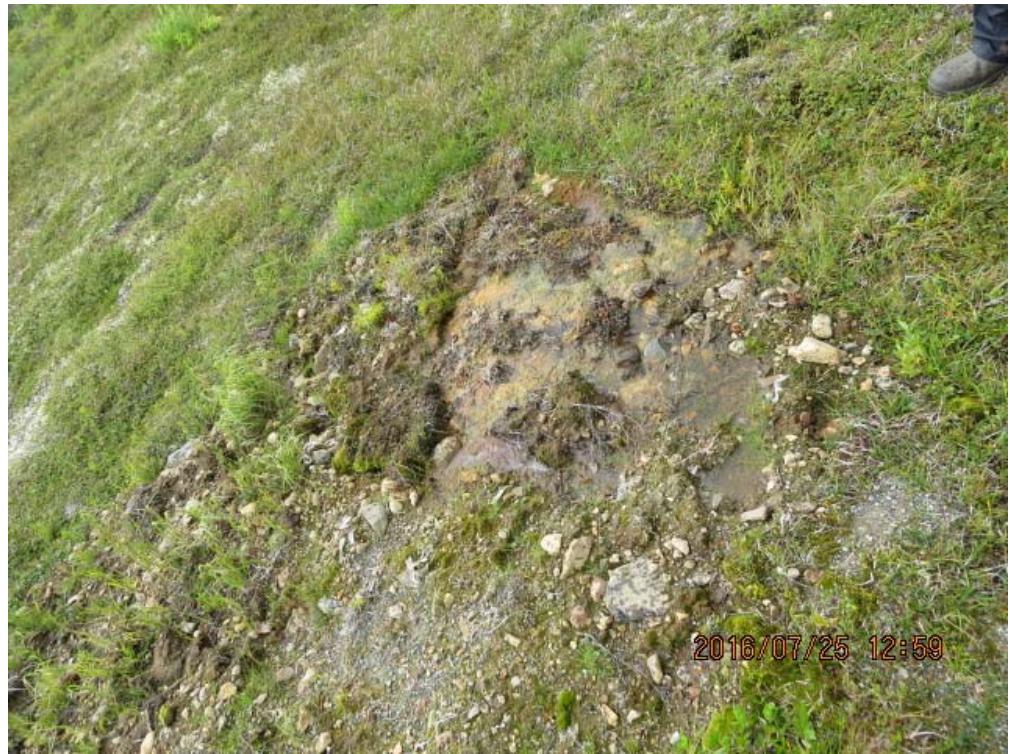
5. Borehole 3132

Weep does not extend more than 24" from borehole. Standing water is less than 2".

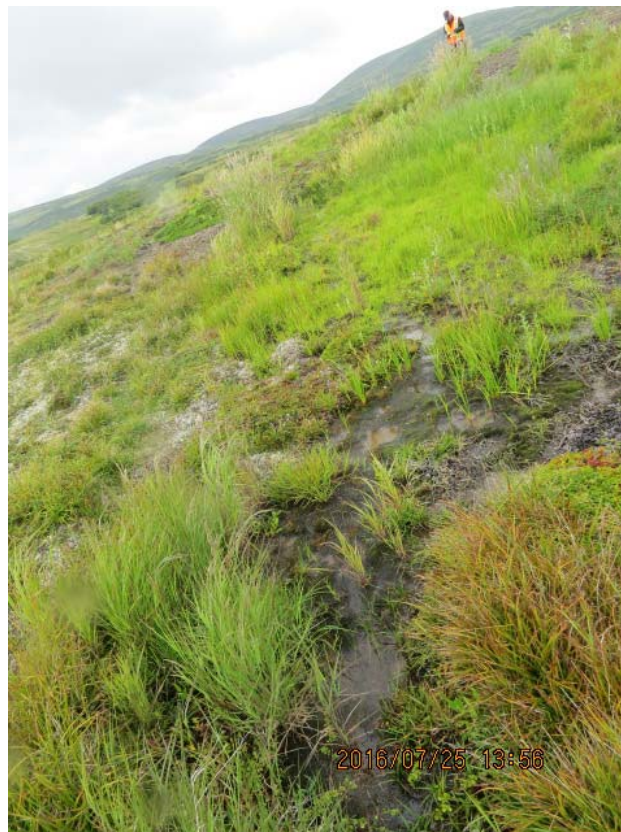
6. Borehole 9475

Borehole 9475 continues to produce water outside of the casing despite efforts in 2015 to stop water flow. In September 2015, PLP grouted the casing at a depth of 40' on one side and 80' on the other using a mixture of sand, cement and bentonite. Water discharging from the site flows downhill to the west approximately 132' before dissipating into the surrounding vegetation. The water catchment trench and sump were successfully reclaimed in 2015 and reseeding efforts appear to be successful. ANDR would like PLP to continue to investigate a resolution at Borehole 9475 and monitor vegetation growth.

Repaired in 2015 by grouting exterior, but grout failed in spring 2016. Photo taken from dissipation point (44 yards or 132' using handheld rangefinder) with staff standing at borehole marker.

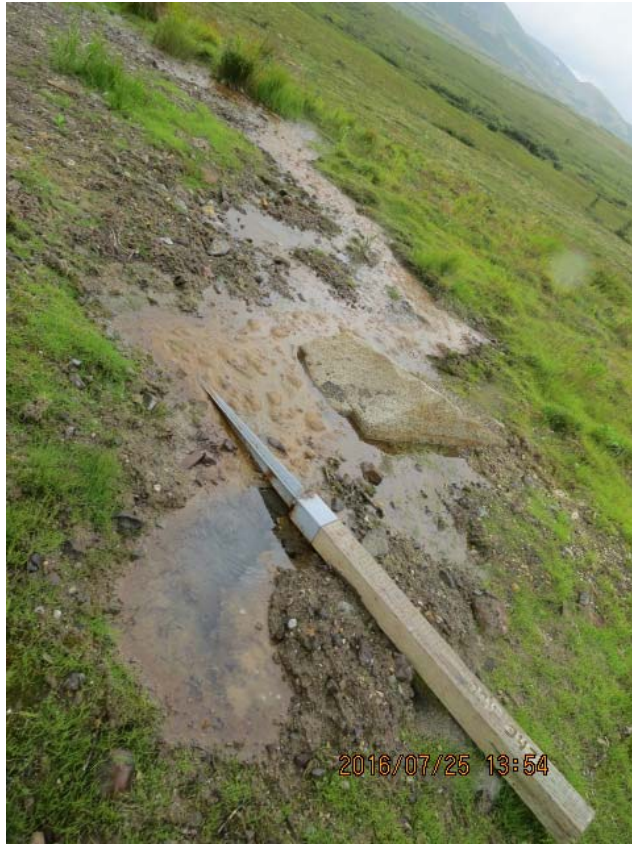
7. Borehole 9475

Water production from failed 2015 repair. Water flow extends downhill before dissipating into the tundra. Iron bacteria growth was observed. Surrounding area was reseeded in spring 2016.

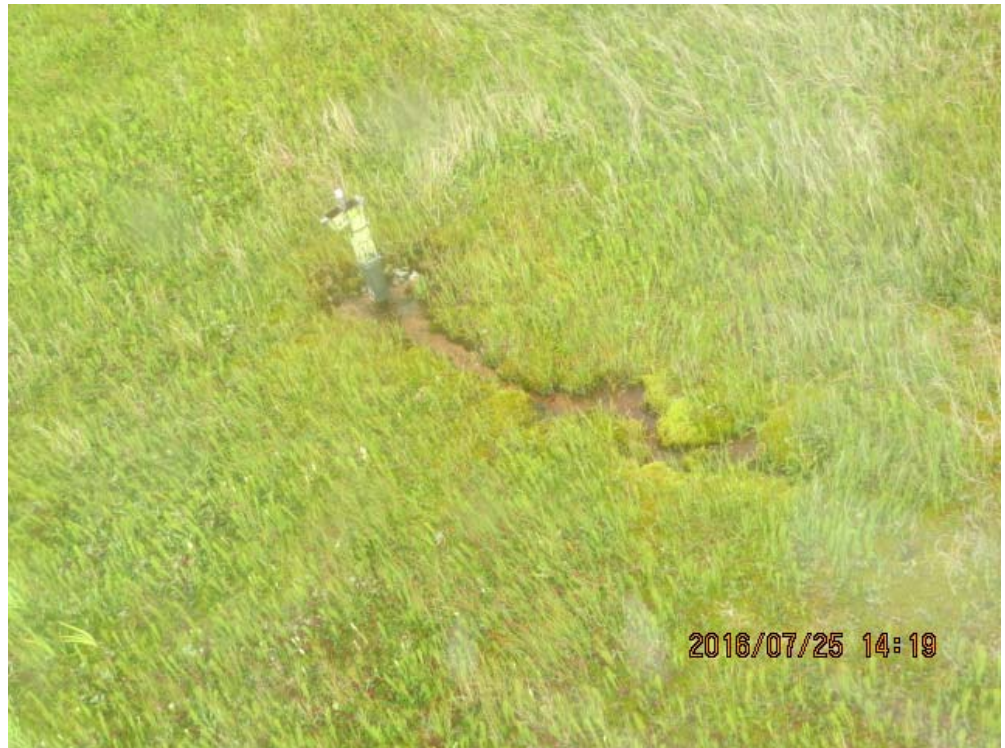
8. Borehole GH08-156

Borehole GH08-156 displays minor upwelling which dissipates approximately 8-10' from the casing. Minor iron bacteria growth is present and flow is beginning to channelize. ADNR requests PLP to investigate the origin of water production and submit a work plan for resolution.

Minor upwelling was observed. The origin is not clear. Channelization and minor iron bacteria staining has begun. Water flow extends approx. 8-10' before dissipating into the tundra.

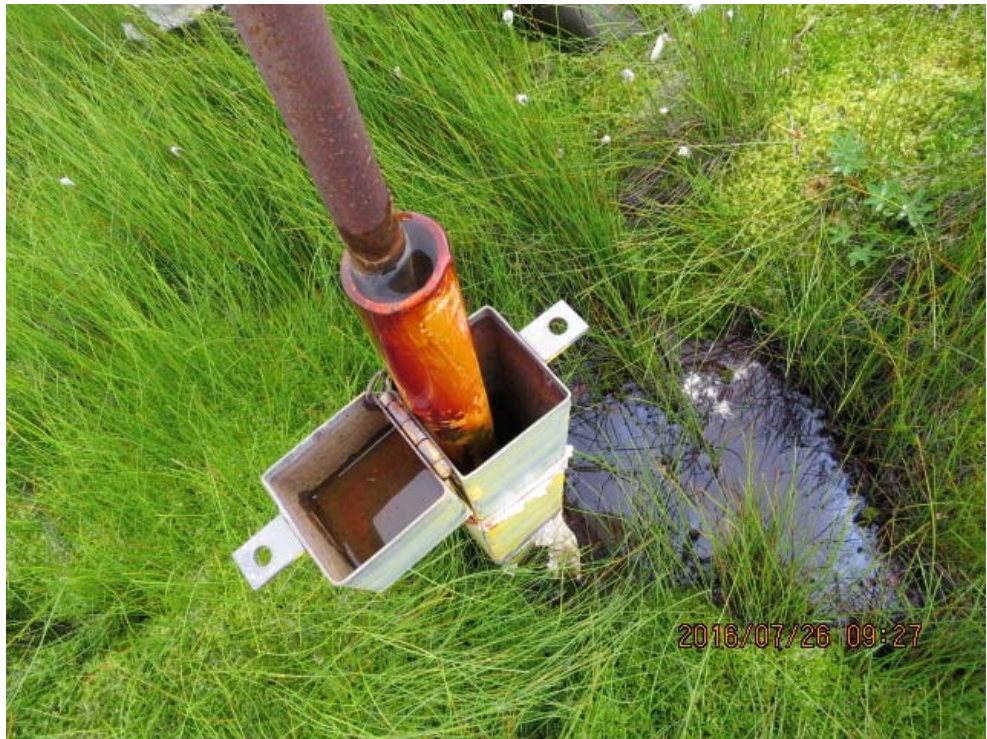
**9. Borehole
GH06-072**
27 July 2016

Borehole GH06-072 is located in a saturated lacustrine marsh of Frying Pan Lake. The casing is producing a very minor upwelling with an estimated flow of less than one-half gallon per minute. The Margo plug is rusty and likely the cause for the condition. The sheen observed on the water dissipates with disruption and is likely caused by anaerobic bacteria converting methane into larger hydrocarbons⁵. The sheen did not act like a petroleum product and no samples were taken. ADNR request PLP to upgrade the rating of this borehole from 1-D to 1-B until repairs are documented as successful.

Water production from within the casing is estimated at less than 0.5 gpm. A small pool has gathered at the base of the casing. Organic sheen on water dissipates with disruption.

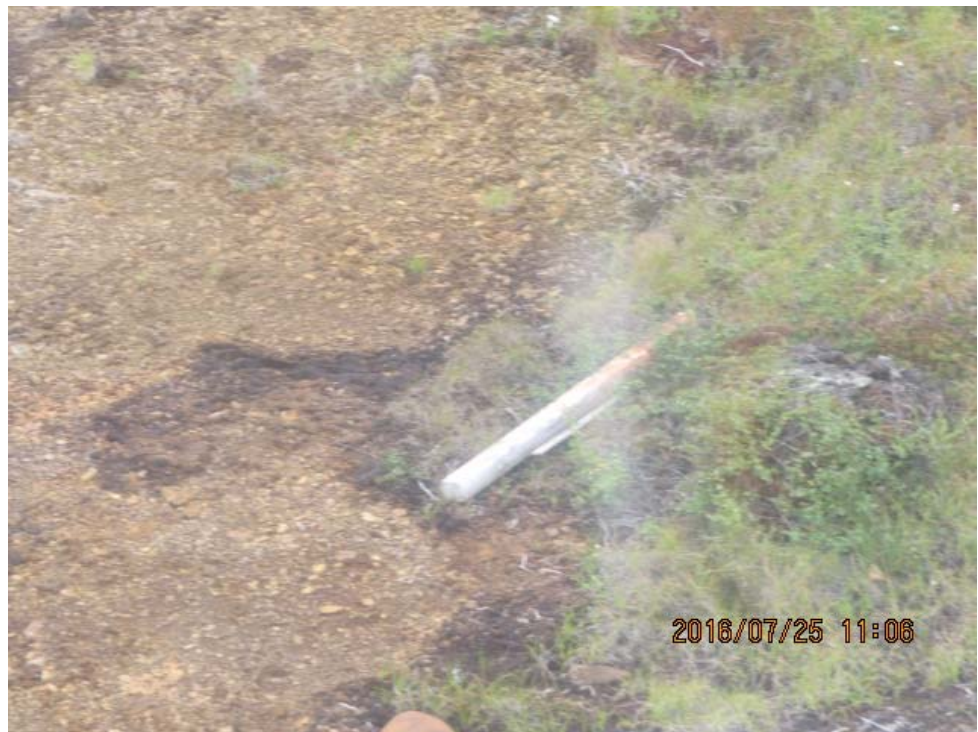
**10. Borehole
4279**
26 July 2016

Borehole 4279 was documented in 2015 with ponded water of unknown origin. In spring 2016, PLP attempted a repair by filling the borehole with bentonite and pulling the identification post to reduce the opportunity for shallow groundwater to migrate upwards. The repair appears to have helped, but has not completely resolved the issue. ADNR requests PLP to continue to investigate the cause of ponding, and submit a work plan for resolution.

Borehole was repaired in spring 2016. Repairs have slowed water production but not resolved them.

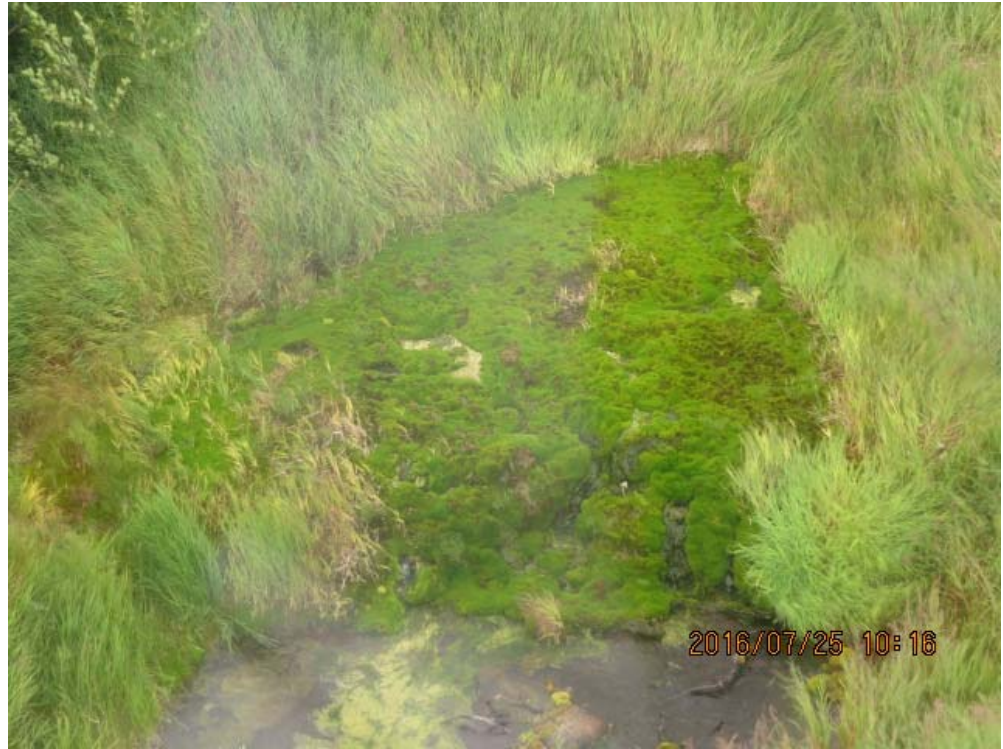
**11. Borehole
4223**

Low-level aerial view shows site remains stable since 2015 inspection.

No discoloration of discharge location or immediate area was observed.

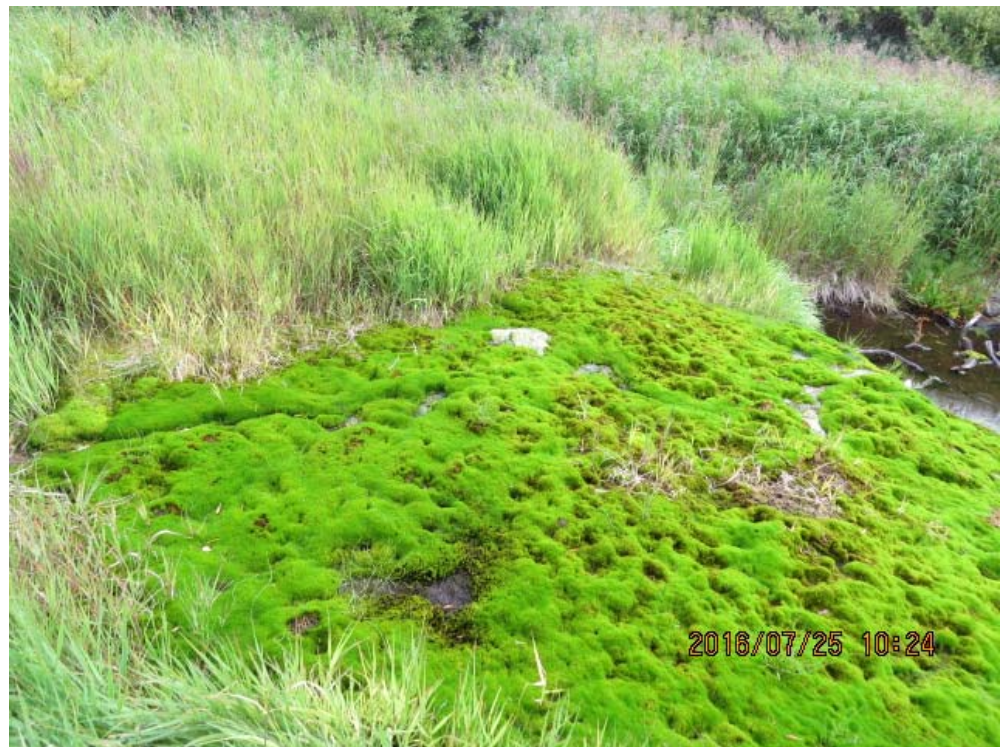
**12. Borehole
4223**

Borehole marker is just left off frame. Channel from 2015 can be seen through mid-ground. Small volume of water continues to flow. Site is considerably dryer in 2016 than 2015.

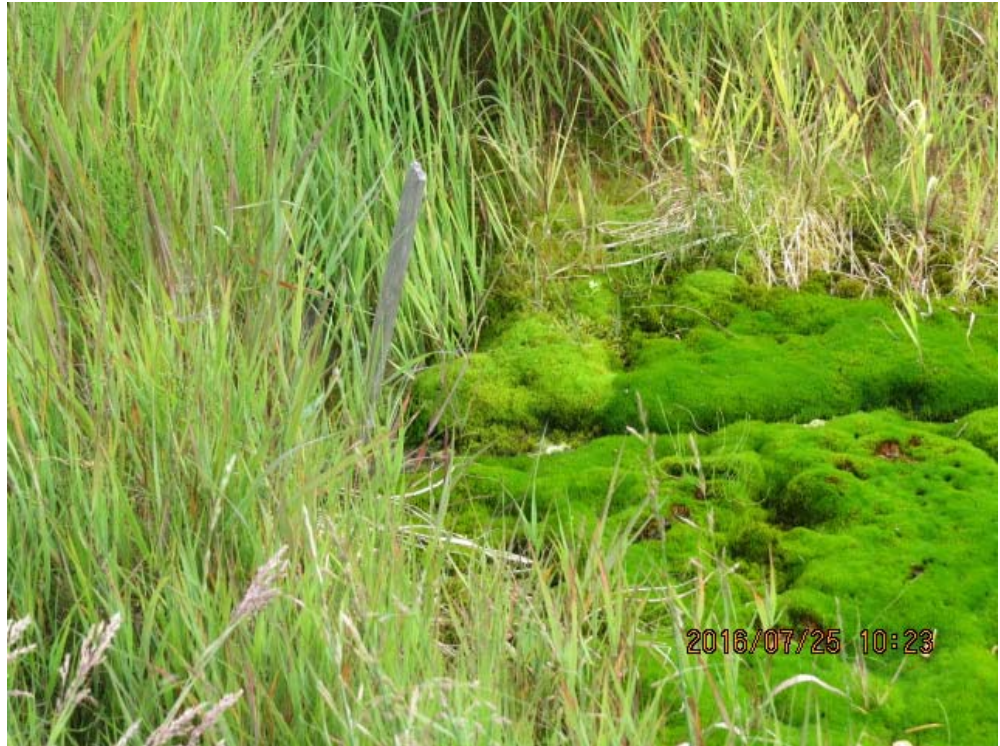
13. Borehole 4223
26 July 2016

Marker indicating borehole location. An approximate 7" deep by 5" wide channel is established but water flow is quite low.

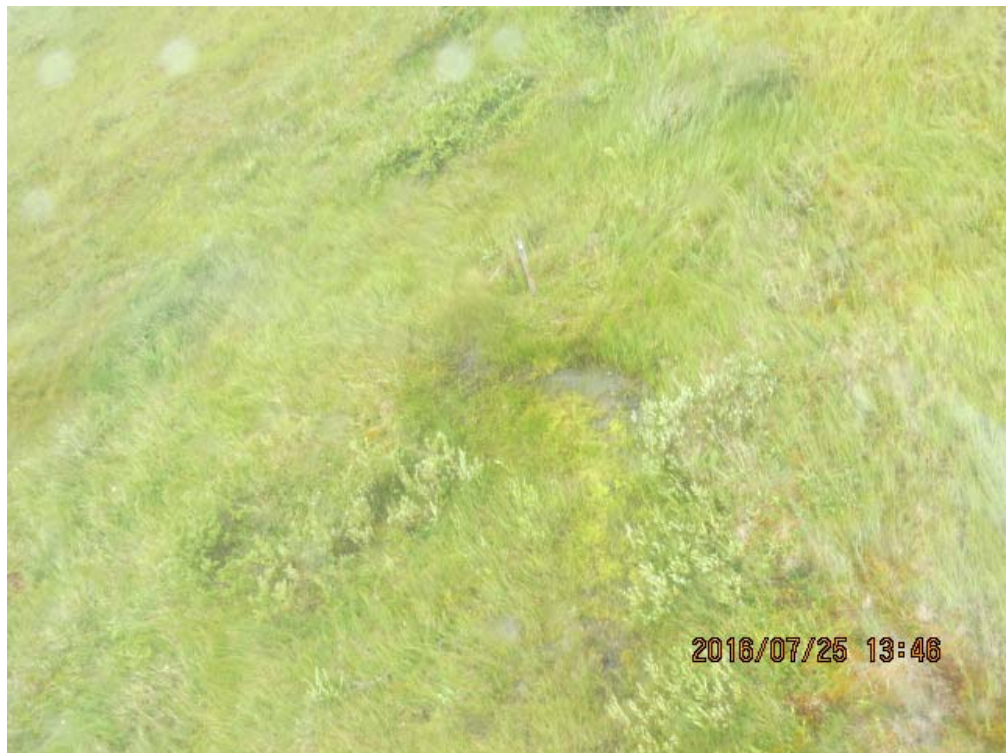
14. Borehole 5332
26 July 2016

Borehole 5332 is producing a small flow of water in an area of known artesian conditions. The water flow is minimal and does not enter a surface water body. No staining was observed. ADNR requests PLP to investigate the cause and submit a work plan for resolution.

Minor upwelling is observed in an area of known artesian conditions. May be upwelling of shallow groundwater.

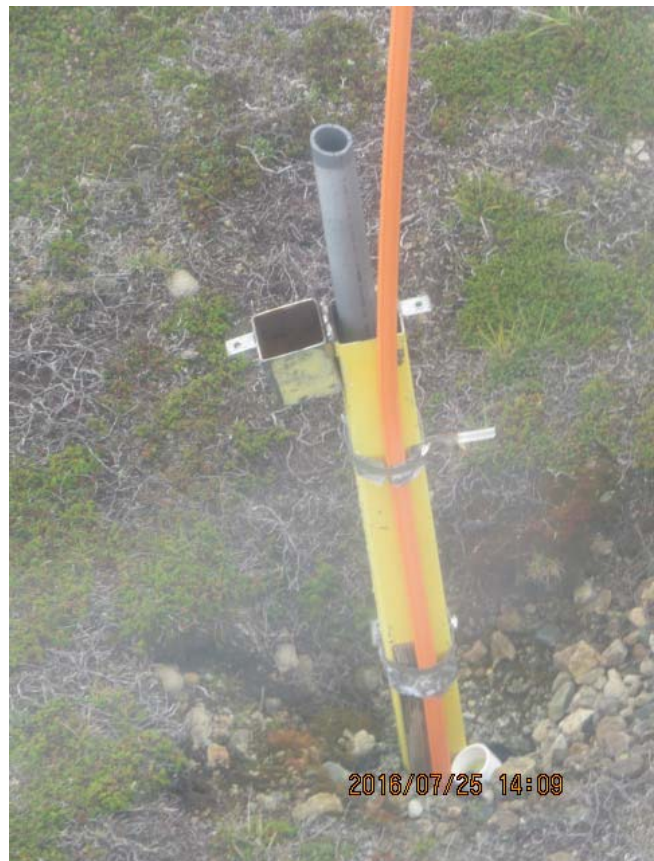
15. Borehole GH11-236

Borehole GH11-236 may be experiencing subsidence. The approximate diameter of the depression around the casing is 32" wide and 16-18" deep. ADNR requests PLP to measure and monitor the depression to determine if the location is subsiding. If subsidence is not evident, PLP should fill the depression. If subsidence is likely, ADNR requests the operator to identify the potential cause and submit a corrective work plan.

Subsidence was observed surrounding the casing at Borehole GH11-236. There is no standing water in the depression. The depression was noted in 2015 and should be monitored to assess movement.

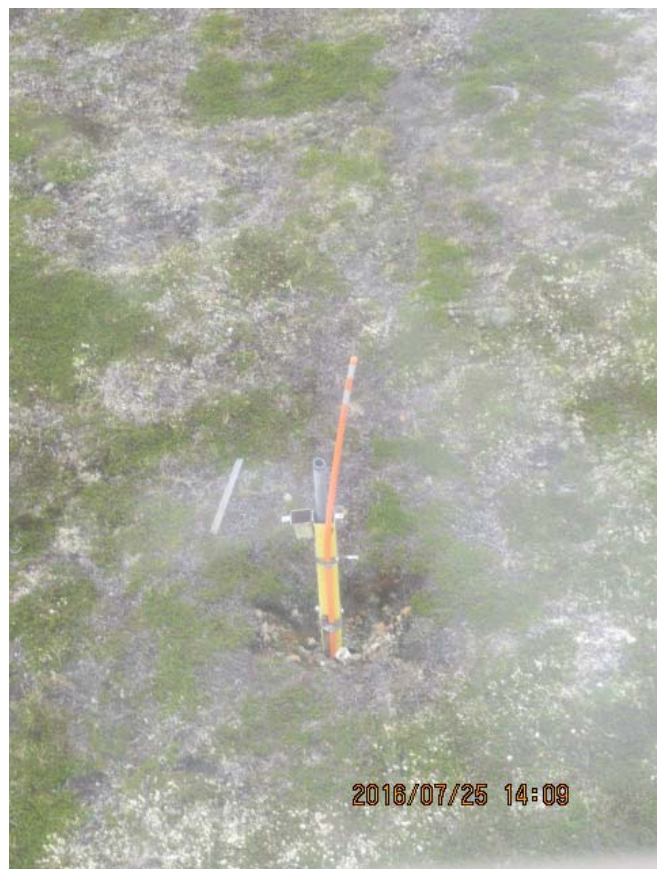
16. Borehole GH11-236

Depression observed is approximately 32" wide and 16-18" deep.

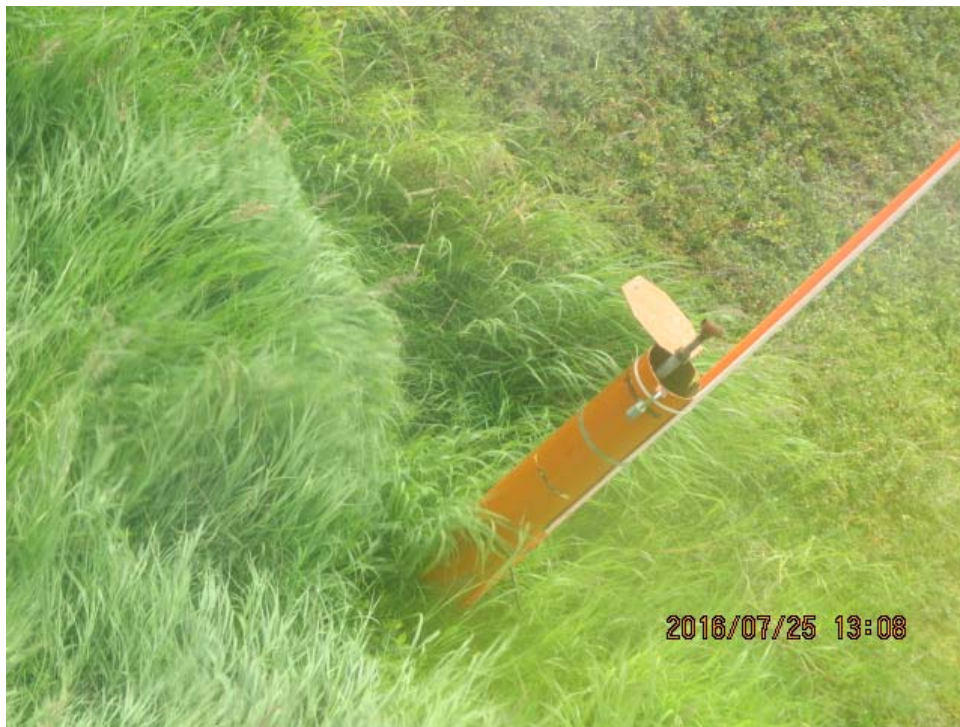
**23. Borehole
SRK-5D**
26 July 2016

Borehole SRK-5D was observed producing water under artesian pressure in October 2015 by PLP. Placement of a new Margo plug in June 2016 remedied condition and is now stable. No impacts to surroundings or vegetation was observed.

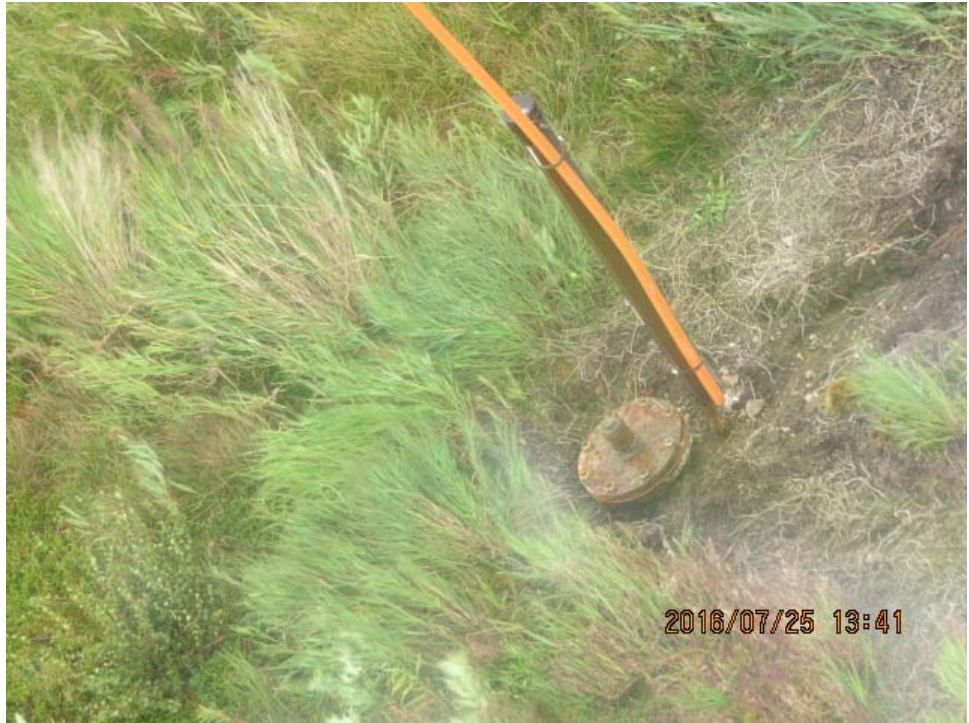
**25. Borehole
GH11-292S**
26 July 2016

Replaced cap in July 2016. Repairs appear to be successful.

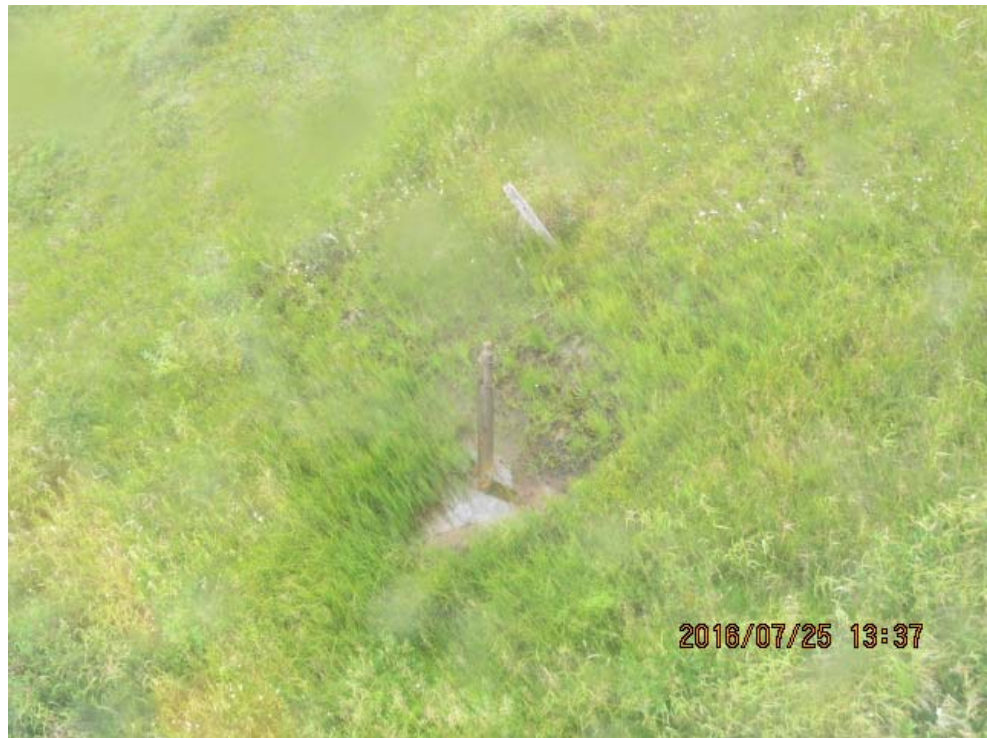
High artesian condition was repaired when a new Margo plug was placed in 2015. Surface water may be ponded precipitation or shallow groundwater. Re-inspect in 2016 to verify. New vegetation growth was observed.

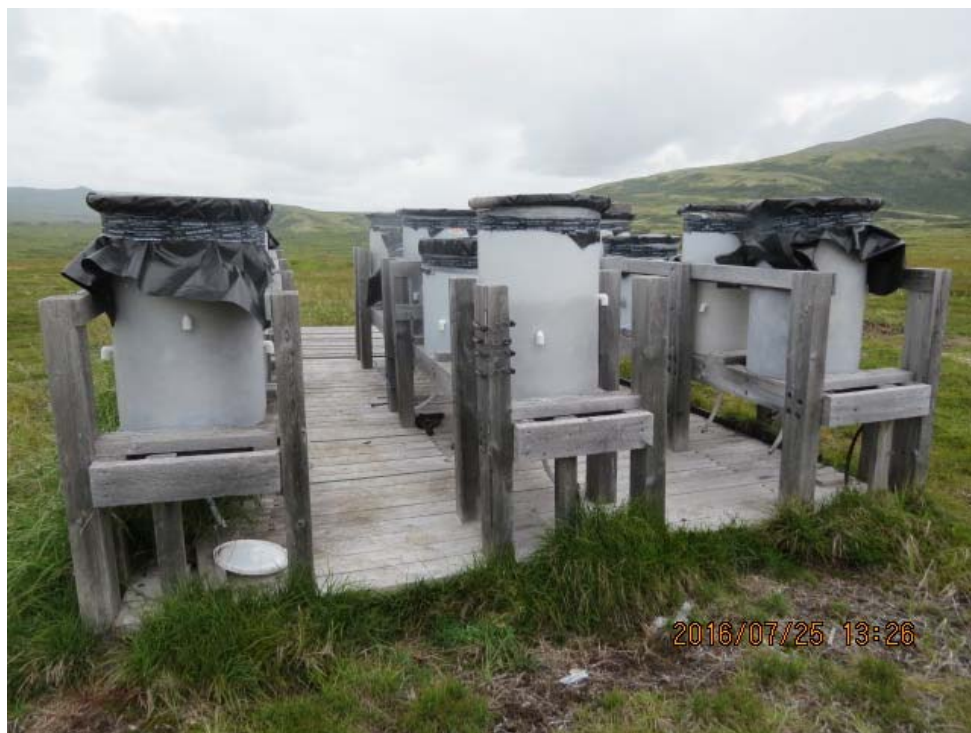
**38. Acid Rock
Drainage Barrel
Test Site**

The ARD Test Site is comprised of twelve poly drums containing rock material. All inlets and outlets to the drums are adequately sealed. PLP described having trouble with avian wildlife disrupting the tops of the barrels. PLP plans to replace the plastic tops with aluminum or other more durable lids. All drums are located on a tundra pad and no water was present onsite. No discoloration or other indicators of leakage were present. ADNR requests PLP continue to monitor regularly and to replace lids to prevent perforation. Any repairs or modifications should be detailed in the annual reclamation report.

Test site was observed in stable condition. No water or ponded precipitation was observed. Barrel lids were intact during visit. Operator informed ADNR that lids would be replaced with impermeable material to prevent avian wildlife from compromising lid integrity.

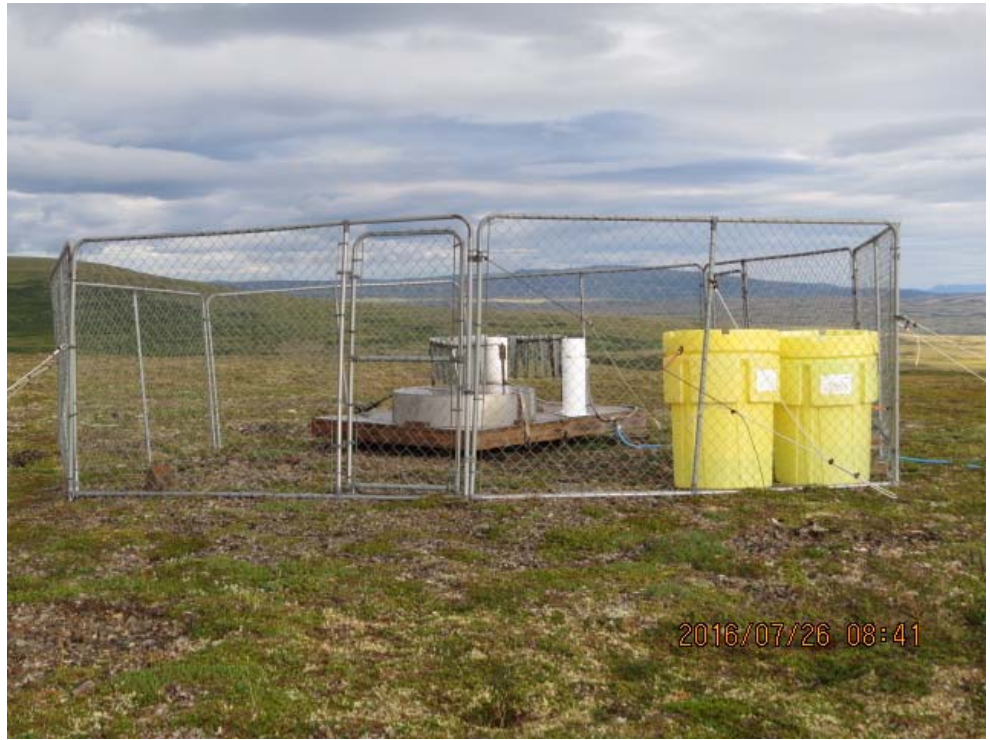
**45. Pebble 1
Meteorological
Observation
Station**

The Pebble 1 Meteorological Station is orderly. Relay maintenance at this site has been delayed by several years, however, the station continues to collect data. ADNR requests PLP to identify and report the nature of the liquid in two yellow poly containers kept onsite. All containers are in good condition but the contents are unknown.

Equipment in center is used for rainfall measurement. Two poly drums are filled 1/3 of an unknown liquid. ADNR has requested PLP identify and report contents (rainwater likely).
