## Field Monitoring Report -- Pebble Copper/Gold Exploration Project --

Personnel: Kate Malloy (ADF&G)	Inspection Date: 5-24-2011
Ron Benkert (ADF&G)	Site Contact: Jeff Norberg (PLP)
	APMA #: A116118
<b>■ Inspection Type:</b> <input type="radio"/> Complete: x <input type="radio"/> Partial: <input type="radio"/> Follow-up: <input type="radio"/> Response to Public Complaint:	<b>■ Wildlife Observed:</b> <input type="radio"/> Bear: <input type="radio"/> Caribou: <input type="radio"/> Moose: <input type="radio"/> Waterfowl: <input type="radio"/> Fish: <input type="radio"/> Other: 2 ptarmigan
<b>■ Weather Conditions:</b> <input type="radio"/> Temperature: 36 degrees F <input type="radio"/> Wind: 28 mph, with gusts up to 37 mph <input type="radio"/> Precipitation: None <input type="radio"/> Visibility: Good, approx. 10 miles <input type="radio"/> Sky Conditions: Overcast but high ceiling <input type="radio"/> Ground Conditions: Some snow still present	
<b>■ Comments:</b> Pipes were observed laying on the tundra at DDH 11526/11527. The crew was instructed to move pipes onto the tundra pad and this was corrected during the inspection. DDH 11528 had areas on the tundra where drill water had

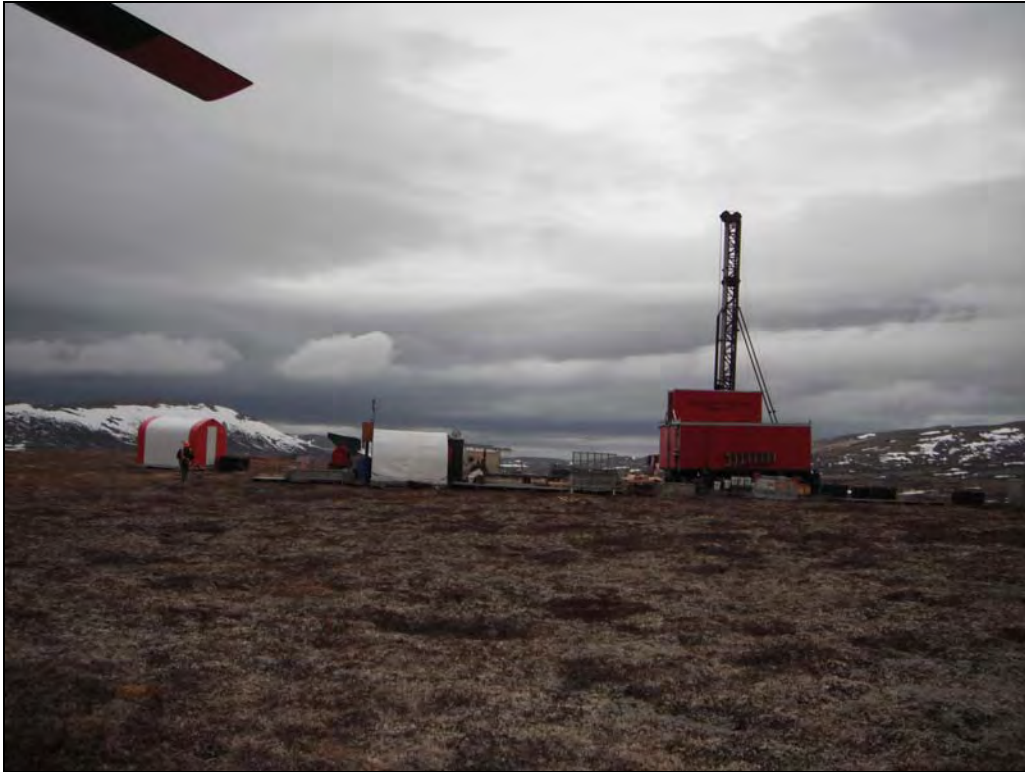
Figure 1. Drill rig # 2 on site of DDH 11526/11527.

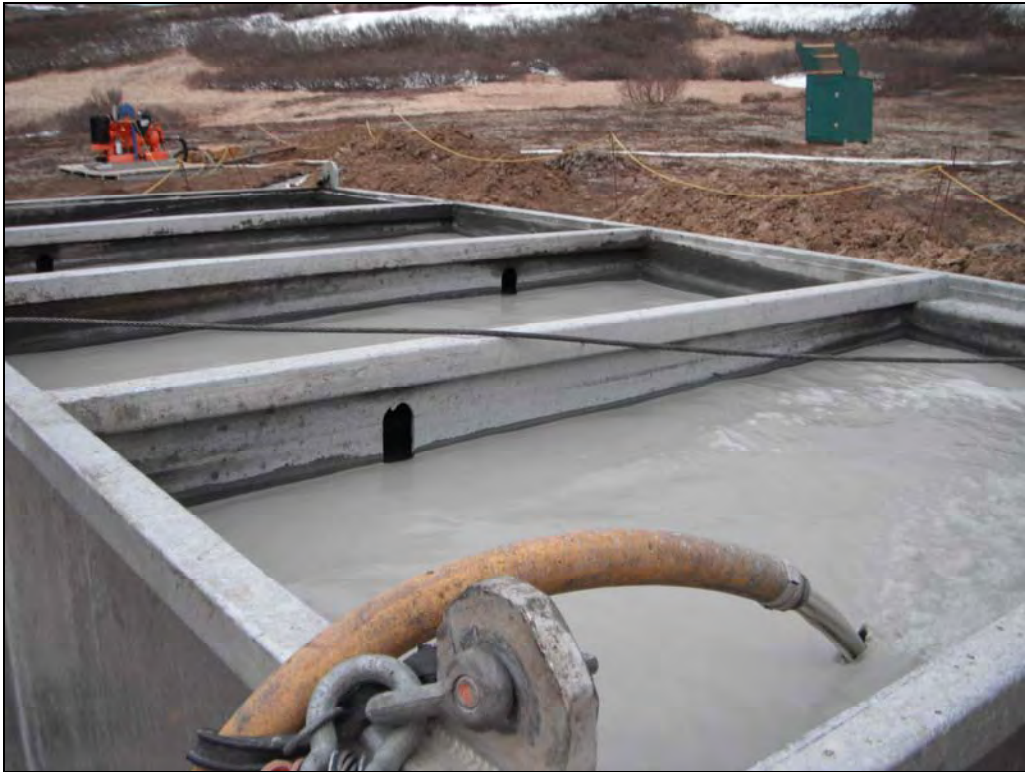
Figure 2. Recirculation tank in use. Drill water from final sump pit is recirculated back to drill for reuse.

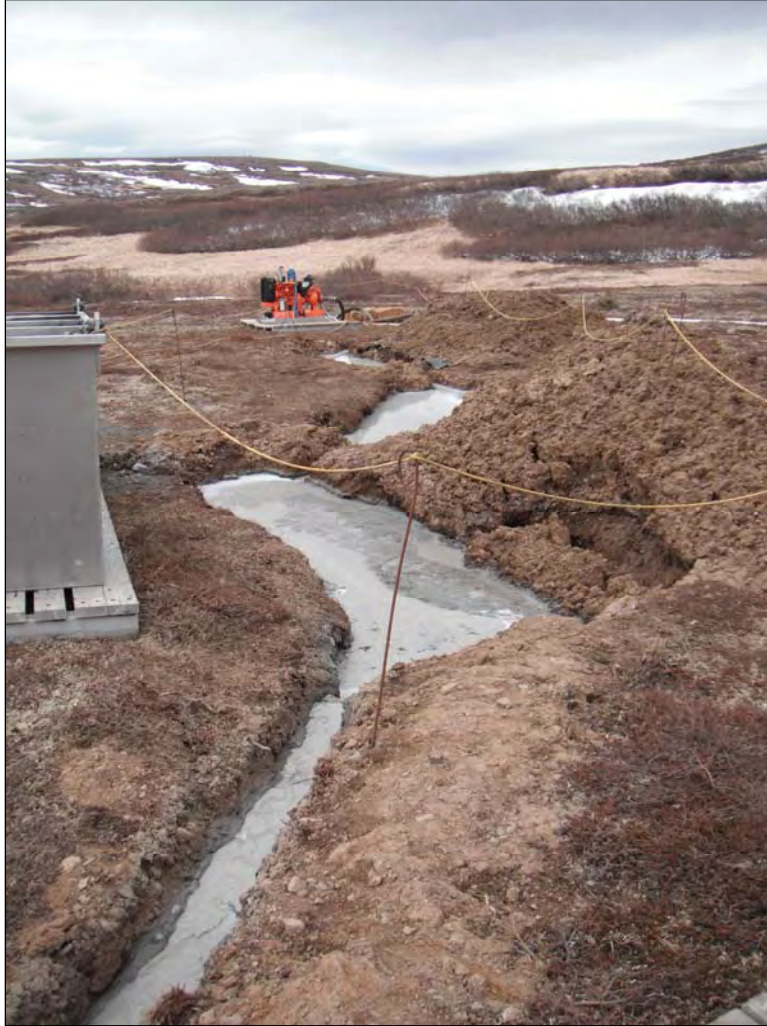
Figure 3. Series of sump pits (left) and stockpiled muck (on right) to be used later in site reclamation.

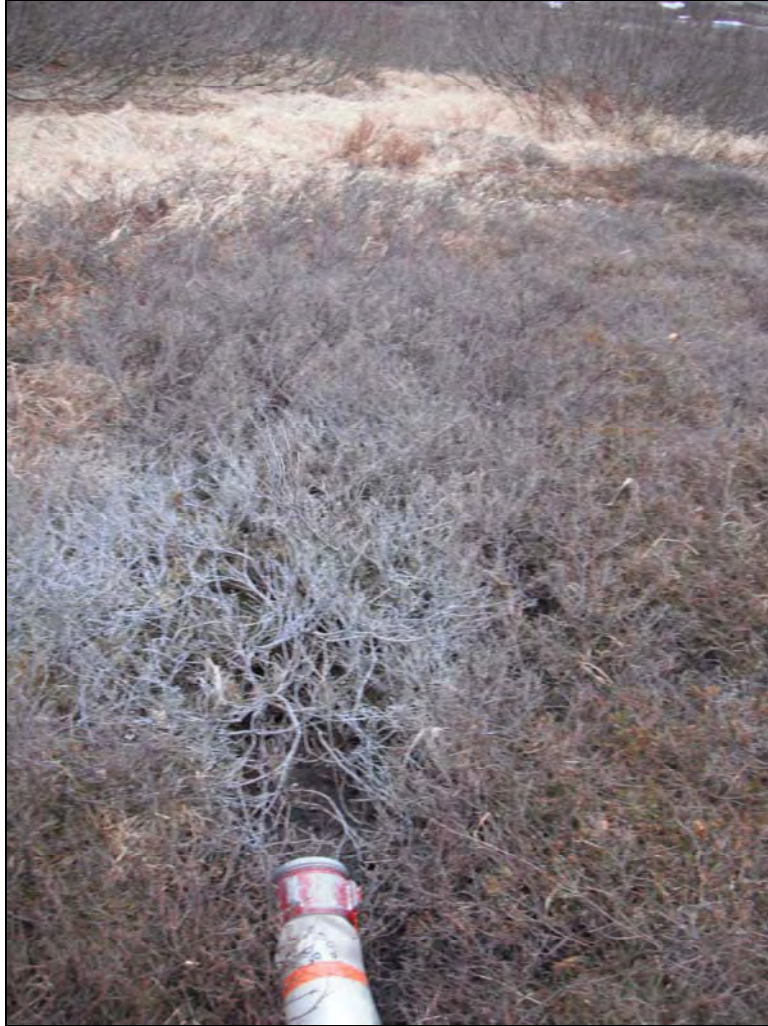
Figure 4. End of sump pit discharge line. Ground is temporarily discolored from drill water that was previously discharged. Water absorbed well in immediate area and with no run-off visible.

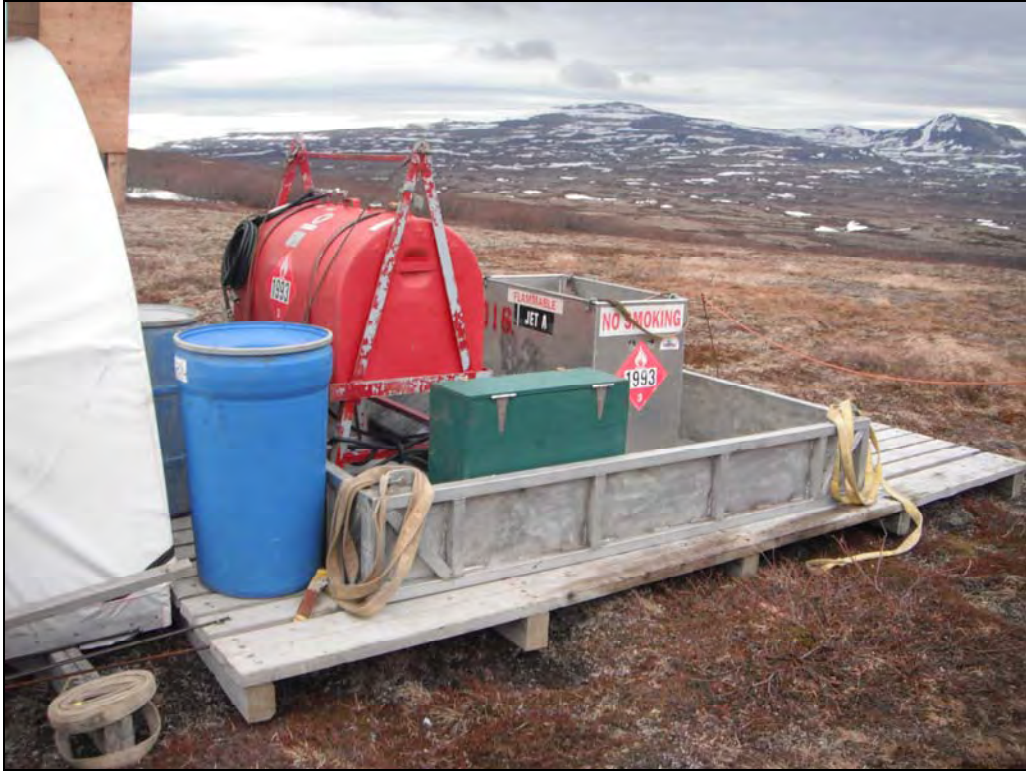
Figure 5. Fuel storage in catch basin on tundra pad, with spill kit and scrubbers (blue bin).

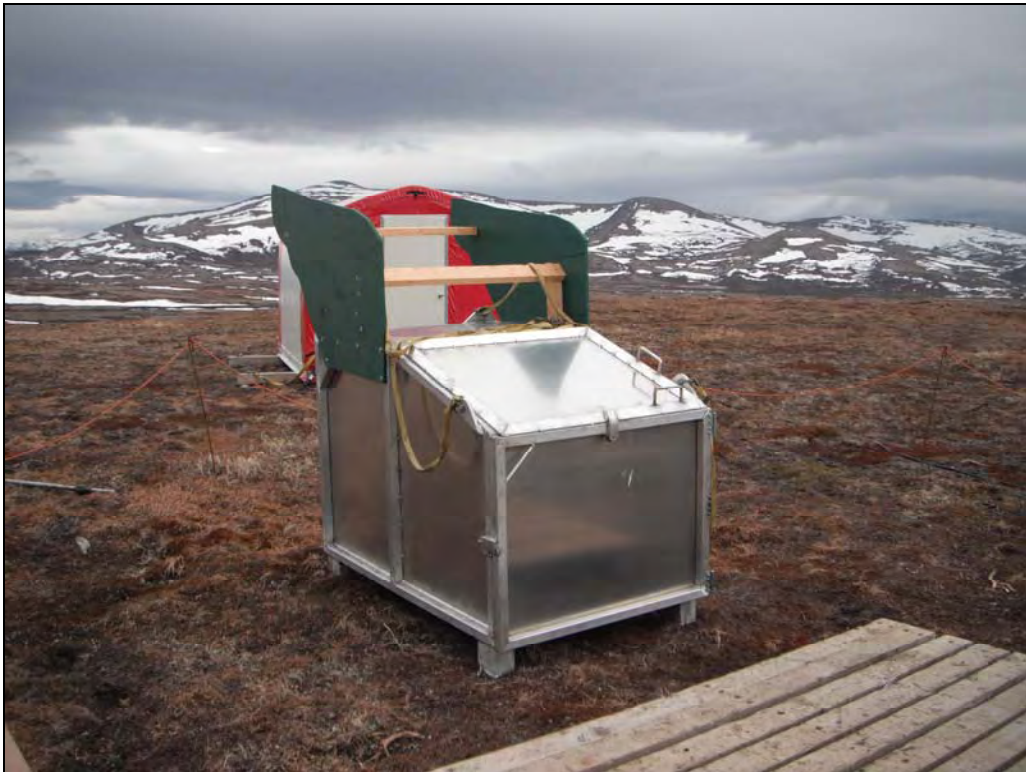
Figure 6. New aluminum dumpsters for trash containment.

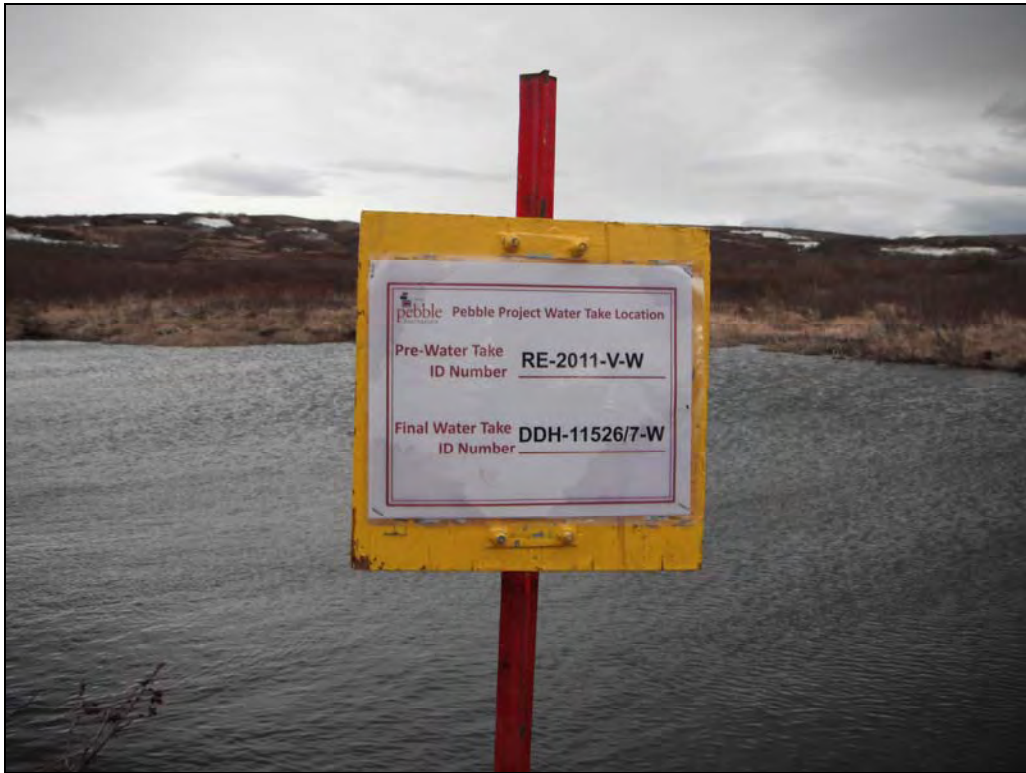
Figure 7. Proper signage designating the water take location with the identification numbers.

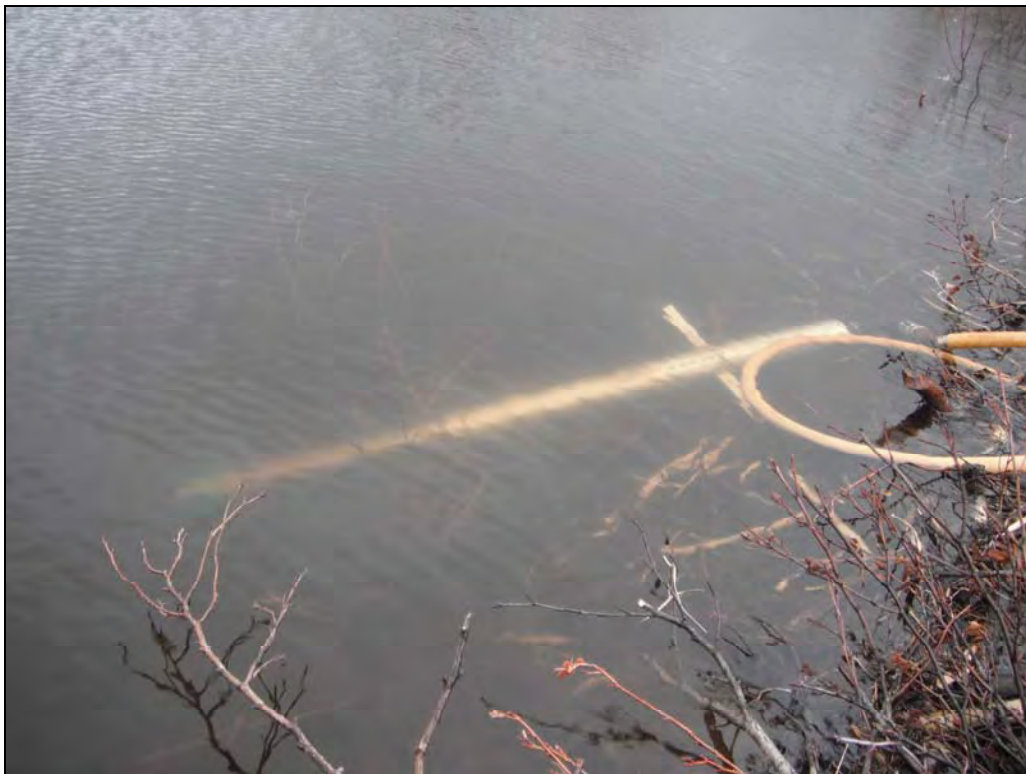
Figure 8. Screened water intake submerged in beaver pond.

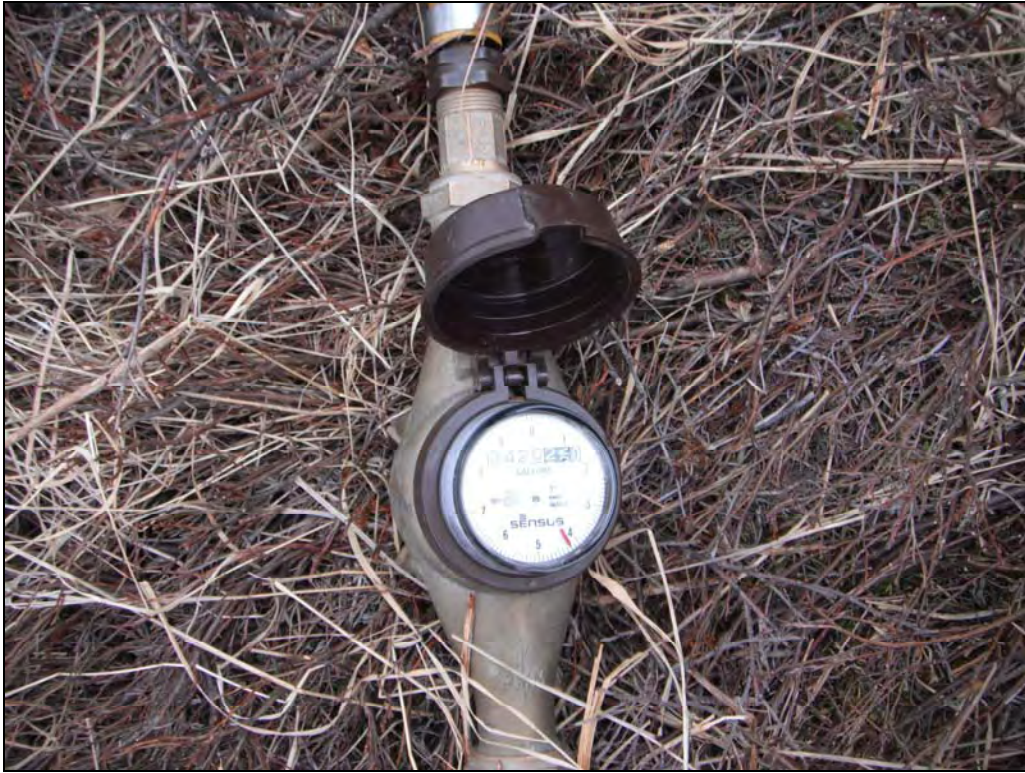
Figure 9. Totalizer connected to water intake line. Field estimate of water withdrawal rate was 23 gpm during the inspection.

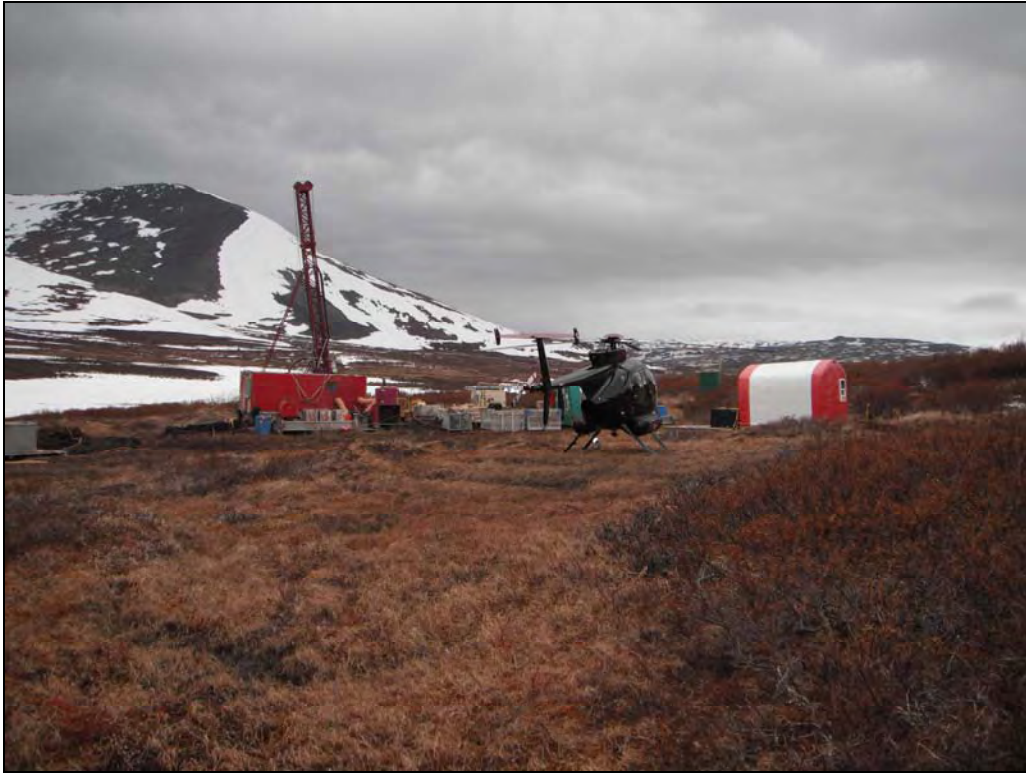
Figure 10. Drill rig # 3 on site of DDH 11528.

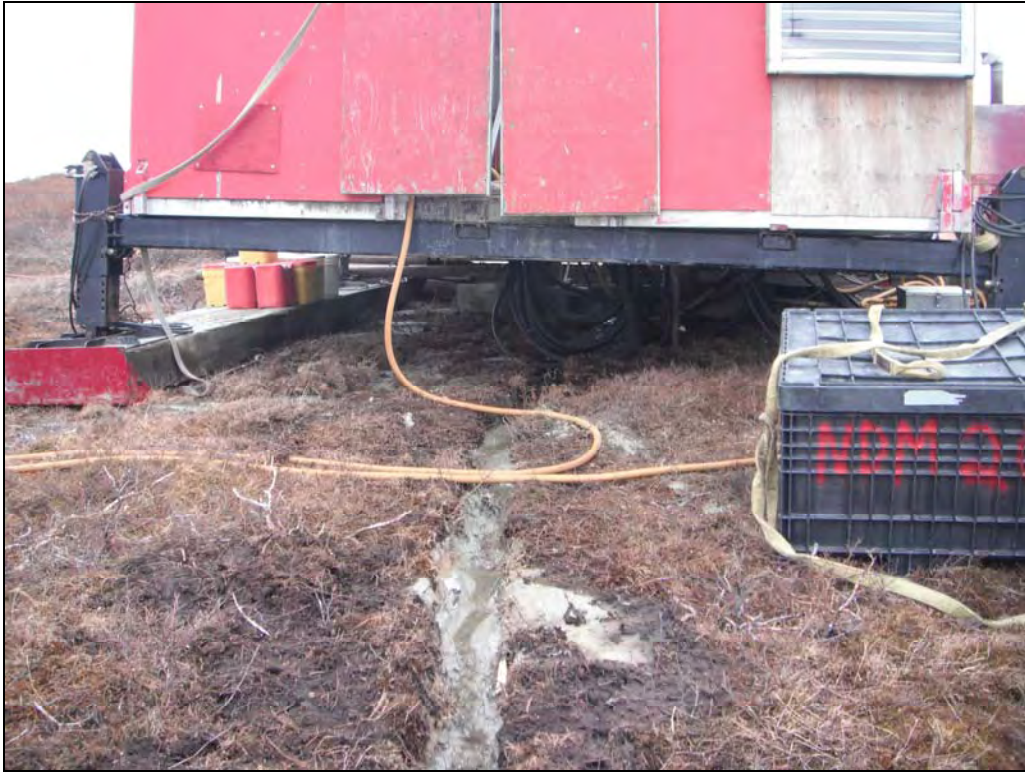
Figure 11. Trench transferring drill water from drill hole to the series of sump pits for settling out and recirculation.

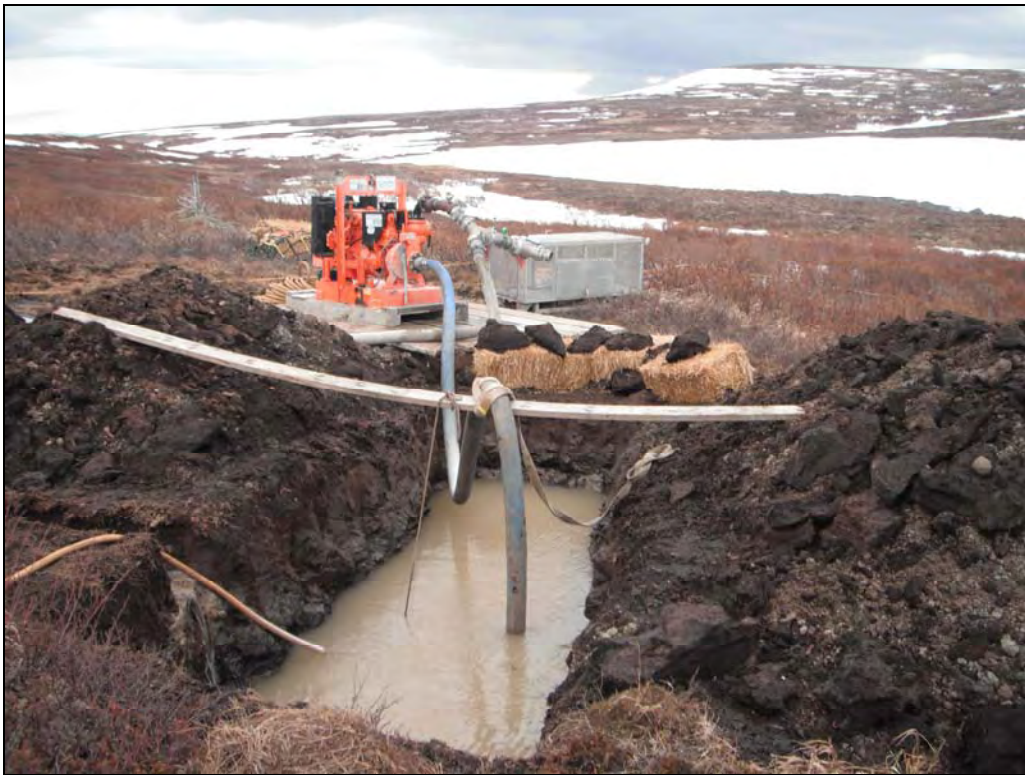
Figure 12. View of the final sump pit in a series of 3 pits. Muck and soil are stock piled on both sides of the sump pit for use in reclamation of the site. Straw bales are in place down gradient as a preventative measure should there be any overflow from the sump pit.

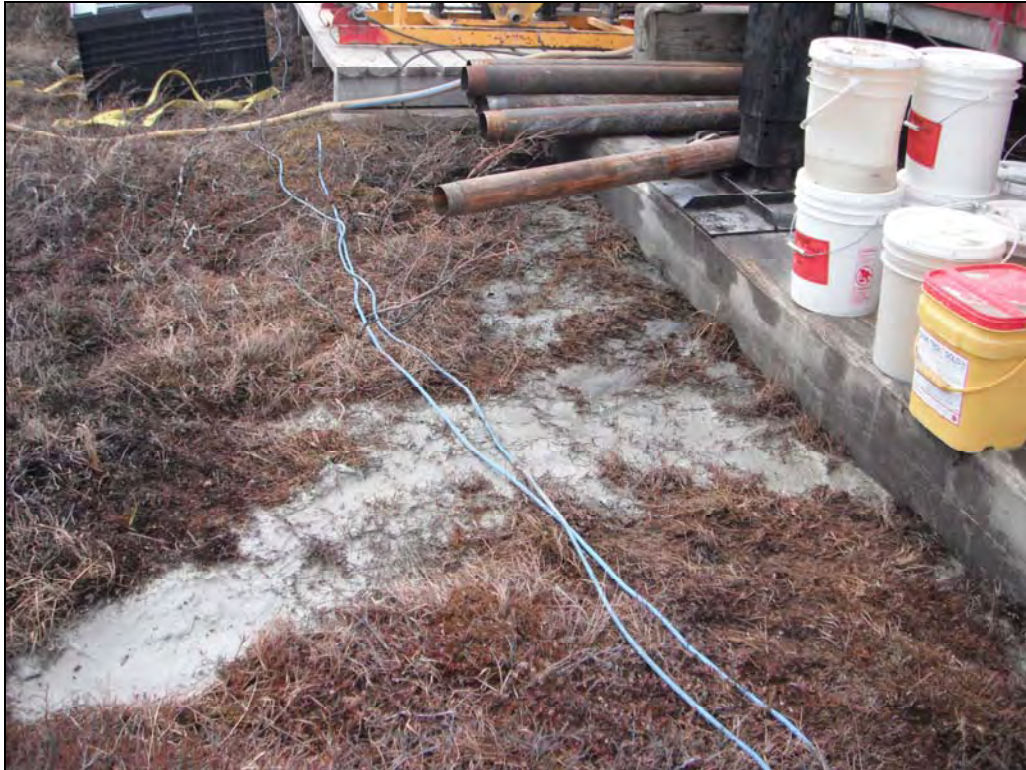
○ Discharge trench: Yes	■ Other Comments: Areas of overflow/seepage near drill hole and from trench.
○ Dimensions of pit: 5' (w) x 4-6' (d) x 20' (l)	
○ In use: Yes

Figure 13. Presence of drill water on tundra adjacent to storage location of additives. This appeared to be overflow from the trench between drill hole and sump pits.

<b>■ Recommendations:</b> It was recommended that the crew move the pipes off the tundra and make sure that they do everything possible to avoid overflow of drill water onto tundra. In this case, the drillers encountered water and were trying to cement the hole to stop flow. Not sure if they could have really done anything differently.	
<b>■ Actions Needed:</b> See above recommendations.

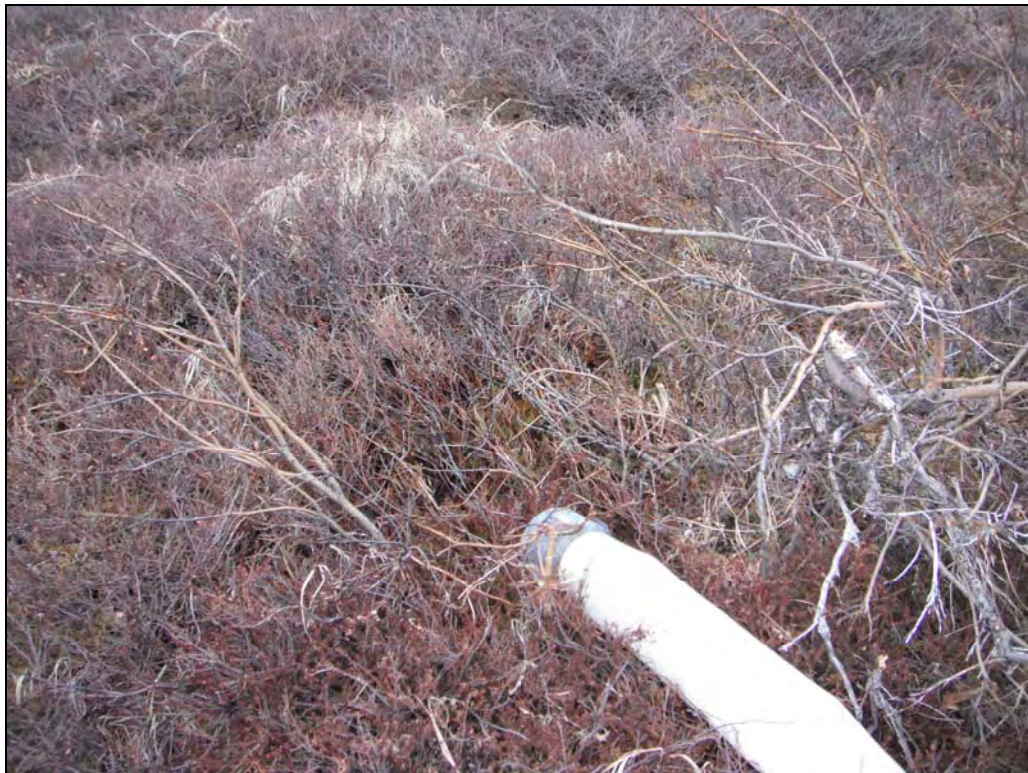
Figure 14. End of sump pit discharge line. Because drilling was shut down, no discharge was occurring during the inspection.

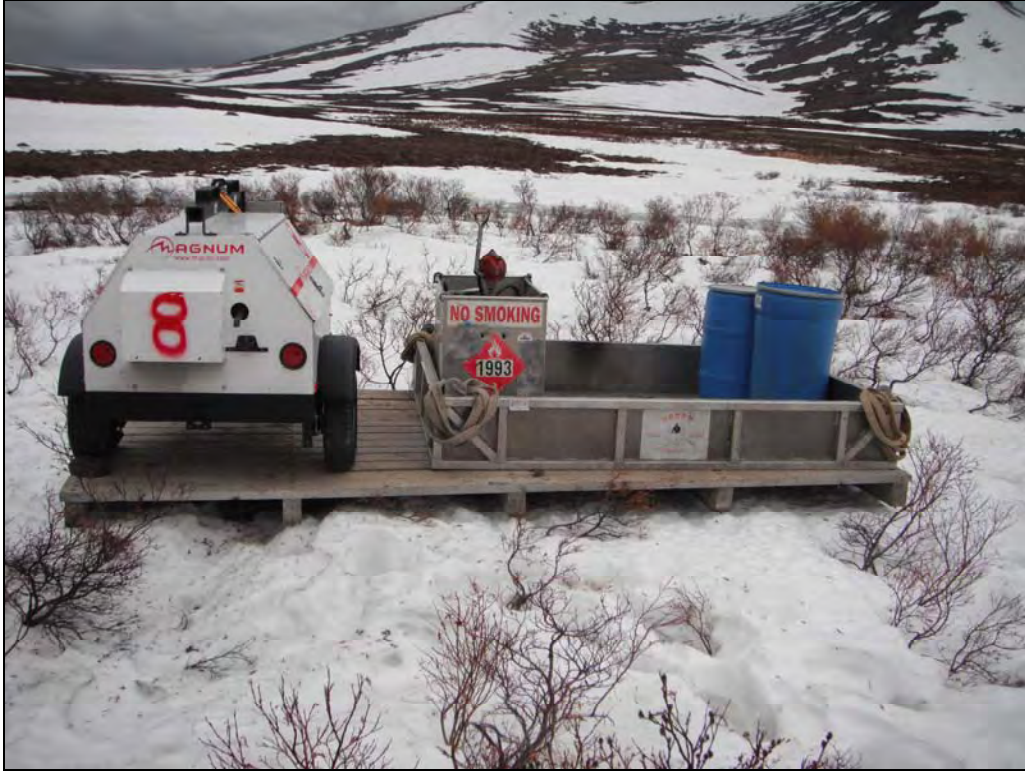
Figure 15. Fuel and generator used for water pump.

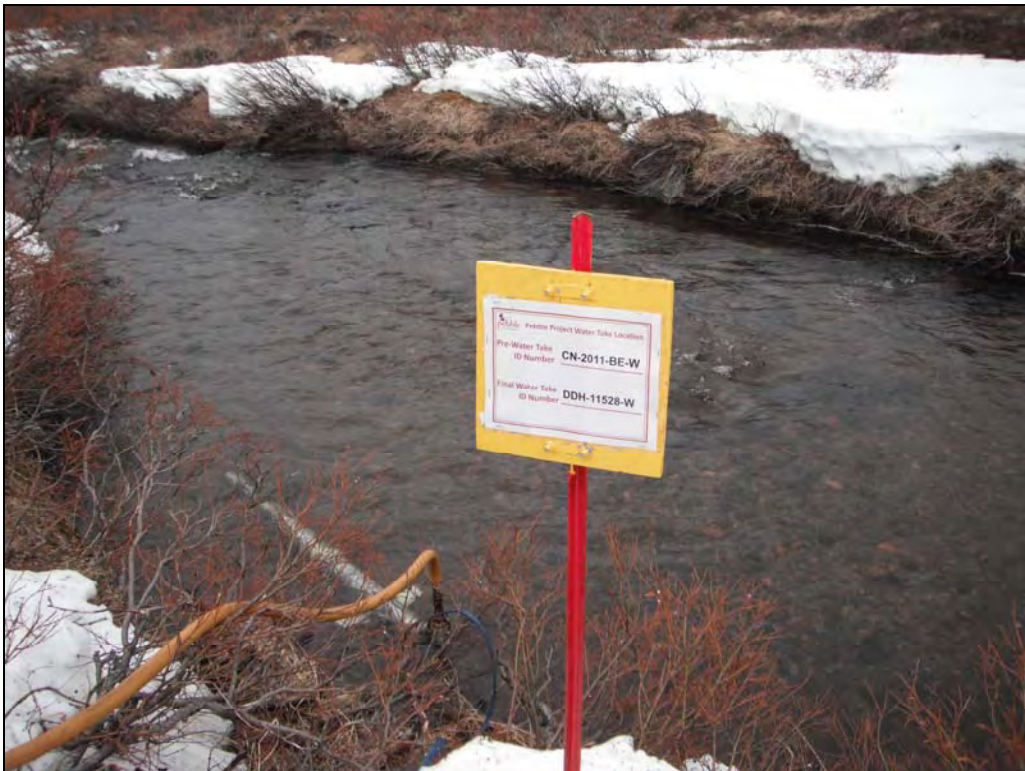
Figure 16. Proper signage designating the water take location with the identification numbers.

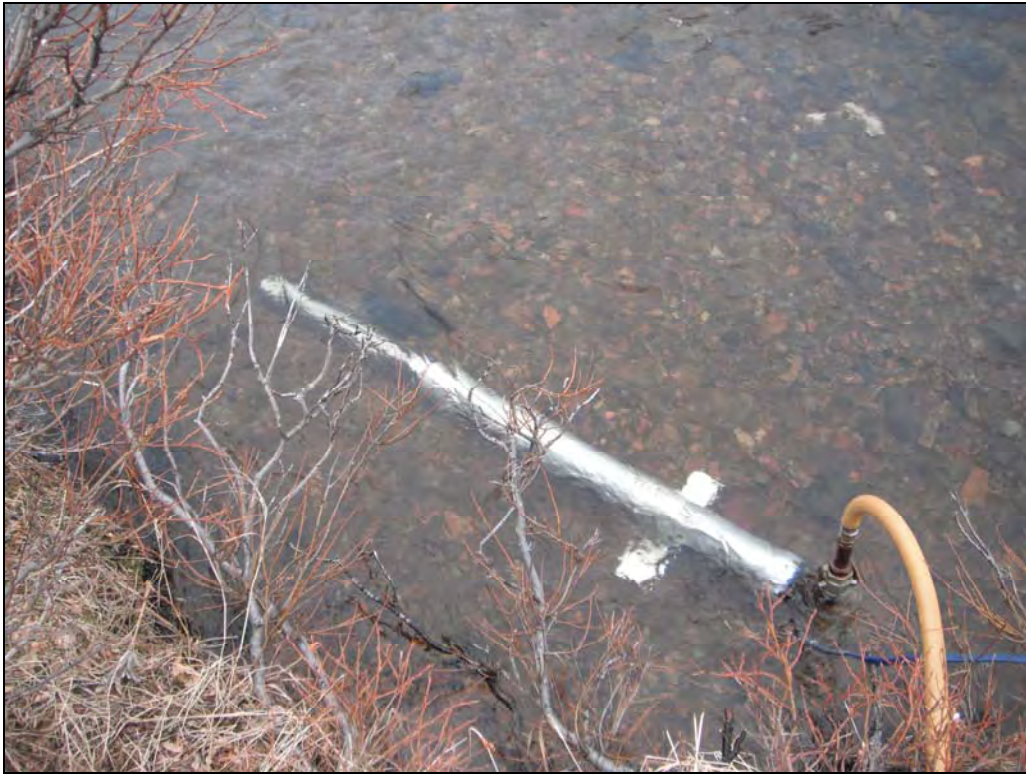
Figure 17. Screened water intake submerged in creek.

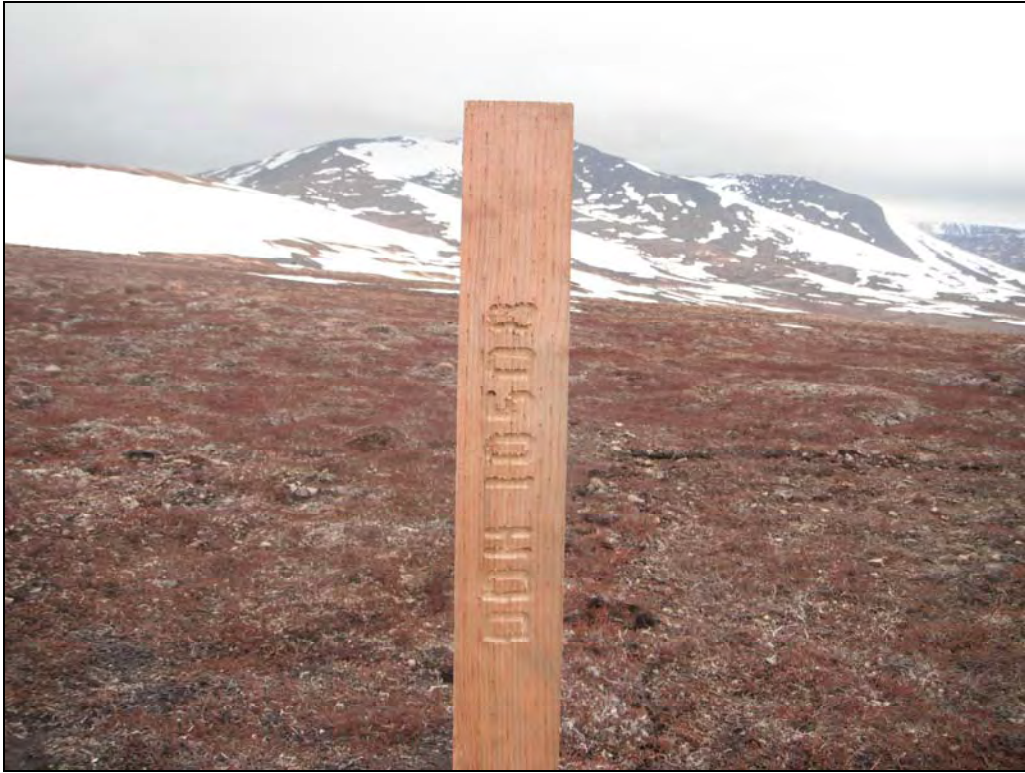
Figure 18. Sign post for reclaimed drill hole 10508.

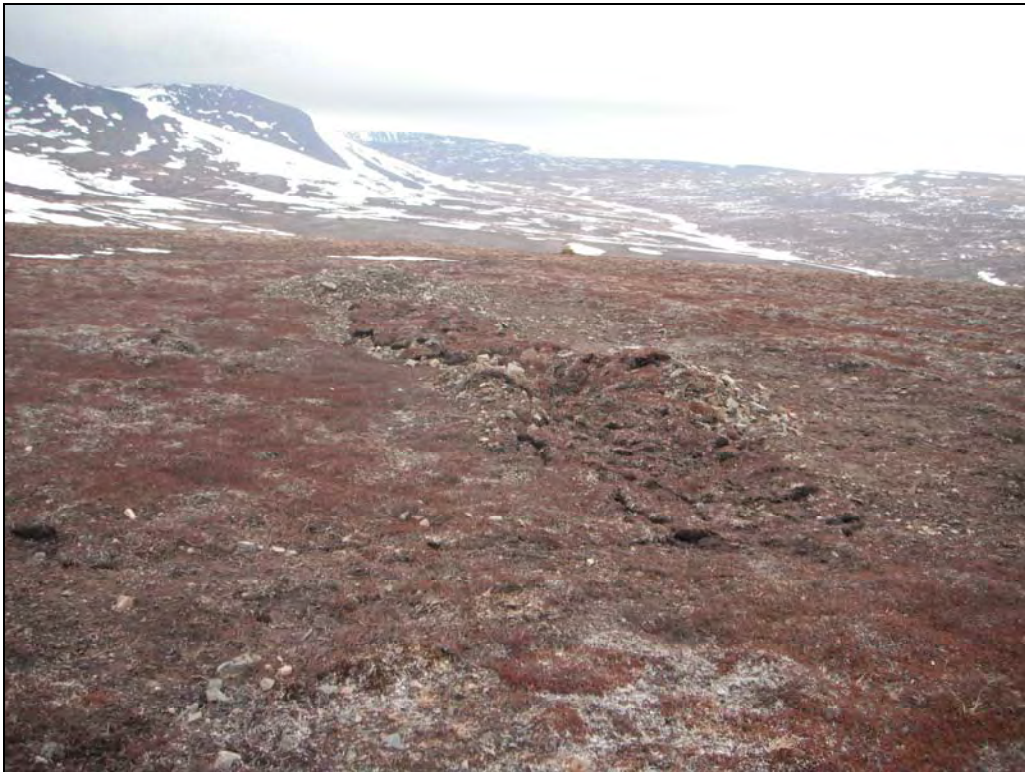
Figure 19. Reclaimed sump pit location. This site was completed in the Fall of 2010 and has not had a complete growing season.

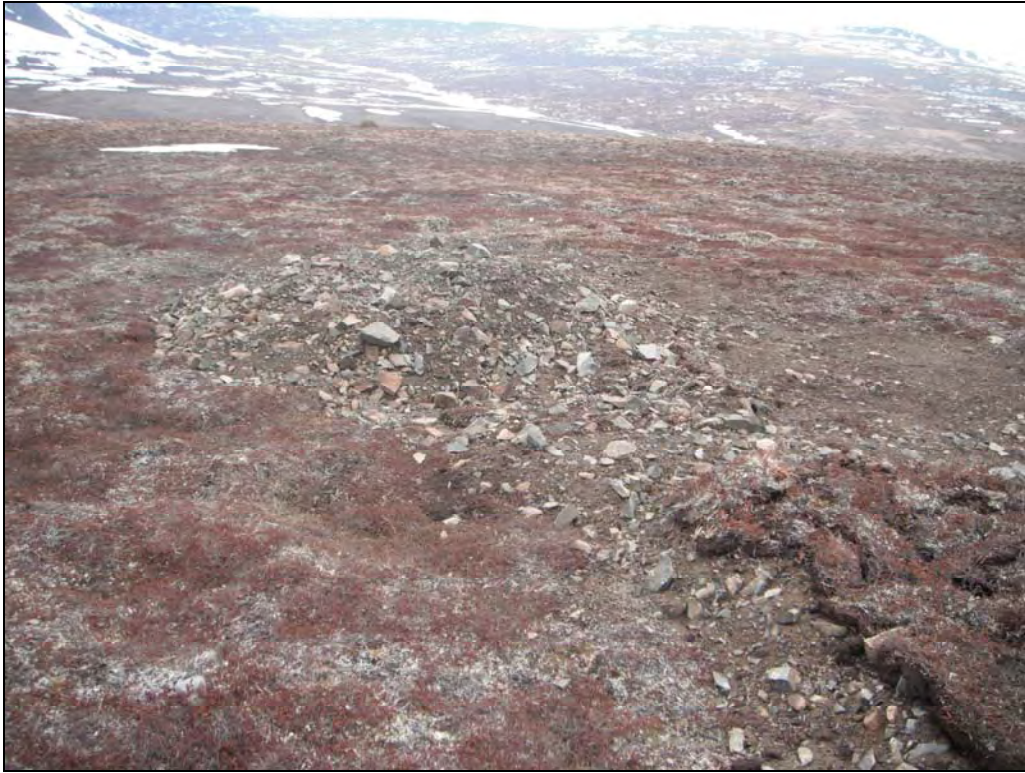
Figure 20. Gravel/rock pile near reclaimed sump pit. This site is 90% complete and the crew will be revisiting this site to smooth out this pile and make more even with existing tundra.

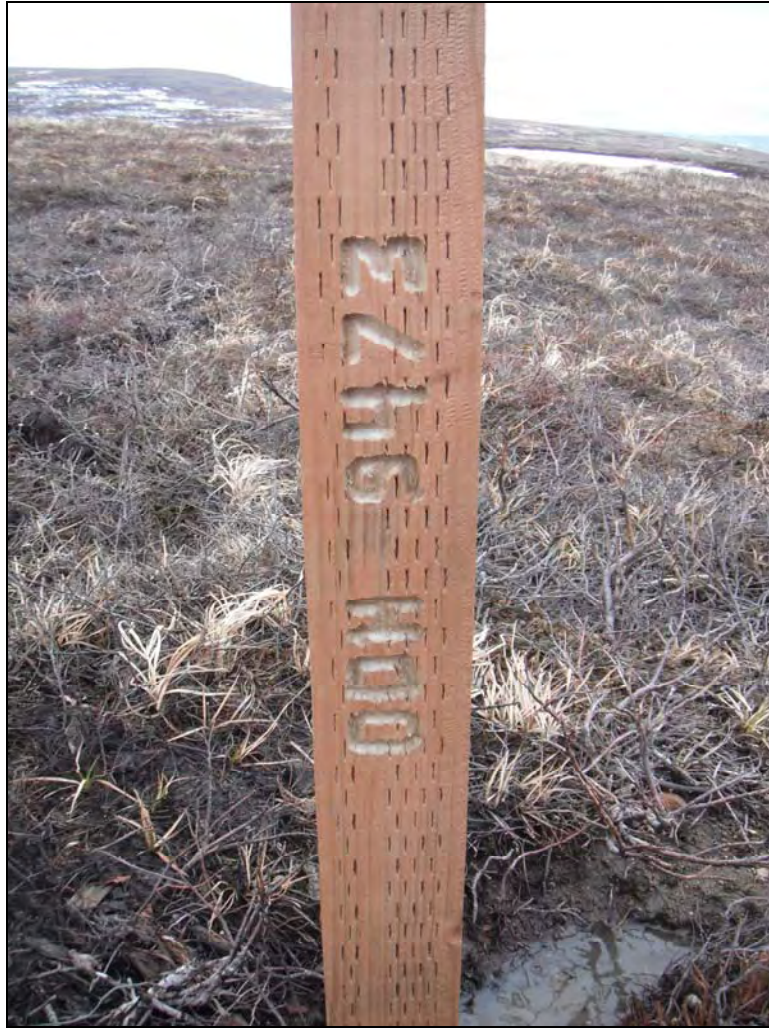
Figure 21. Sign post for reclaimed drill hole 9473.

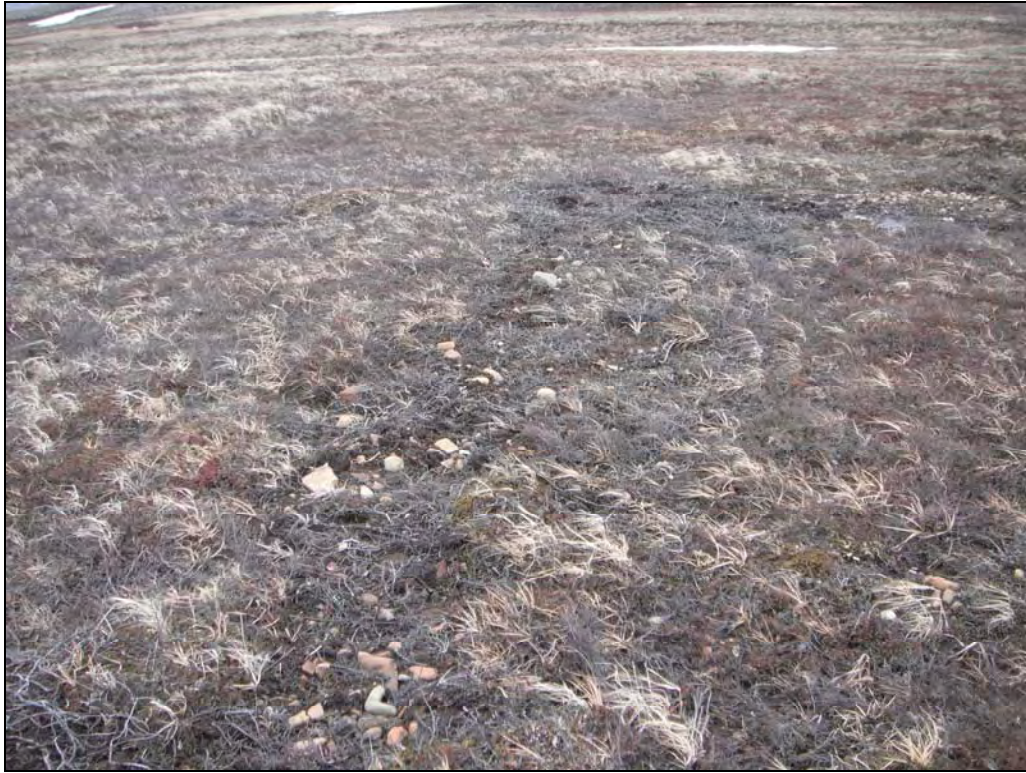
Figure 22. Reclaimed sump pit. This was a 2009 drill site and this has had a complete summer of regrowth/settlement.
