Field Inspection Report

-Pebble Copper/Gold Exploration Project-

Inspection Date: June 17-18, 2008

APMA No.: A086118

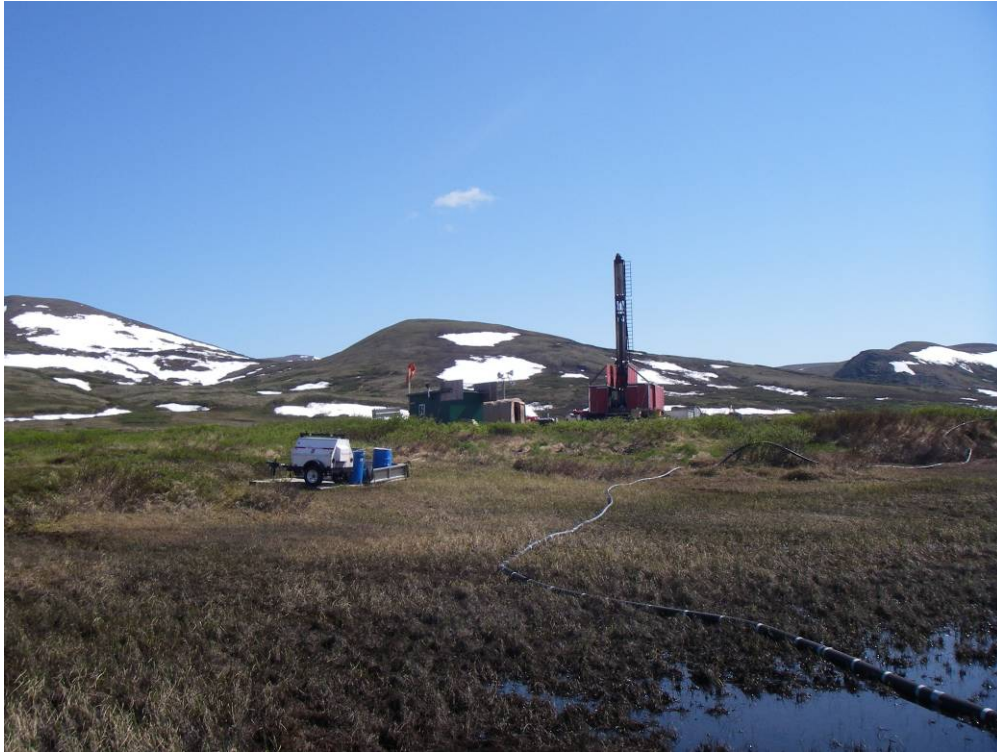
Figure 3. Drill rig 8407 (No. 5).

Drill rig no. 5 (8407; Figure 3)

- Condition of Drilling Site**
 - Distance from water body: **> 100 ft.**
 - Location of fuel storage: **On pad (Figure 4).**
 - Sorbent Pads Present or Not: **Yes**
 - Tundra Mat: **Yes**
 - Pipe off Tundra: **Yes**
 - Litter: **None**
 - Activity: **Operational**
 - Trash Containment: **Yes**
 - Sanitary Facilities: **Yes**
 - Any spills or staining, or 'none' for that matter: **None**
 - General impression of site: **Clean, orderly**

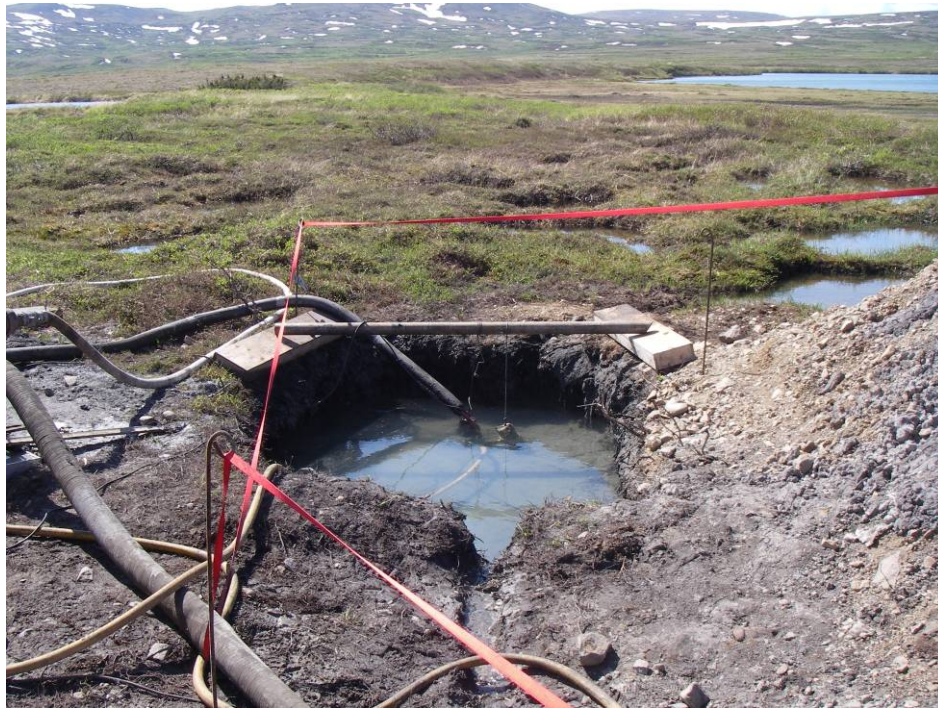
- Sump Pit**
 - Location: **near rig (Figure 5)**
 - Discharge trench: **yes**
 - Dimension pit: **not measured**
 - In use: **yes**

Figure 5. Drill water overflow and recycle sump, drill rig 8407 (No. 5).

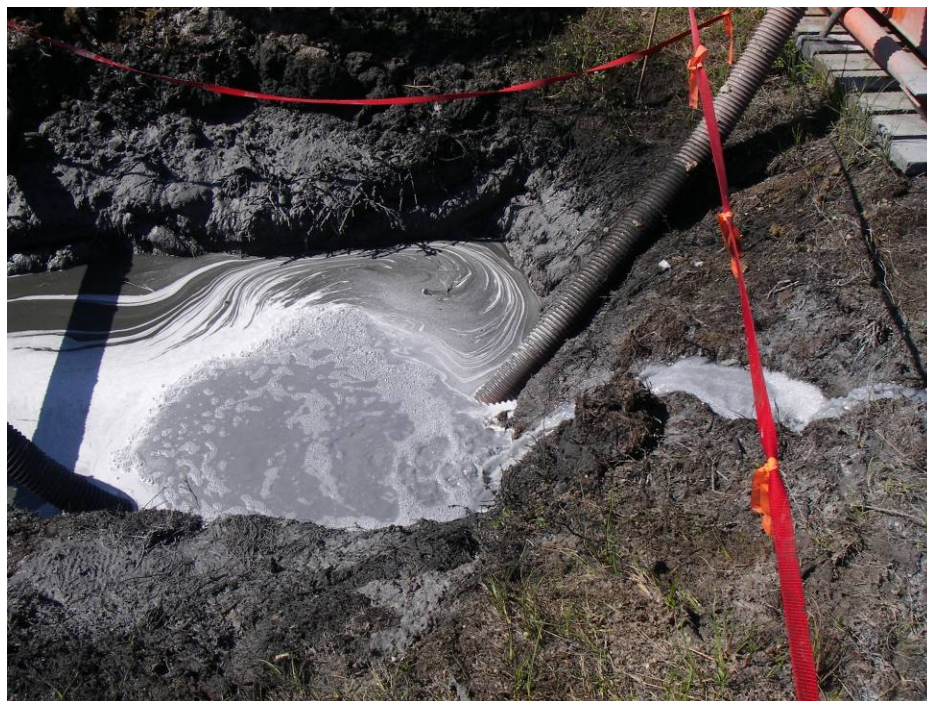
- Water recirculation: **Yes**
 - Artesian zone encountered: **Unknown**
- Sump Pit**
 - Location: **near pad (Figure 6)**
 - Discharge trench: **Yes**
 - Dimension pit: **not measured**

Figure 6. Drill water overflow and recycle sump, drill rig 8412 (No. 6)

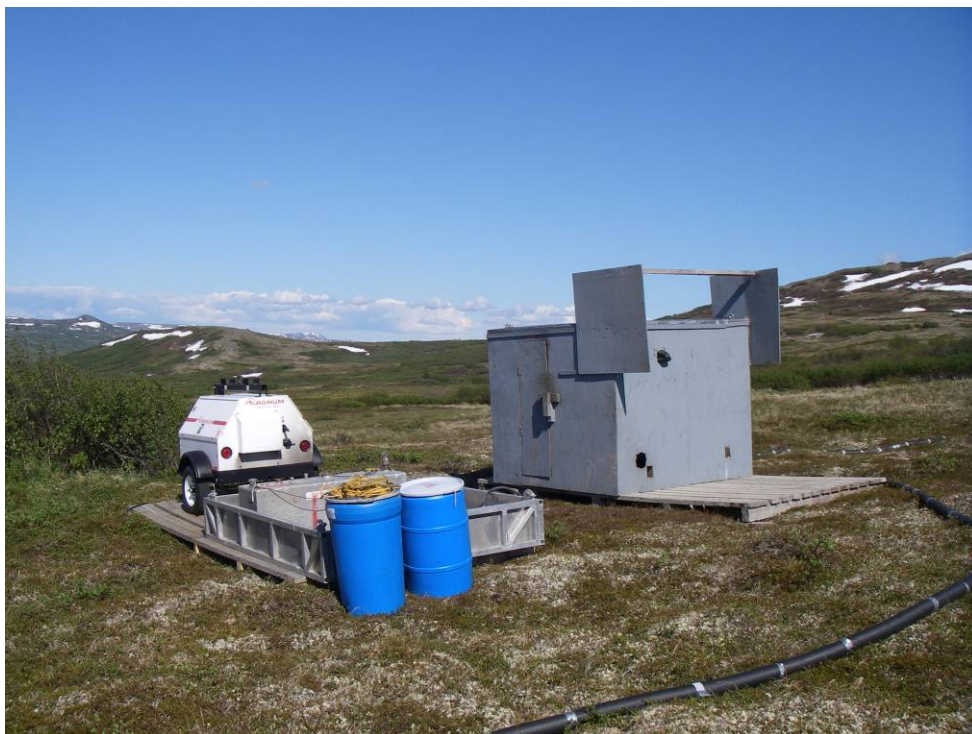
Figure 10. Drill rig 8414 (No. 1) water intake pump, generator, and fuel storage.

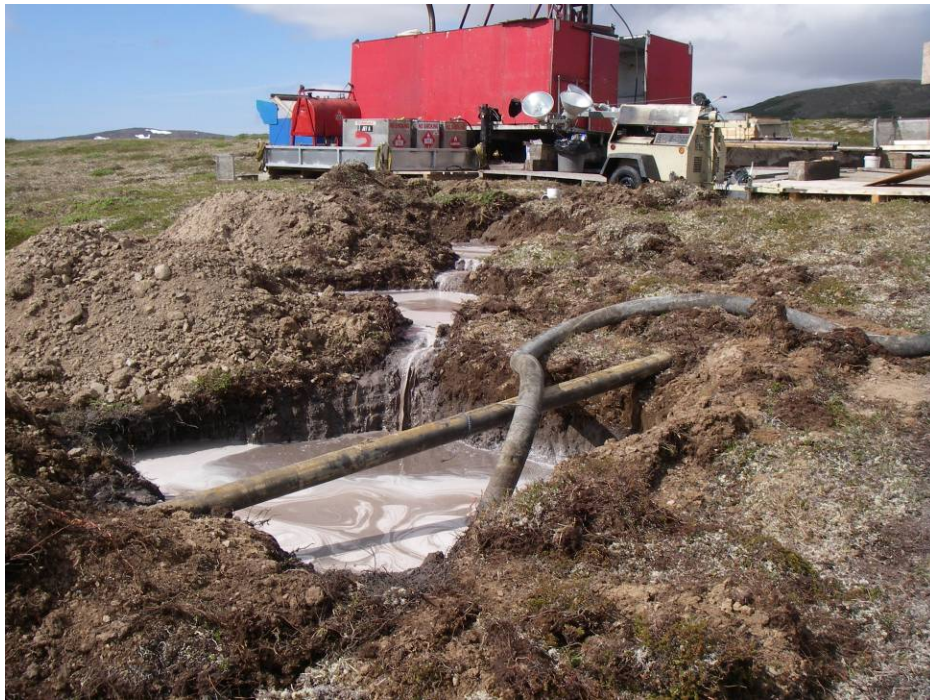
- Sump Pit**
 - Location: **near rig (Figure 11)**
 - Discharge trench: **Yes.**
 - Dimension of pit in use: **Not measured.**
 - Location and extent of discharged material?
Depression away from rig.

Figure 11. Overflow and recycle water sumps, drill rig 8411 (No. 3).

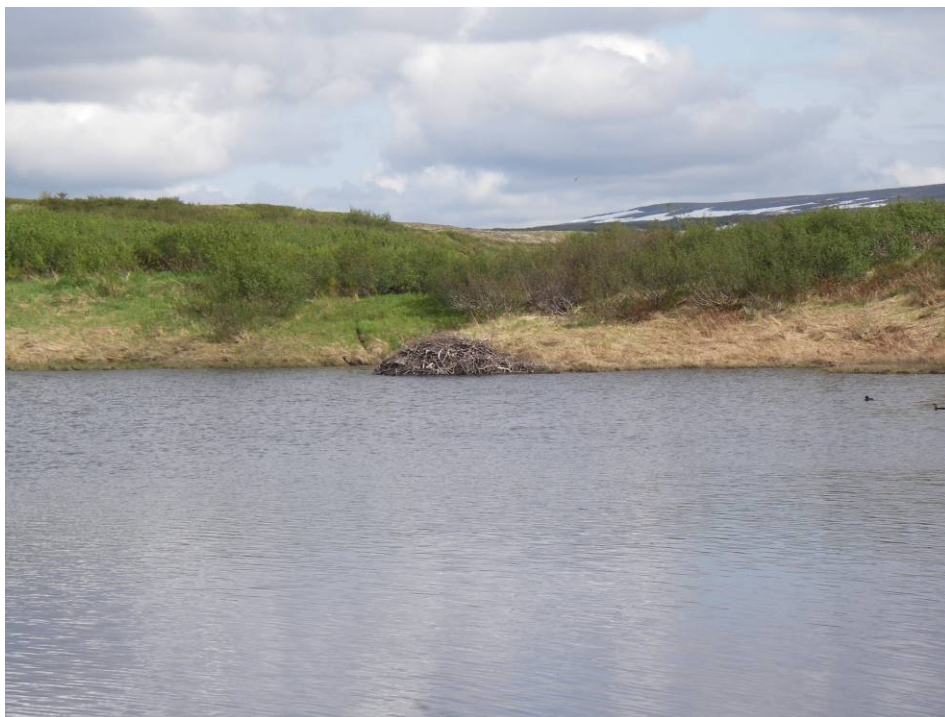
- Drill Water Supply**
 - Stream/Lake/Pond: **kettle pond (Figure 12)**
 - Location: **nearby**
 - Adequate water flow and depth for fish passage in streams? **NA**
 - Evidence of significant impacts to riparian vegetation or stream banks? **No impact to shore observed.**
 - Relative water level? **High**
 - General impression of water body, i.e. clear, turbid, tannic colored, etc.? **No indication of pollution.**
 - Intake structure: **present**
 - Structure clear of debris: **yes**
 - Mesh size: **not measured**
 - Submerged: **yes**
 - Pump location to source: **> 100 feet**
 - Catch basin for fuel supply: **Yes**
 - Sorbent Pads Present or Not: **Yes**
 - Hose color: **Black (insulated)**

Figure 12. Water source, drill rig 8411 (No.3).

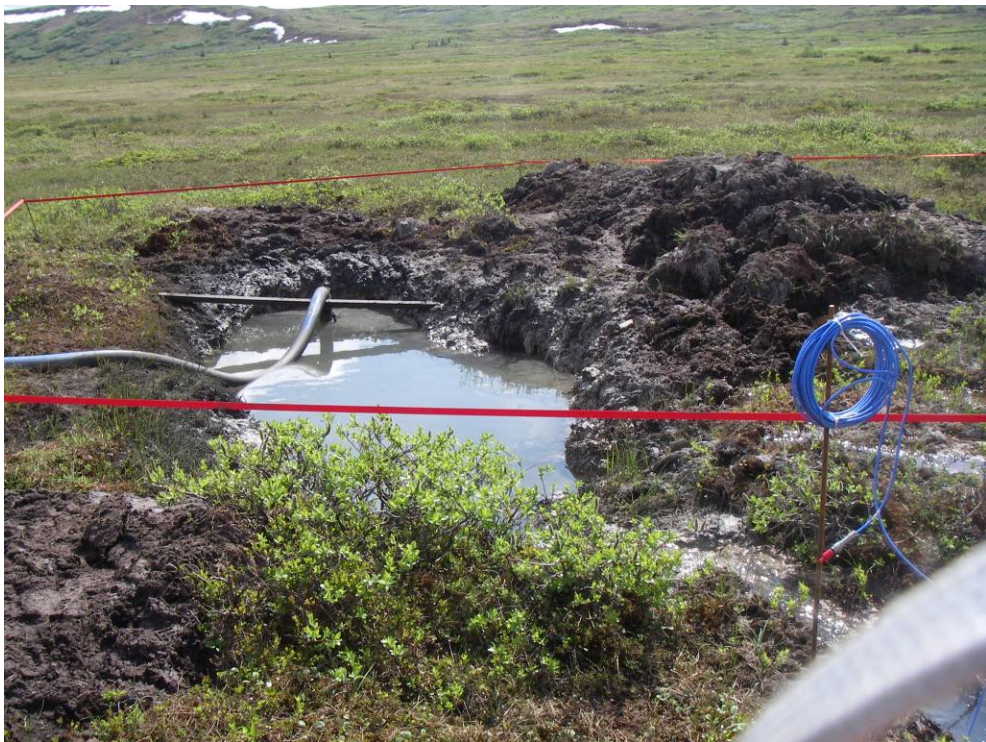
- Sump Pit**
 - Location: **near rig (Figure 14)**
 - Discharge trench: **Yes.**
 - Dimension of pit in use: **Not measured.**
 - Location and extent of discharged material?
Depression away from rig.

Figure 14. Overflow and recycle sump, drill rig 8413 (No. 4).

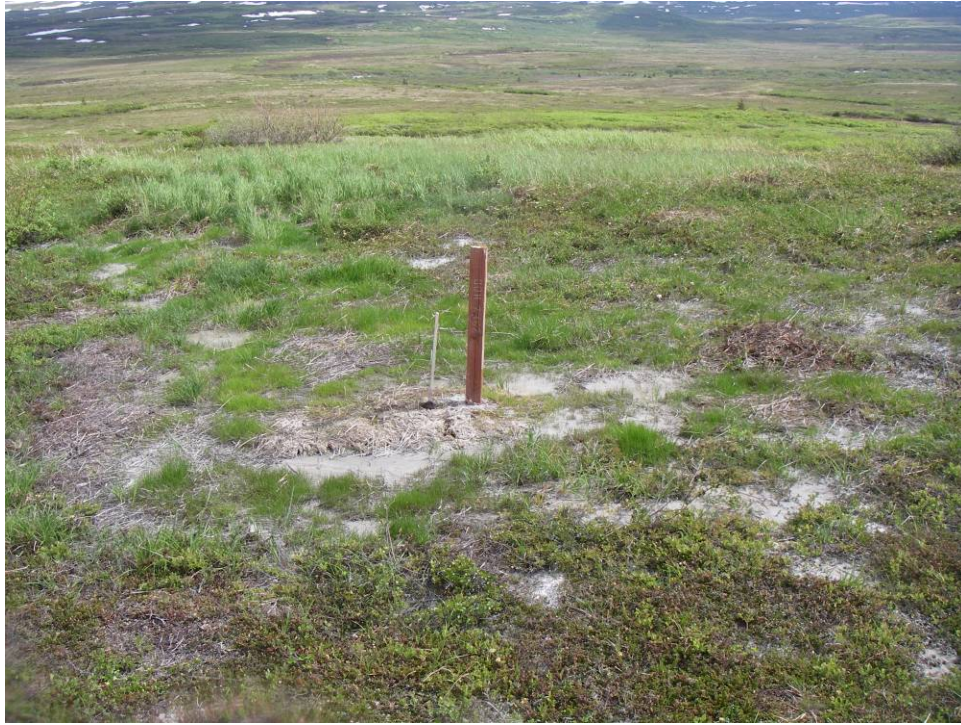
Figure 15. Reclamation site 7362.

Abandoned Drill Site No.: 7362 (Figure 15)

- Plugged: **No**
- Cemented: **Unknown.**
- Standing pipe: **No. Wooden stake marked the location.**
- Sump pit filled in: **Yes**
- Water discharge trench filled in: **Yes.**
- Site re-vegetated: **No.**
- Artesian water present: **No.**
- Any spills or staining, or 'none': **None observed.**

Actions Needed: Follow-up on reclaimed sites 7362 and 7389 to ensure the drill holes are cemented and capped, and the reclamation process is completed. Other reclamation sites should be viewed during future visits.

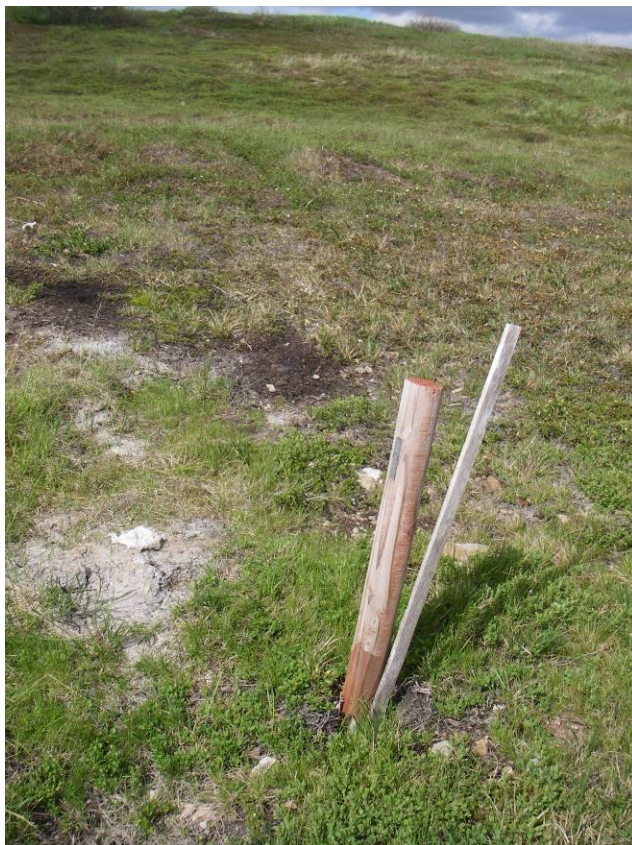
Figure 17. Reclamation site 5331.

Abandoned Drill Site No.: 5331 (Figure 17)

- Plugged: **Yes.**
- Cemented: **Unknown.**
- Standing pipe: **No. Wooden stake marked the location.**
- Sump pit filled in: **Not used. Drilling water discharge was on tundra (prior to change in operation that required sump pit use).**
- Water discharge trench filled in: **Yes.**
- Site re-vegetated: **Yes**
- Artesian water present: **No.**
- Any spills or staining, or 'none': **None observed.**

Comments: **Footprint still visible with bare patches present. Pebble staff informed us site reclamation was ongoing.**

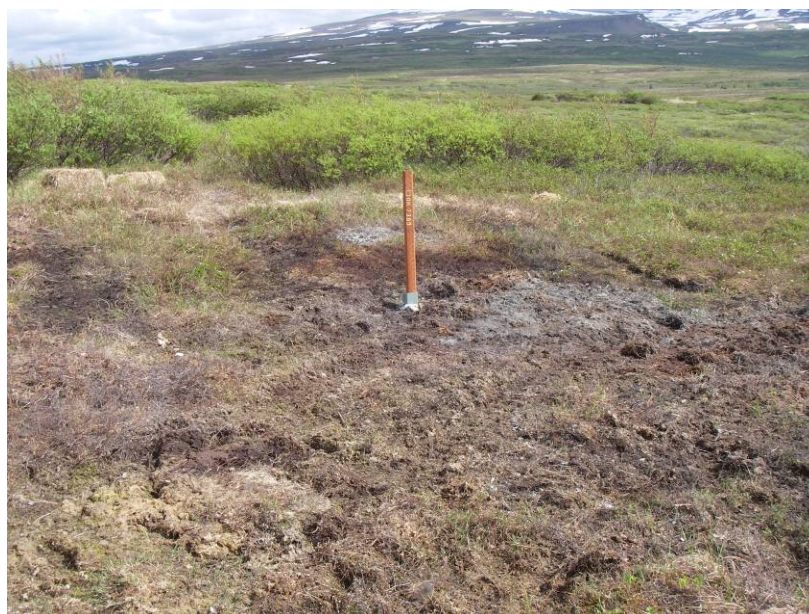
Figure 18. Reclamation site 7389

Abandoned Drill Site No.: 7389 (Figure 18)

- Plugged: **No**
- Cemented: **NA.**
- Standing pipe: **No. Wooden stake marked the location.**
- Sump pit filled in: **Yes**
- Water discharge trench filled in: **Yes.**
- Site re-vegetated: **No.**
- Artesian water present: **No.**
- Any spills or staining, or 'none': **None observed.**

Comments: **Reclamation work had been done at this site. Water appeared to be discharging from the hole. Pebble staff informed us reclamation of this site was ongoing. Future site visits need to follow up and ensure the hole is cemented and plugged.**
