Field Monitoring Report -- Pebble Copper/Gold Exploration Project --

Personnel: William Cole, ADNR-Mining	Inspection Date: 8/6/2013
Carolyn Curley, ADNR-Mining	Site Contact: Jeff Norberg
	APMA #: A20136118
<input checked="" type="checkbox"/> Inspection Type:	<input checked="" type="checkbox"/> Wildlife Observed:
<input type="checkbox"/> Complete:	<input type="checkbox"/> Bear:
<input type="checkbox"/> Partial: Mining Reclamation	<input type="checkbox"/> Caribou:
<input type="checkbox"/> Follow-up:	<input type="checkbox"/> Moose:
<input type="checkbox"/> Response to Public Complaint:	<input type="checkbox"/> Waterfowl:
	<input type="checkbox"/> Fish:
<input checked="" type="checkbox"/> Weather Conditions:	<input type="checkbox"/> Other: Juvenile eagle flying,
<input type="checkbox"/> Temperature: 40s	Ground squirrels
<input type="checkbox"/> Wind: windy with gusts 50-60 knots	
<input type="checkbox"/> Precipitation: occasional light rain	
<input type="checkbox"/> Visibility: Good

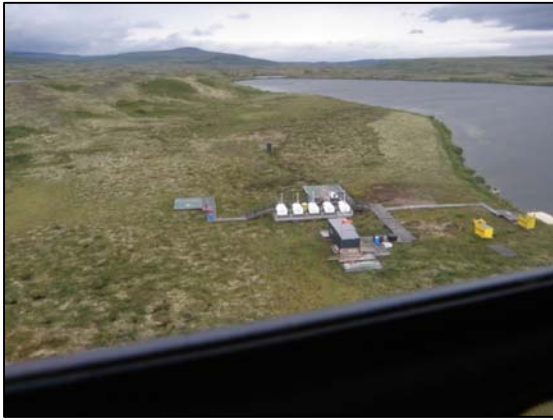
Fuel station for exploration activities.

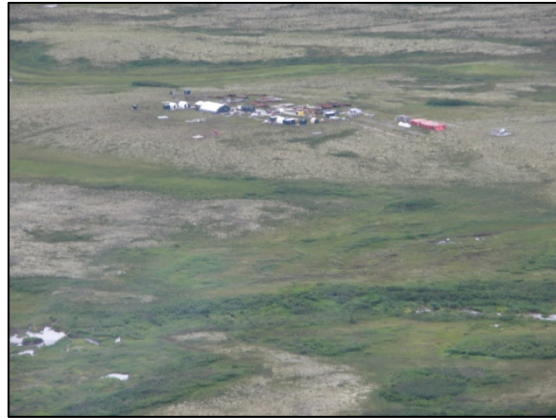
Site of consolidated exploration field camp.

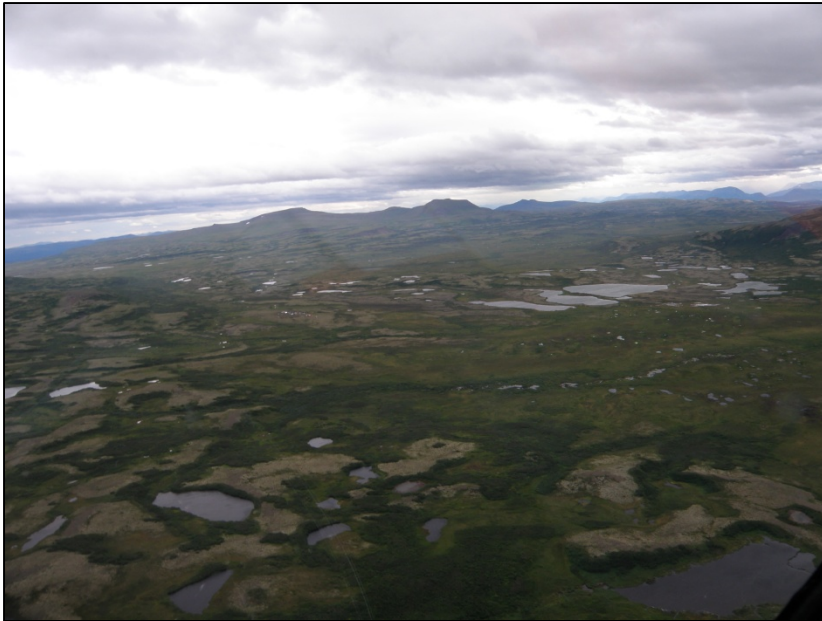
View of deposit and surrounding area.

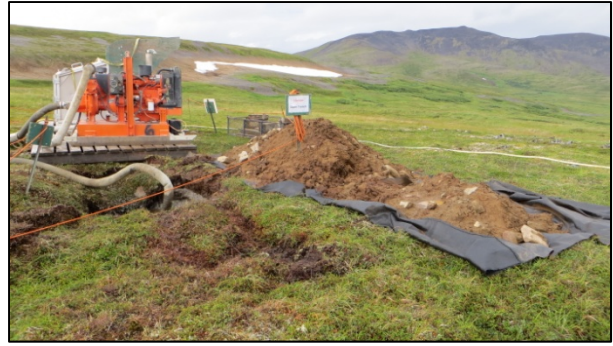
Sump and material stockpile for GH 13374

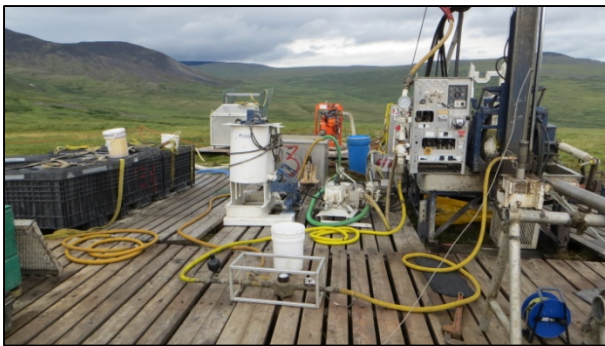
General site conditions for GH 13374.

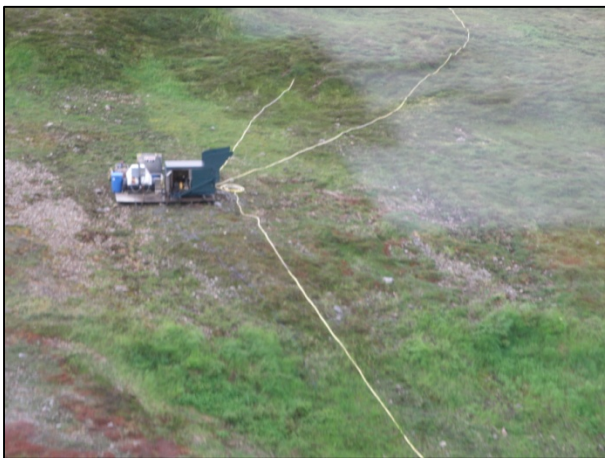
Pump for water is located uphill from the stream.

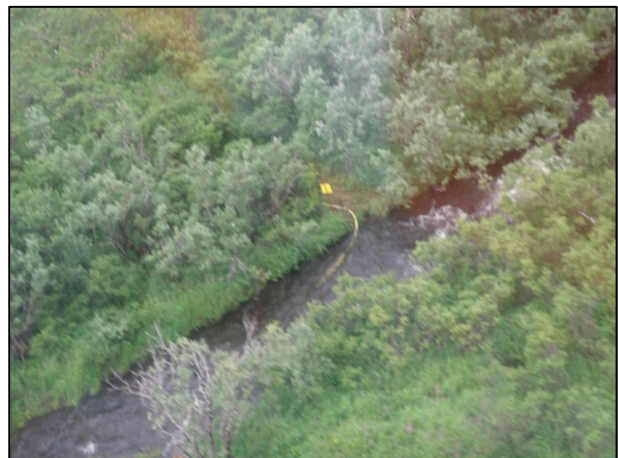
Stream and water take point location.

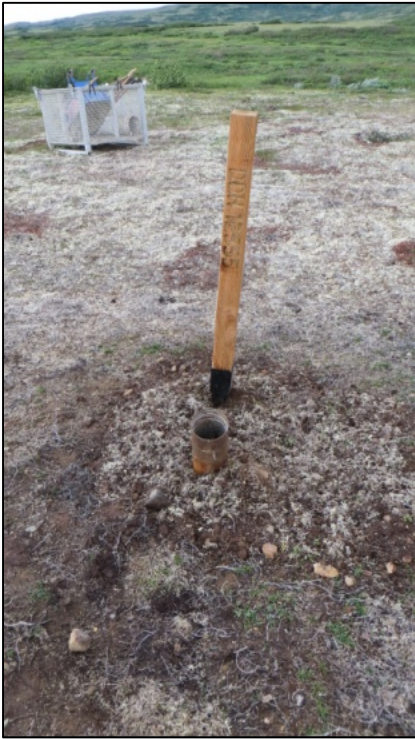
Abandoned Drill Hole/Site No.: DDH12555	Date:8/6/13
	Time: 12:00
■ Plugged: Yes	
■ Cemented: Yes	
■ Standing pipe: Yes	
■ Sump pit filled in: Yes	
■ Water discharge trench filled in: Yes	
■ Site revegetated: Yes	
■ Date revegetated/reclaimed: 6/15/13	
■ Artesian water present: No	
■ Any spills or staining: No	
■ Comments/General impression: Site looks good. Vegetation getting re-established.

DDH12555 marker and drillhole pipe. Reclamation kit is in the background.

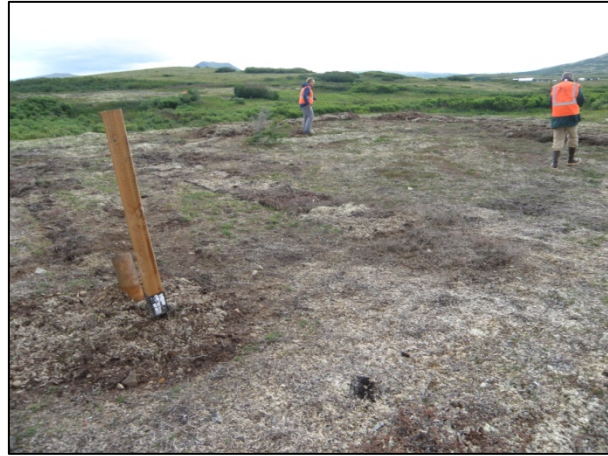
DDH12555 site reclamation in progress.

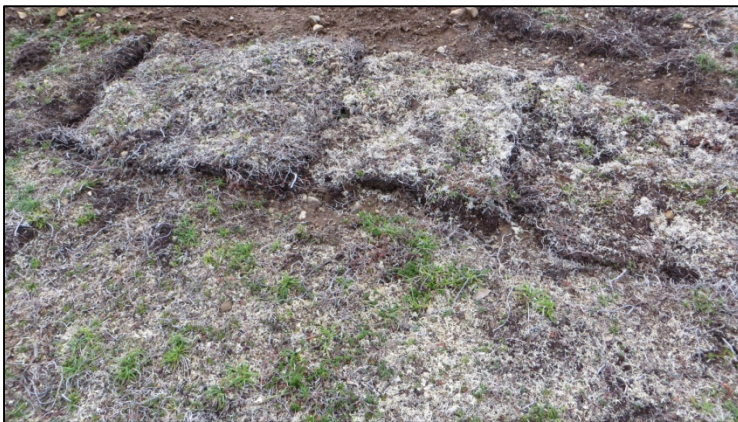
DDH12555 overburden replaced after completion of drilling.

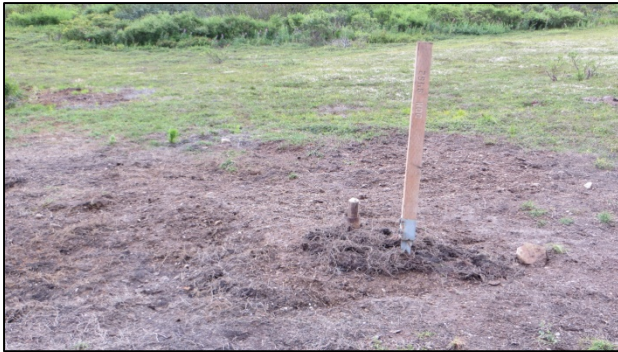
Abandoned Drill Hole/Site No.: DDH 9462	Date: August 6, 2013
	Time: 12:20pm
■ Plugged: Yes	
■ Cemented: Yes	
■ Standing pipe: Yes	
■ Sump pit filled in: Yes	
■ Water discharge trench filled in: Yes	
■ Site revegetated: In process	
■ Date revegetated/reclaimed: various dates	
■ Artesian water present: Artesian water flow stopped 6/12/2013	
■ Any spills or staining: Yellow-brown staining from artesian flow.	
■ Comments/General impression: Difficult artesian flow. Specialist from Colorado flown in to help. ~30gpm with brown Fe bacterial staining. Flow surfaced ~40' from drillhole and infiltrated back into the ground without entering surface streams, Flow was stopped 6/12/2013. Natural vegetation beginning to grow in area of ground affected by artesian flow.

DDH 9462 drillhole marker and drillhole pipe.

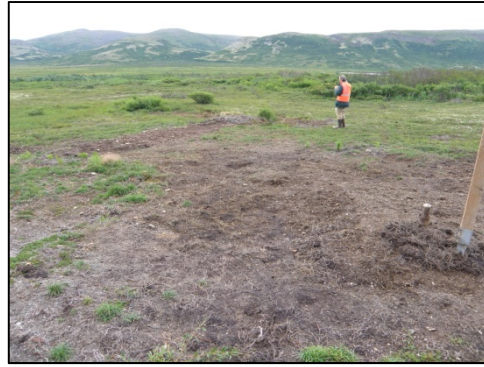
DDH 9462 site showing path of artesian flow and reclamation efforts.

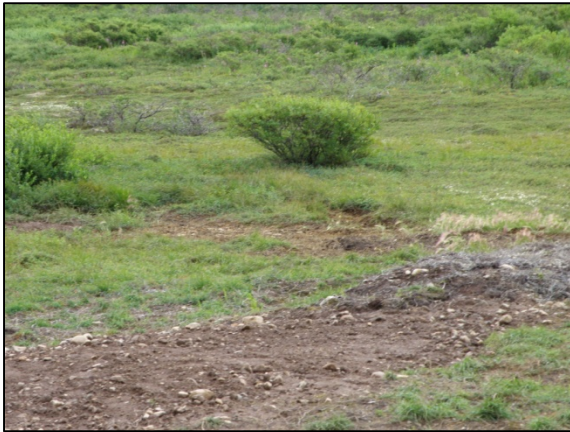
DDH 9462 approximate end location of surface artesian flow.

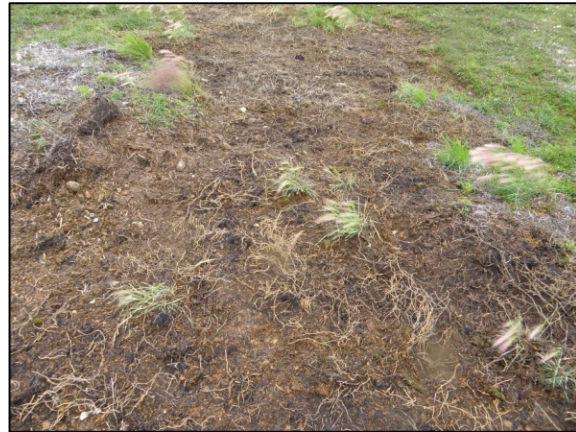
DDH 9462 natural revegetation on area affected by surface flow of artesian water.
