## Field Monitoring Report -- Pebble Copper/Gold Exploration Project --

Personnel: Steve McGroarty (ADNR)	Inspection Date: August 27, 2008
David Johnson (ADEC)	Site Contact: Lena Brommeland
	APMA #: A086118
<input checked="" type="checkbox"/> Inspection Type: Routine - Partial	<input checked="" type="checkbox"/> Wildlife Observed:
<input type="checkbox"/> Complete:	<input type="checkbox"/> Bear: None
<input type="checkbox"/> Partial:	<input type="checkbox"/> Caribou: None
<input type="checkbox"/> Follow-up:	<input type="checkbox"/> Moose: None
<input type="checkbox"/> Response to Public Complaint:	<input type="checkbox"/> Waterfowl: None
	<input type="checkbox"/> Fish: None
<input checked="" type="checkbox"/> Weather Conditions:	<input type="checkbox"/> Other: One ground squirrel & one ptarmigan
<input type="checkbox"/> Temperature: 50 f	
<input type="checkbox"/> Wind: Light	<input checked="" type="checkbox"/> Water level at Frying Pan Lake:
<input type="checkbox"/> Precipitation: N/A	<input type="checkbox"/> Observed inflow: not observed

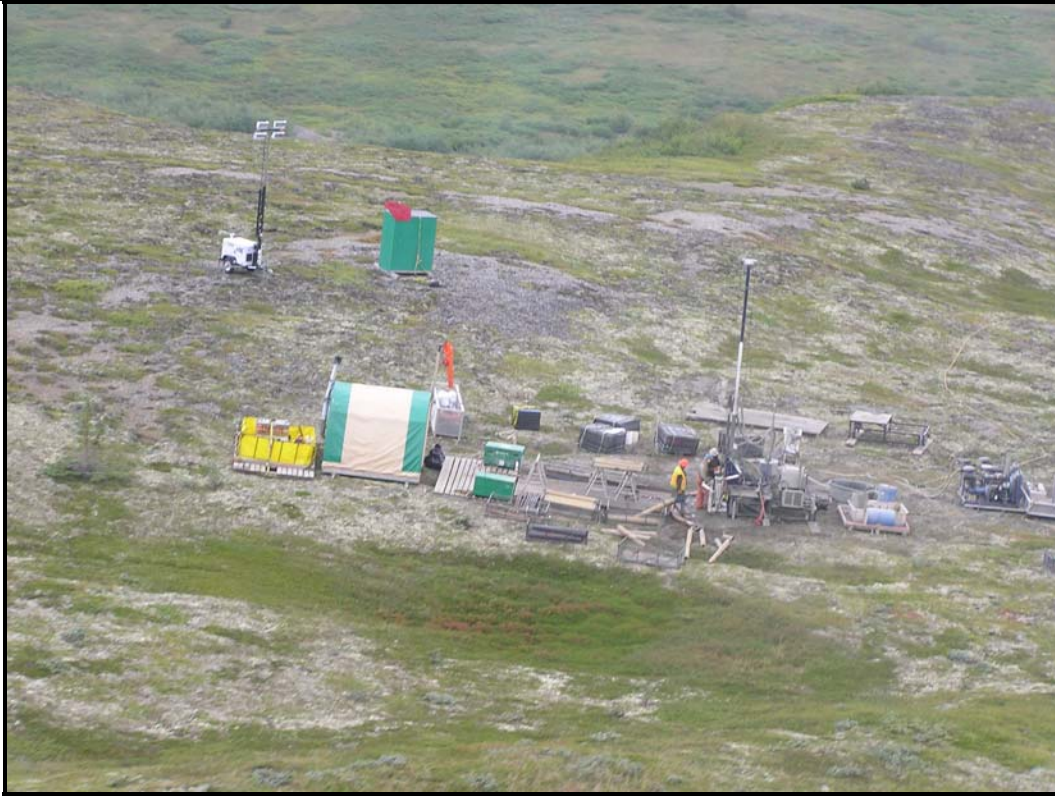
**Figure 1: Drill Rig # 8 - Geotechnical drilling rig at hole number P-08-87.**

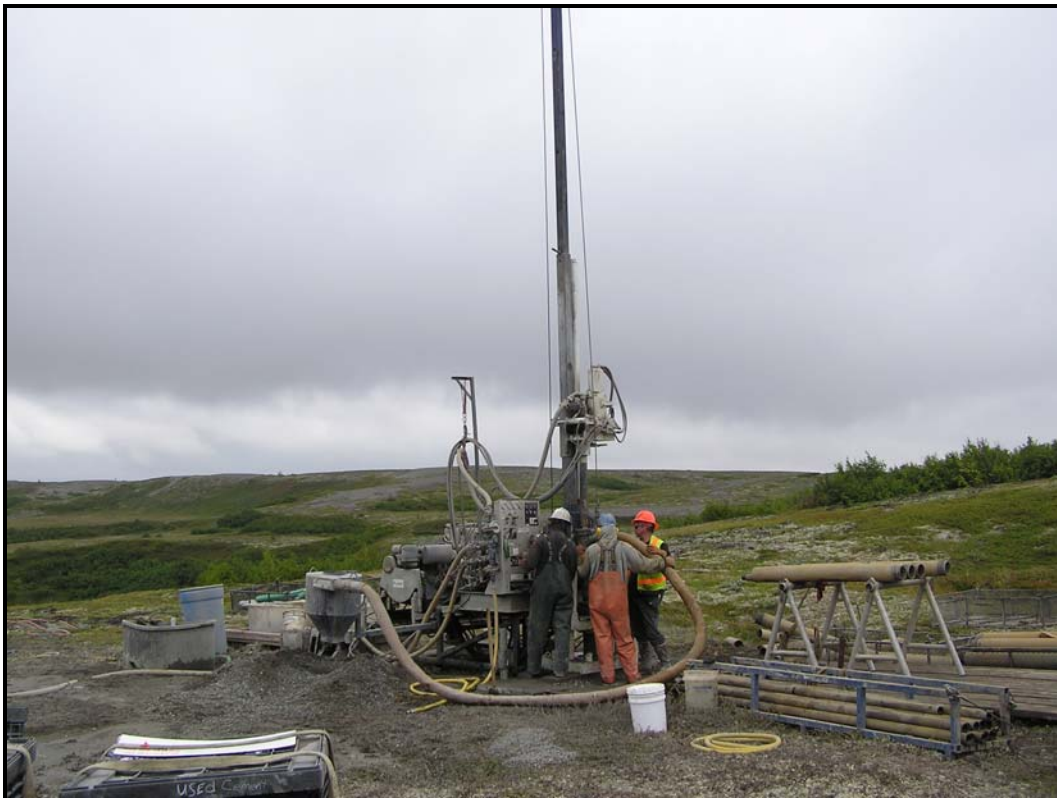
**Figure 2: Drill cuttings from geotechnical hole.**

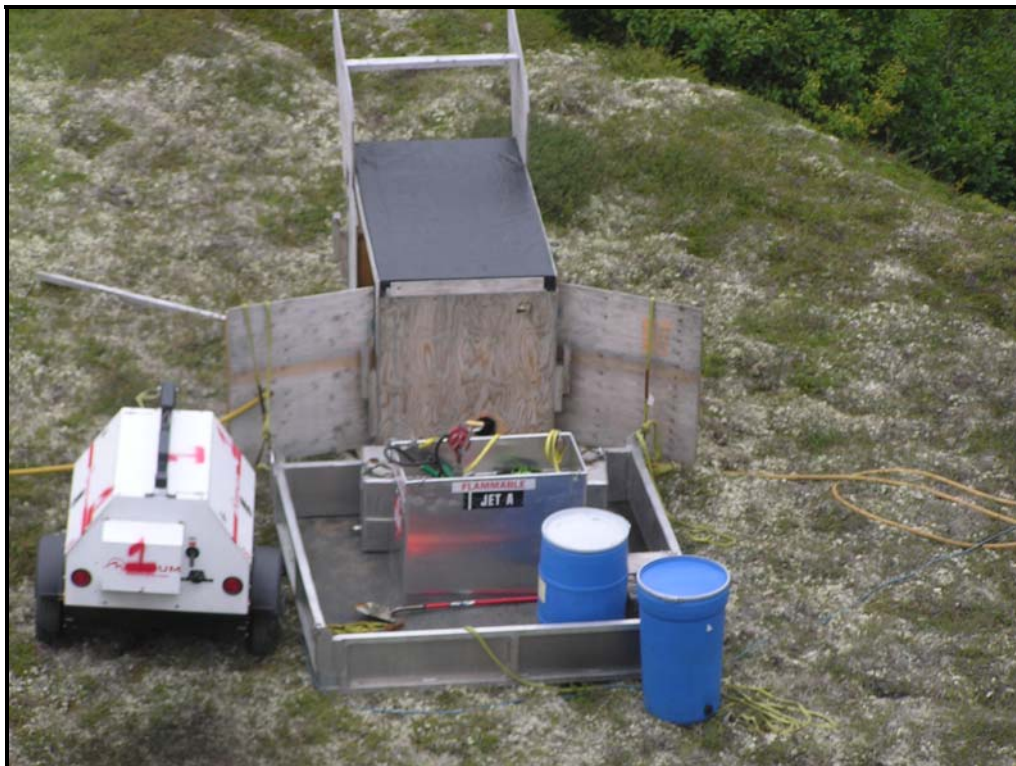
**Figure 4: Water pump for Drill Rig # 8.**

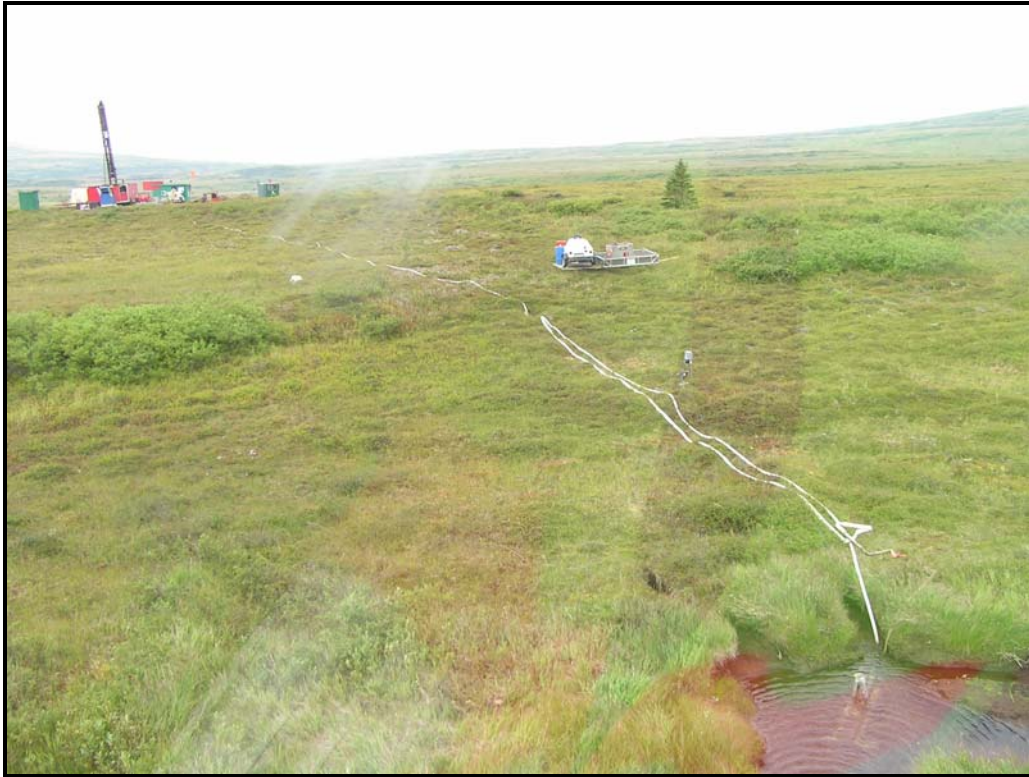
**Figure 7: Source water pump with generator & Drill Rig # 3 in background.**

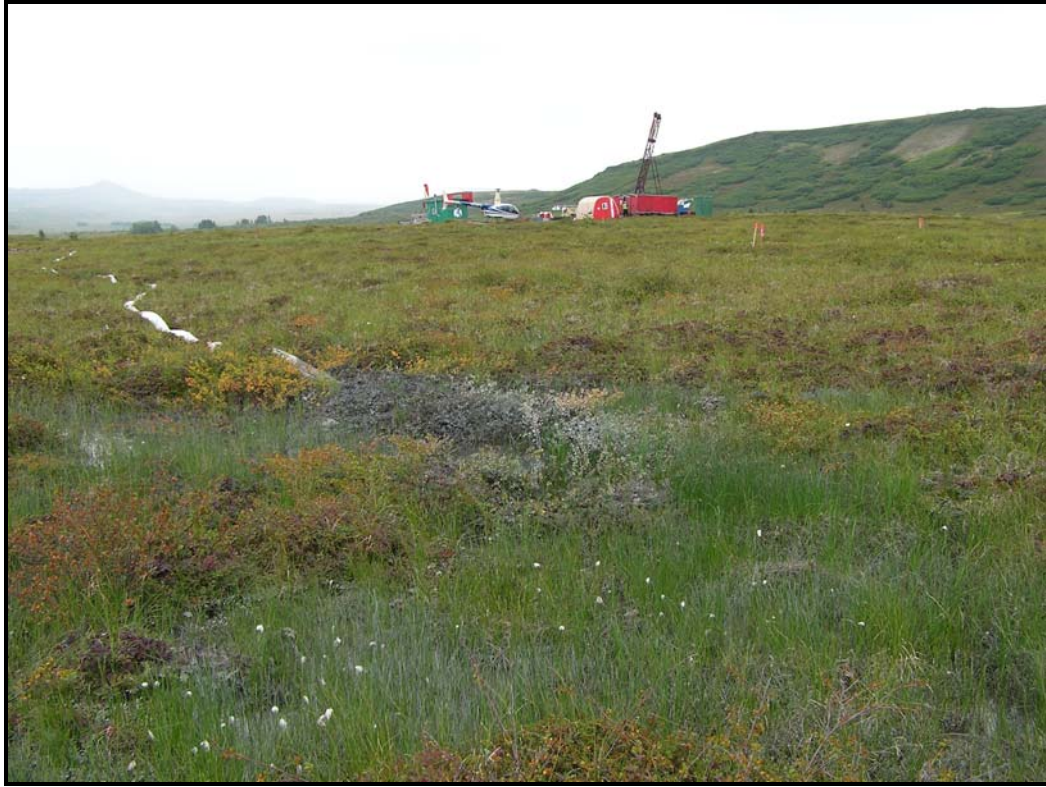
**Figure 8: Discharge location for Drill Rig #3 (Rig # 3 in background).**

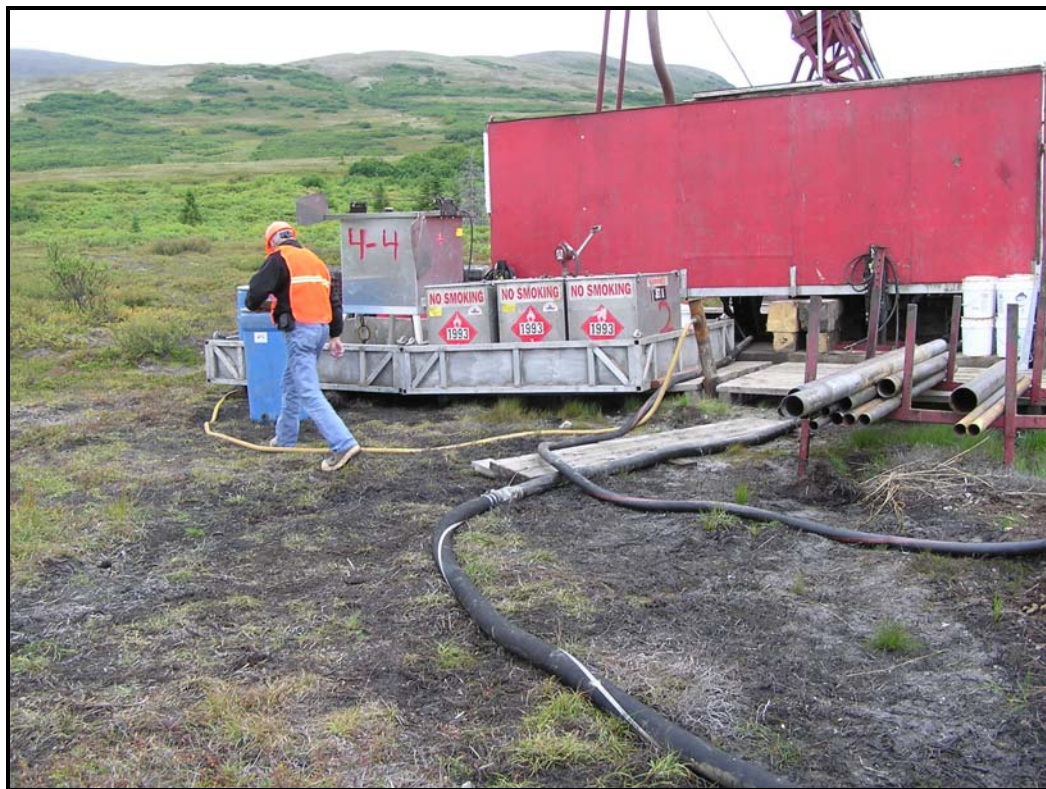
Drill Hole/Site No.: 8423	Rig No.: 2
Activity: Active Drilling	Date: 8/27/08
	59 53 54.3/155 14 37.3
<ul style="list-style-type: none"> <li>■ Condition of Drilling Site: Fuel odor/small stain</li> </ul>	<ul style="list-style-type: none"> <li>■ Sump Pit (continued):</li> </ul>
<ul style="list-style-type: none"> <li>○ Distance from waterbody: See photo</li> </ul>	<ul style="list-style-type: none"> <li>○ Location and extent of discharged material: on ridge near rig - see photo.</li> </ul>
<ul style="list-style-type: none"> <li>○ Location of fuel storage: At drill rig; in secondary containment</li> </ul>	<ul style="list-style-type: none"> <li>○ Topsoil, muck, tundra stockpiled: Yes</li> </ul>
<ul style="list-style-type: none"> <li>○ Sorbent pads present: Yes</li> </ul>	<ul style="list-style-type: none"> <li>○ Location of secondary sump pit: Next to primary sump.</li> </ul>
<ul style="list-style-type: none"> <li>○ Tundra mat: Yes</li> </ul>	<ul style="list-style-type: none"> <li>○ Hose color: Black.</li> </ul>

**Figure 12: There was a slight fuel odor near the fuel tanks for Drill Rig # 2 and a little staining on the ground.**

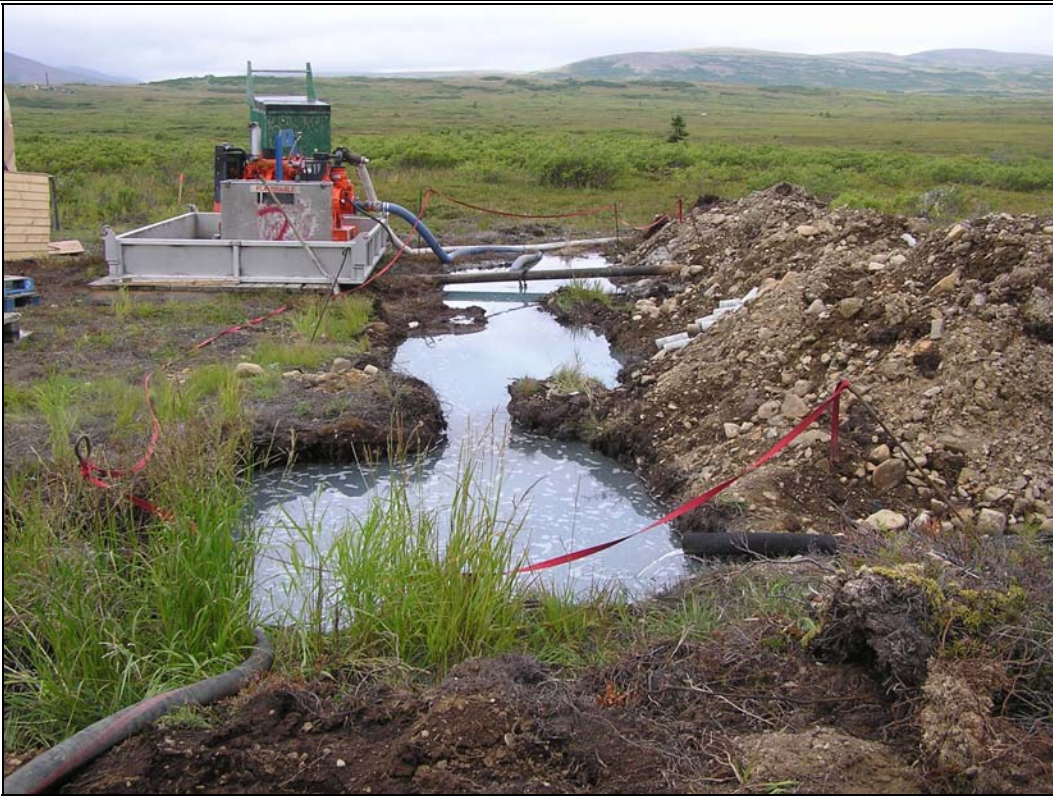
**Figure 13: Sumps at Drill Rig # 2.**

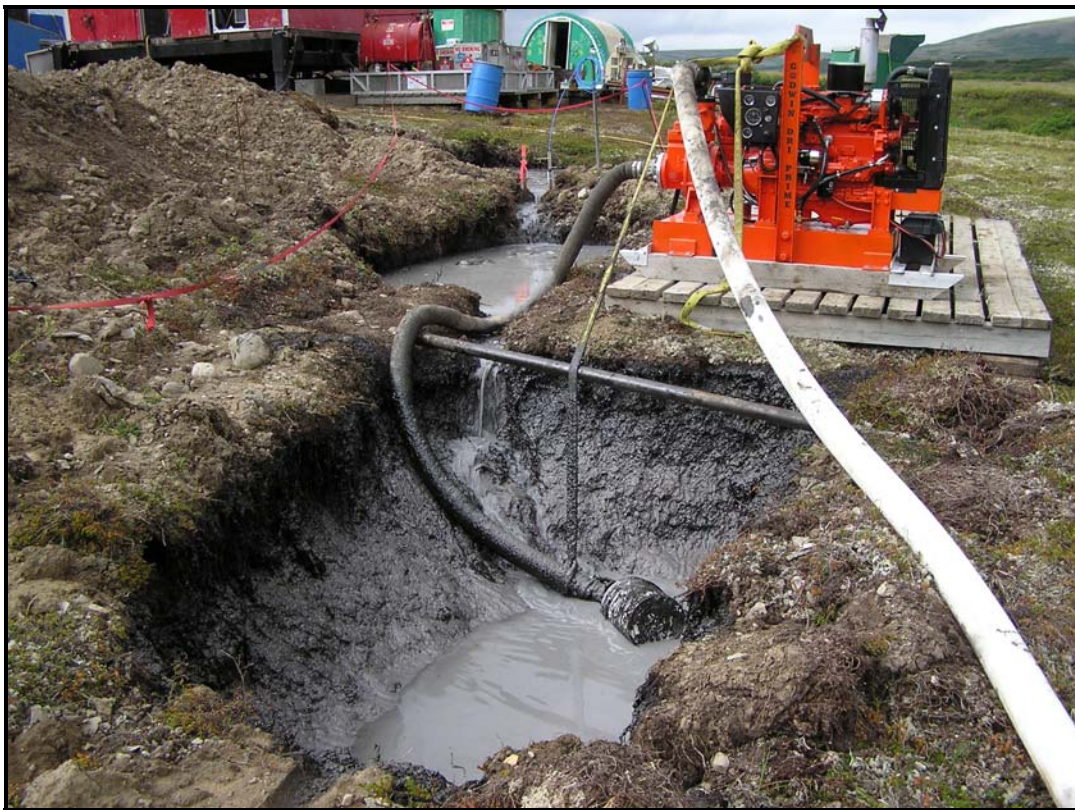
<ul style="list-style-type: none"> <li>○ Pump location to source: Electric pump in source; generator in containment away from pond.</li> </ul>
<ul style="list-style-type: none"> <li>■ Sump Pit:</li> </ul>	<ul style="list-style-type: none"> <li>○ Catch basin for fuel supply: Yes</li> </ul>
<ul style="list-style-type: none"> <li>○ Location: Next to drill rig – see photo</li> </ul>	<ul style="list-style-type: none"> <li>○ Sorbent pads: yes</li> </ul>
<ul style="list-style-type: none"> <li>○ Discharge trench: Yes, see photo</li> </ul>	<ul style="list-style-type: none"> <li>○ Hose color: Yellow</li> </ul>
<ul style="list-style-type: none"> <li>○ Dimensions of pit: 3 sumps 8'x10' - see photo</li> </ul>	
<ul style="list-style-type: none"> <li>○ In use: Yes</li> </ul>

**Figure 16: Drill Rig # 5 sumps.**

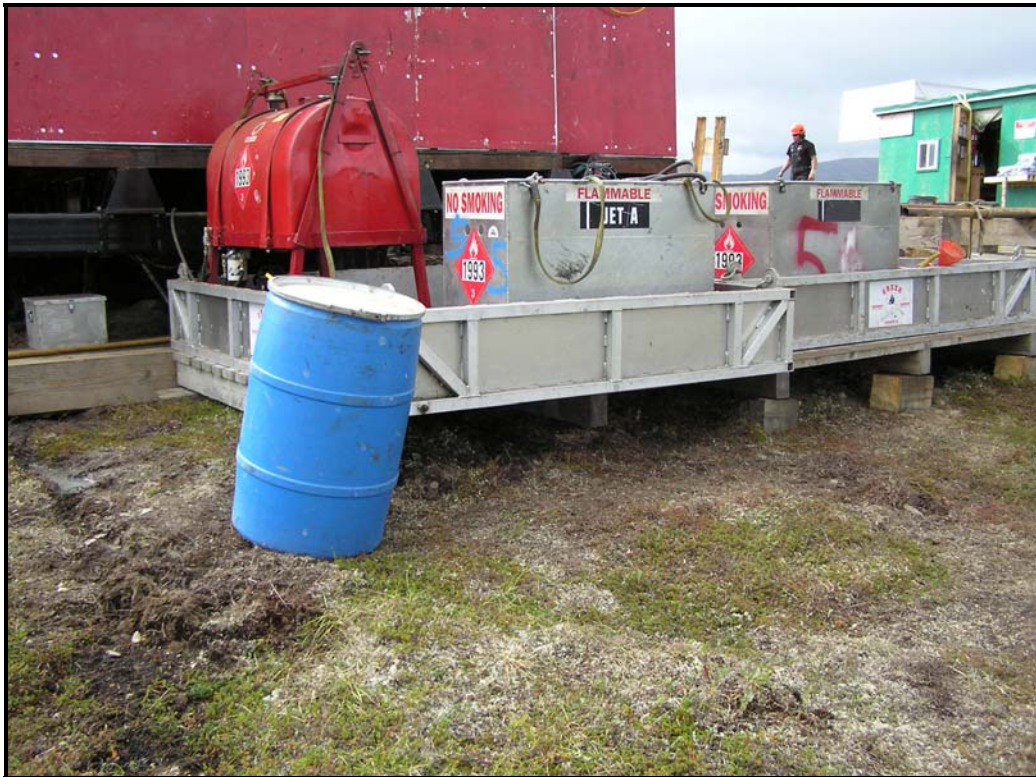
**Figure 17: Fuel storage for Rig # 5.**

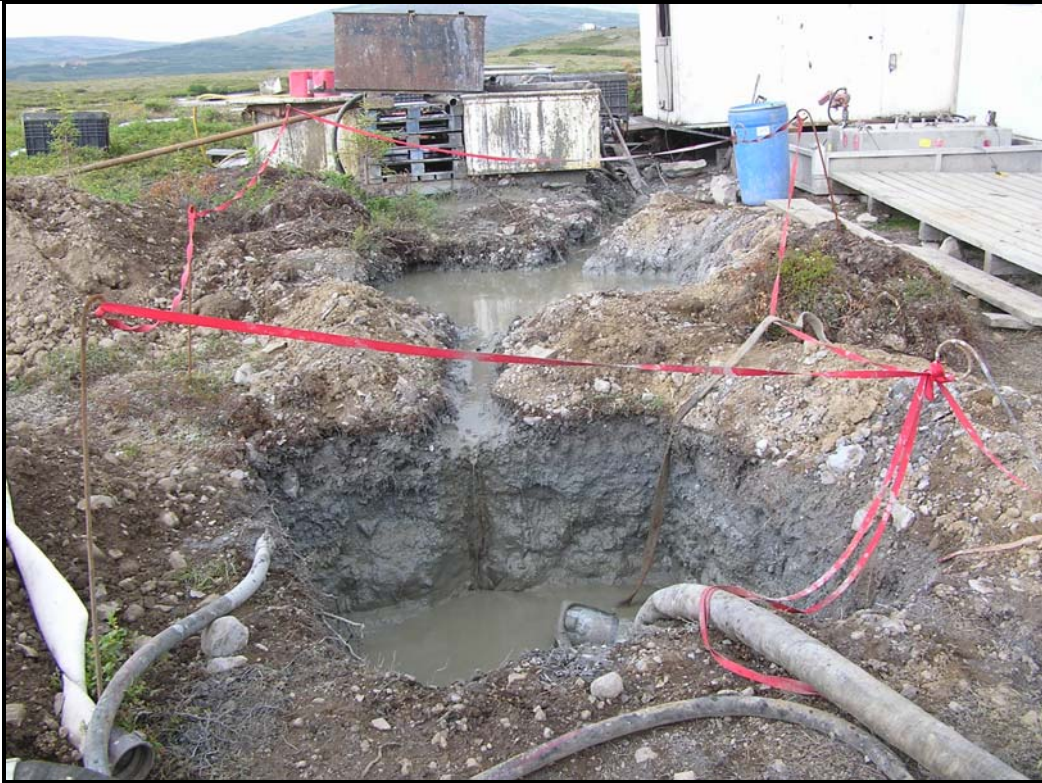
**Figure 23: Sumps at Drill Rig # 1.**

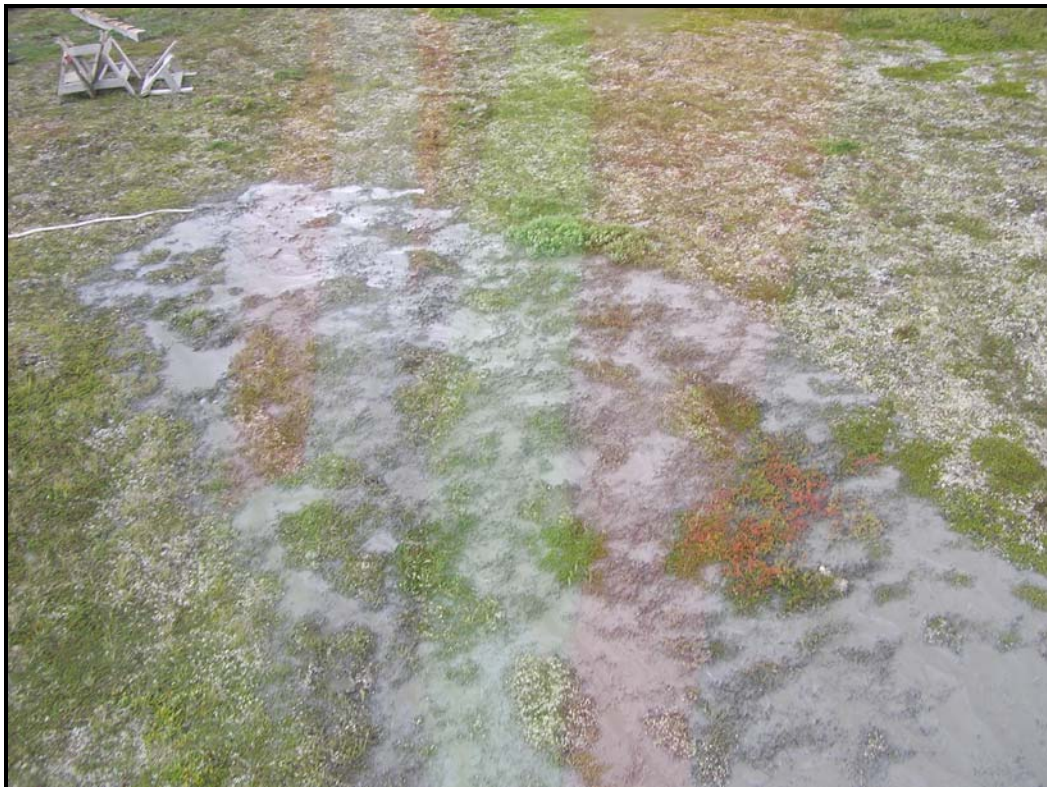
**Figure 24: Discharge from Drill Rig # 1.**

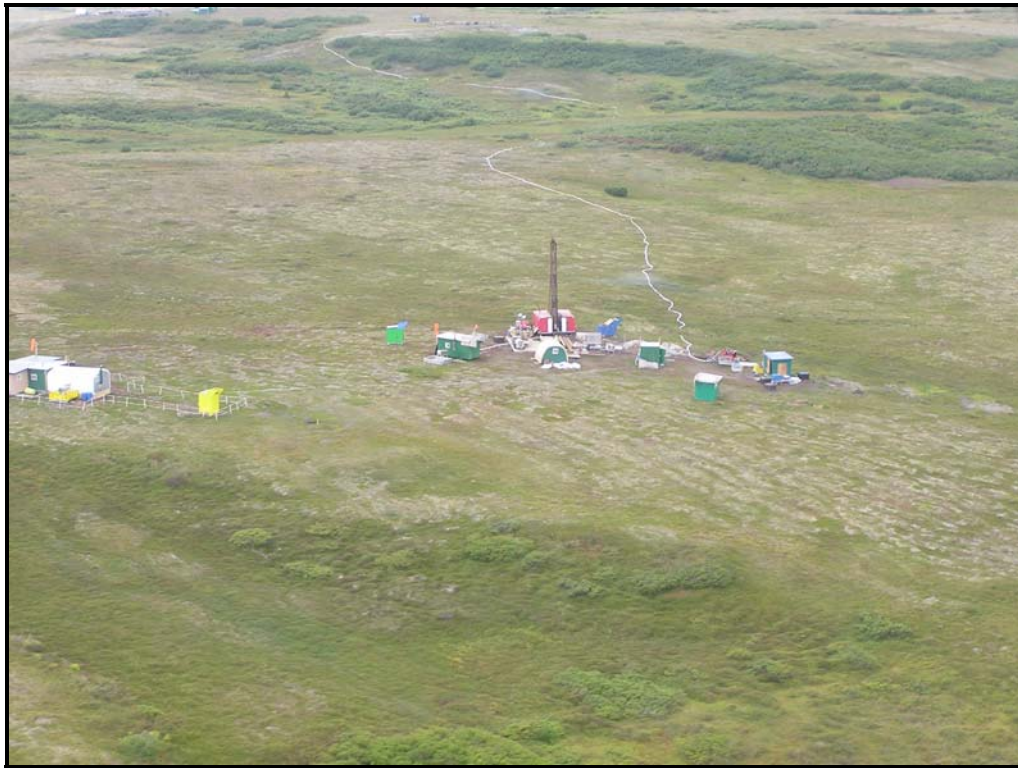
**Figure 27: Drill Rig # 4; note distance from water.**

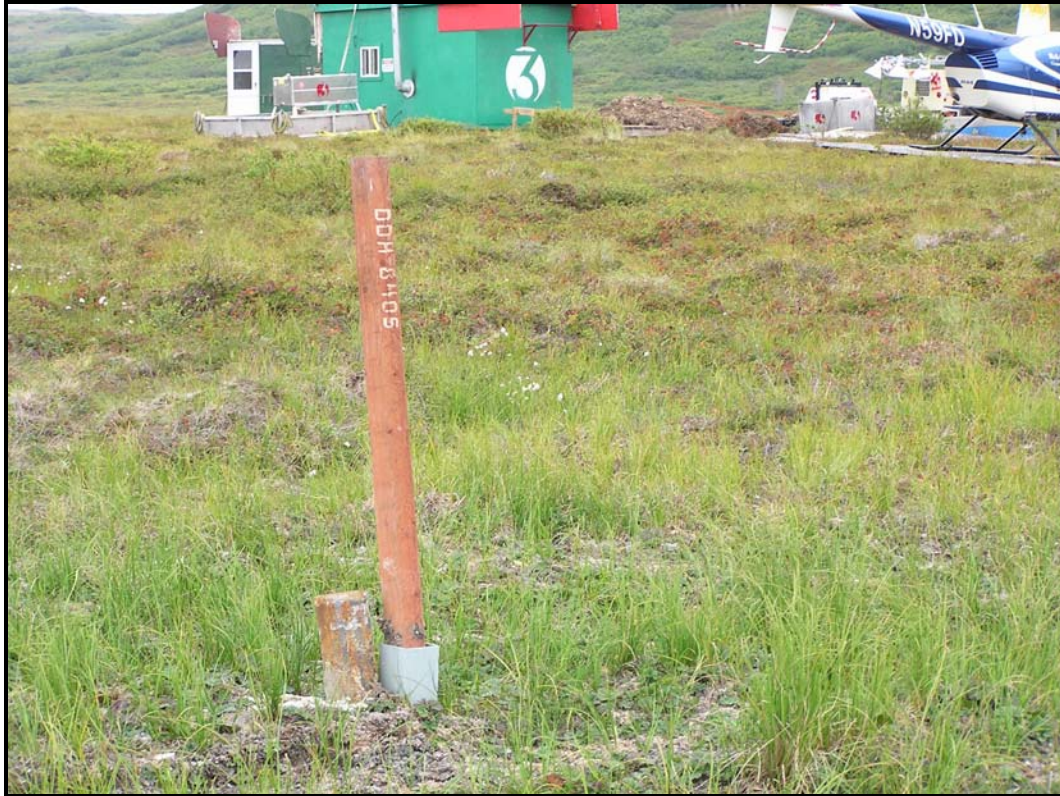
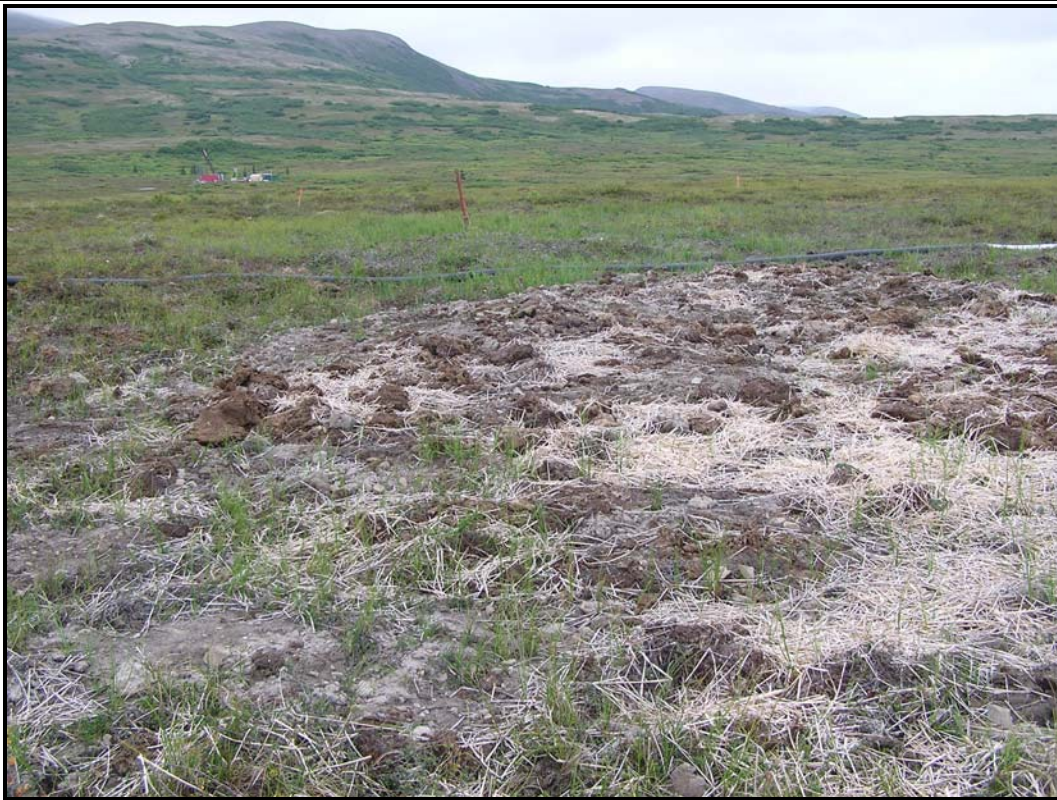
DDH-8405 site was observed near Drill Rig # 3. The site was free of litter and debris. The disturbed area had straw mulch. The drillhole casing extended above the ground surface approximately one foot. It was not possible to determine whether or not this drill hole had been plugged.

**Figure 29: Reclaimed site - DDH # 8405.**

**Figure 30: Reclaimed site of DDH # 8405.**

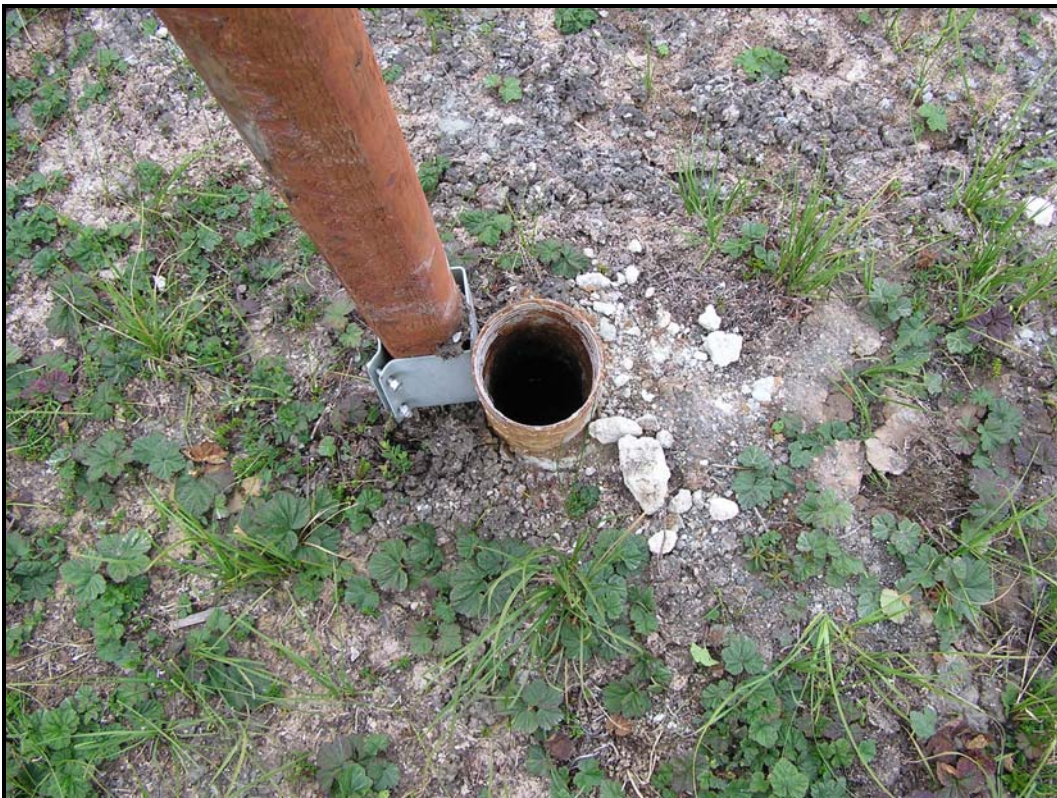
**Figure 31: Open casing for DDH # 8405; unable to determine if hole had been plugged.**

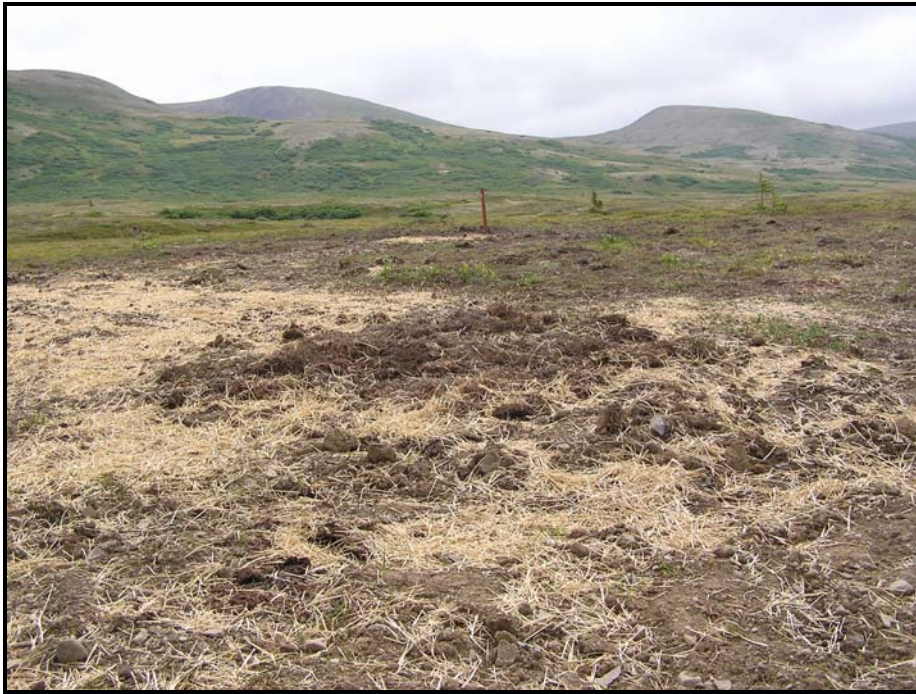
DDH-8415 site was observed near Drill Rig # 5. The site was free of litter and debris. The disturbed area had straw mulch. The drillhole casing extended above the ground surface approximately one foot. It was not possible to determine whether or not this drill hole had been plugged.

**Figure 32: Reclaimed drill site for hole No. 8415.**

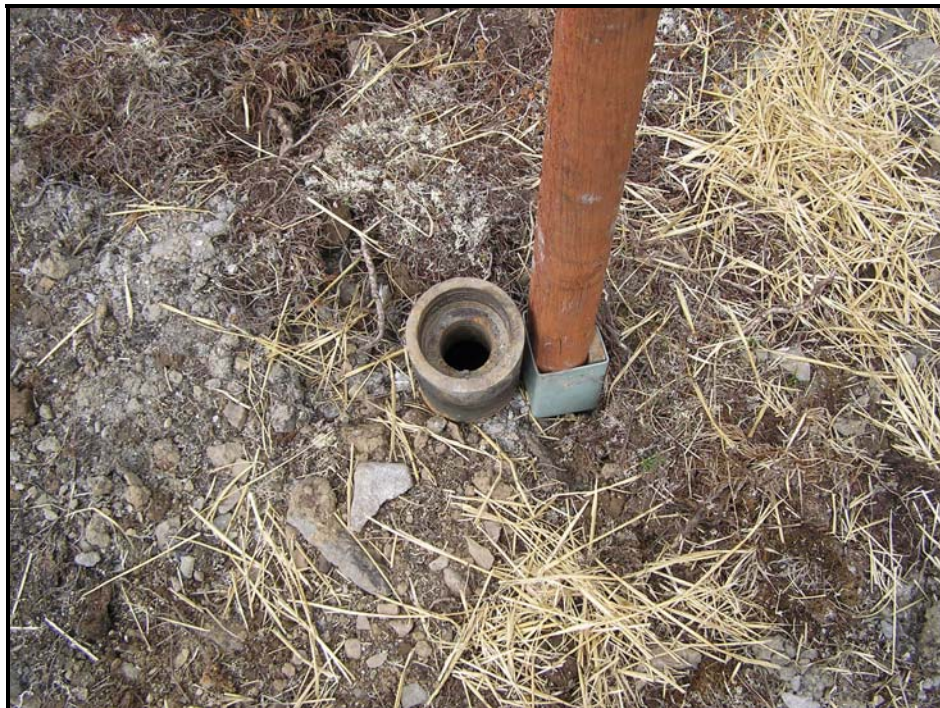
**Figure 33: DDH No. 8415 - unable to determine if hole was plugged.**

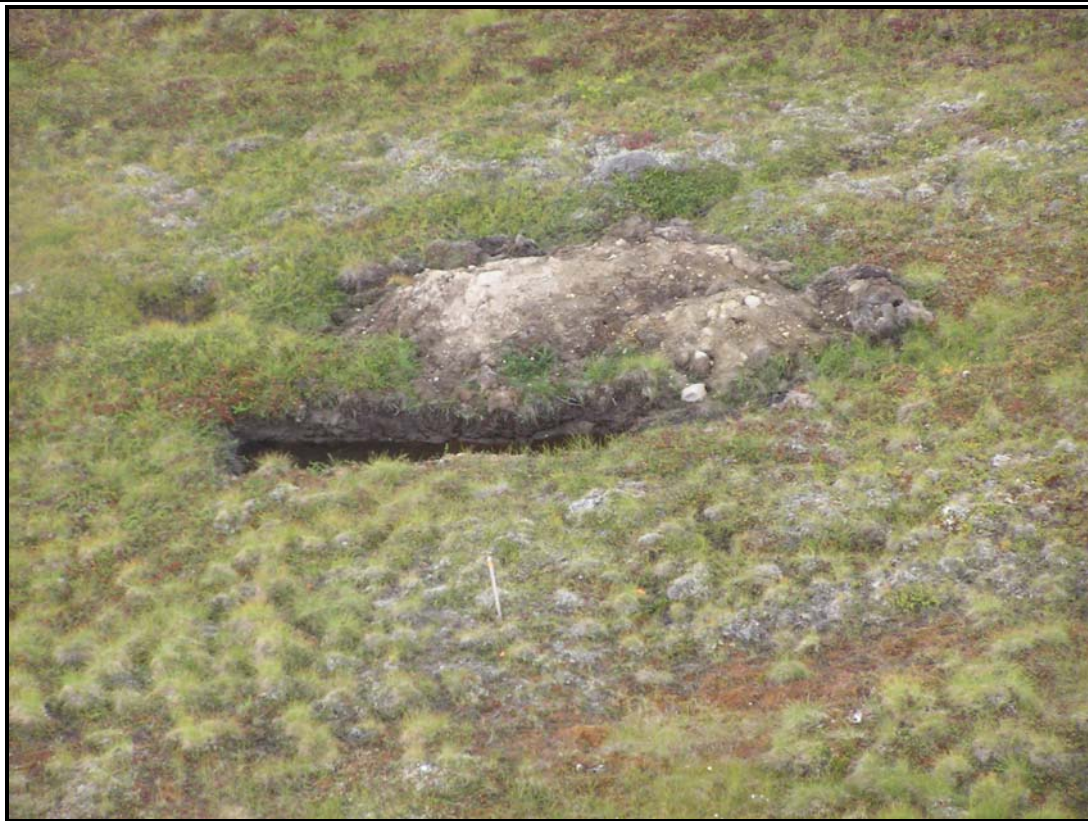
During the flight back from the project area to Iliamna, we observed an unreclaimed trench at 59 52.00.6 / 155 09 45.1. These coordinates indicate that the unreclaimed trench is located on State Mining Claim PEB EB 7 (ADL 642344).

**Figure 36: Unreclaimed trench at 59 52 00.6 / 155 09 45.1.**

<input type="checkbox"/> Visibility: > 1 mile	<input type="checkbox"/> Observed outflow: not observed
<input type="checkbox"/> Sky Conditions: PC/Cloudy	
<input type="checkbox"/> Ground Conditions:	
<p>Comments: Most drill sites were clean and orderly.</p>	
<p>Recommendations: None.</p>	
<p>Actions Needed: It was not apparent whether or not DDH # 8405 and DDH # 8415 were plugged when sites were reclaimed; please confirm whether or not this is the case. Please determine whether the unreclaimed exploration trench is located on PLP claims and if so, please indicate when it will be reclaimed.</p>
