Field Monitoring Report -- Pebble Copper/Gold Exploration Project --

Personnel: Bill Cole (DNR, Mining Section)	Inspection Date: October 15, 2009
Ron Benkert (DF&G)	Site Contact: Gary Deschutter
	APMA #: A096118
■ Inspection Type:	■ Wildlife Observed:
<ul style="list-style-type: none"> ○ Complete: Inspected 2 of three drills on site. One was moving to new location. Visited Big Wiggly fuel storage site and inspected 4 reclaimed 2009 core hole sites. 	<ul style="list-style-type: none"> ○ Bear:
<ul style="list-style-type: none"> ○ Partial: 	<ul style="list-style-type: none"> ○ Caribou:
<ul style="list-style-type: none"> ○ Follow-up: 	<ul style="list-style-type: none"> ○ Moose:
<ul style="list-style-type: none"> ○ Response to Public Complaint: 	<ul style="list-style-type: none"> ○ Waterfowl:
	<ul style="list-style-type: none"> ○ Fish:
■ Weather Conditions:	<ul style="list-style-type: none"> ○ Other: Noted beaver ponds and lodges in upper South Fork Koktuli River drainage, above Frying Pan Lake. Ponds appear to be occupied, as indicated by well maintained lodges and dams. Two swans observed on Big Wiggly Lake

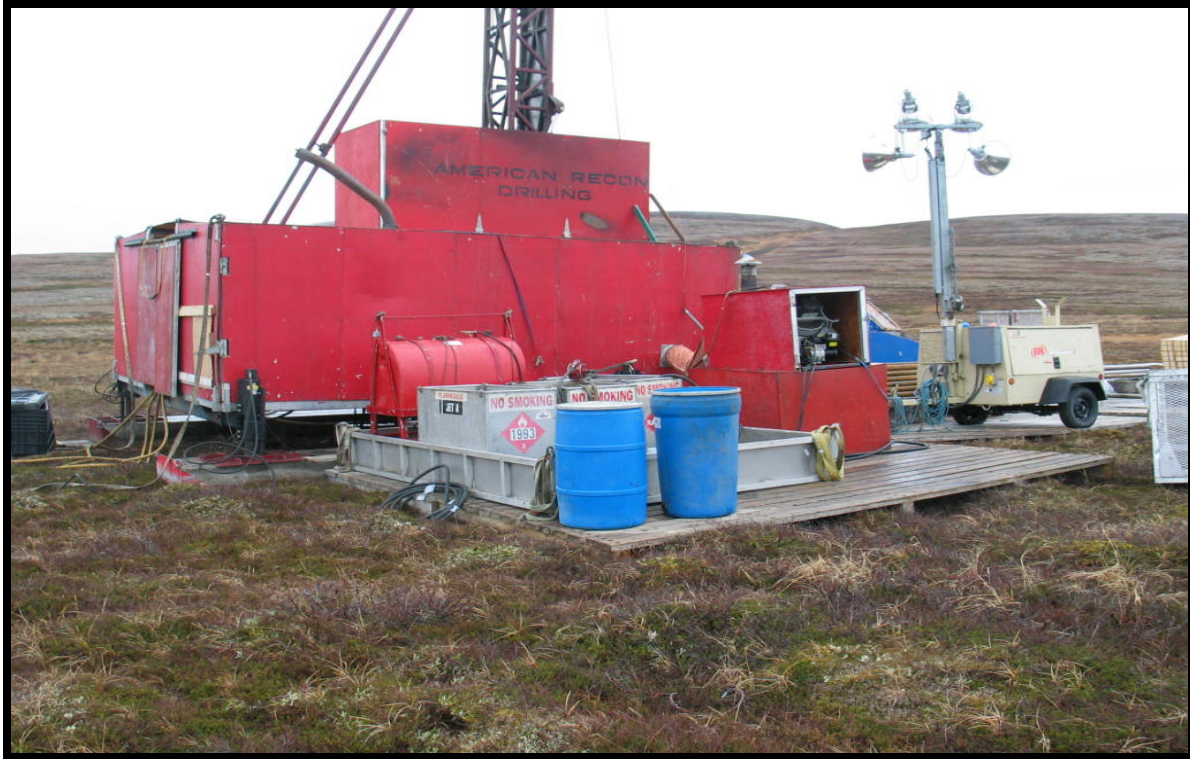
Figure 1: Drill #4 on DDH 9473. Note fuel containment, spill barrel and oil scrubber, tundra pads.

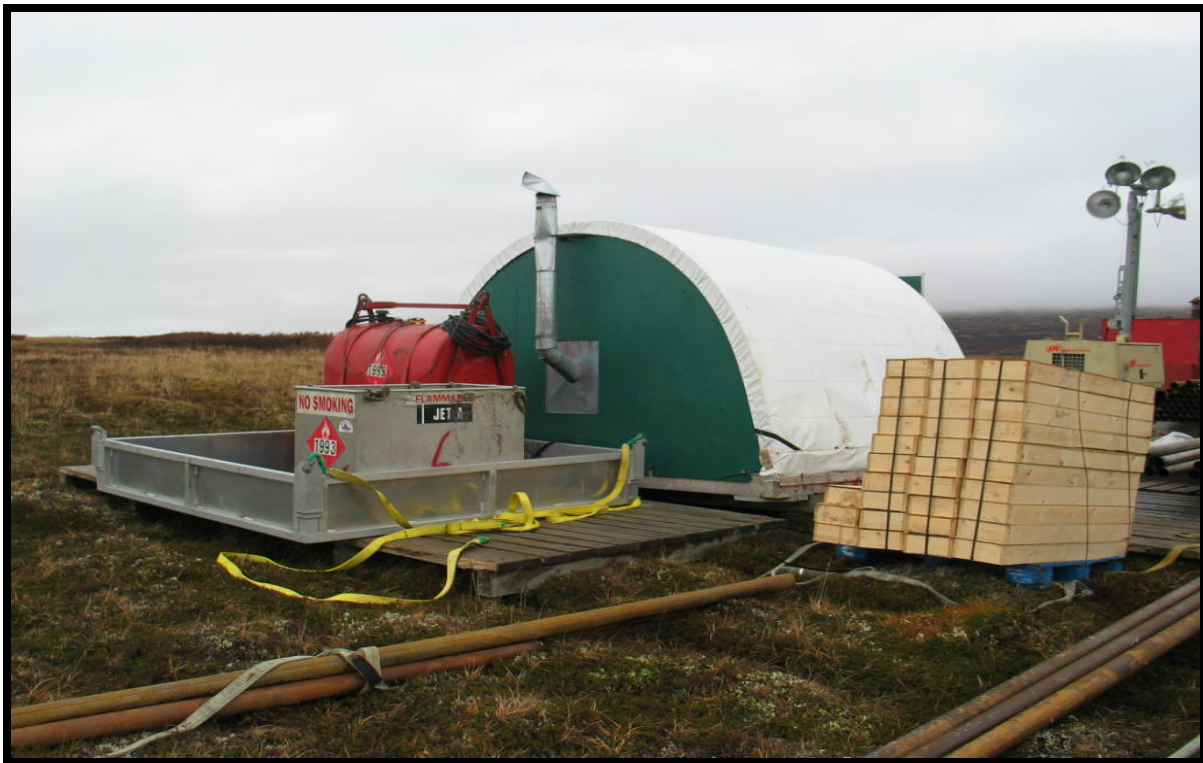
Figure #2: Drill #4. Crew hut with fuel for hut, core boxes.

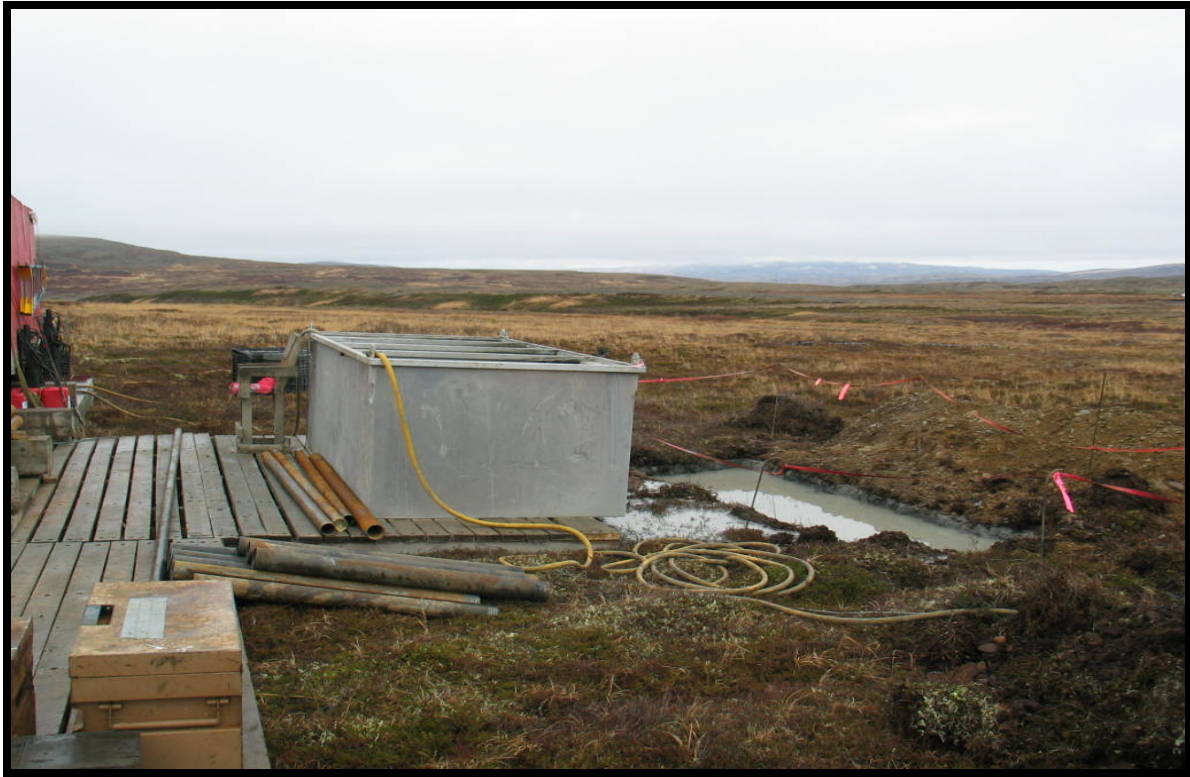
Figure #3: Drill #4. Tank for recycling drilling fluid. Sump is for excess drilling fluid.

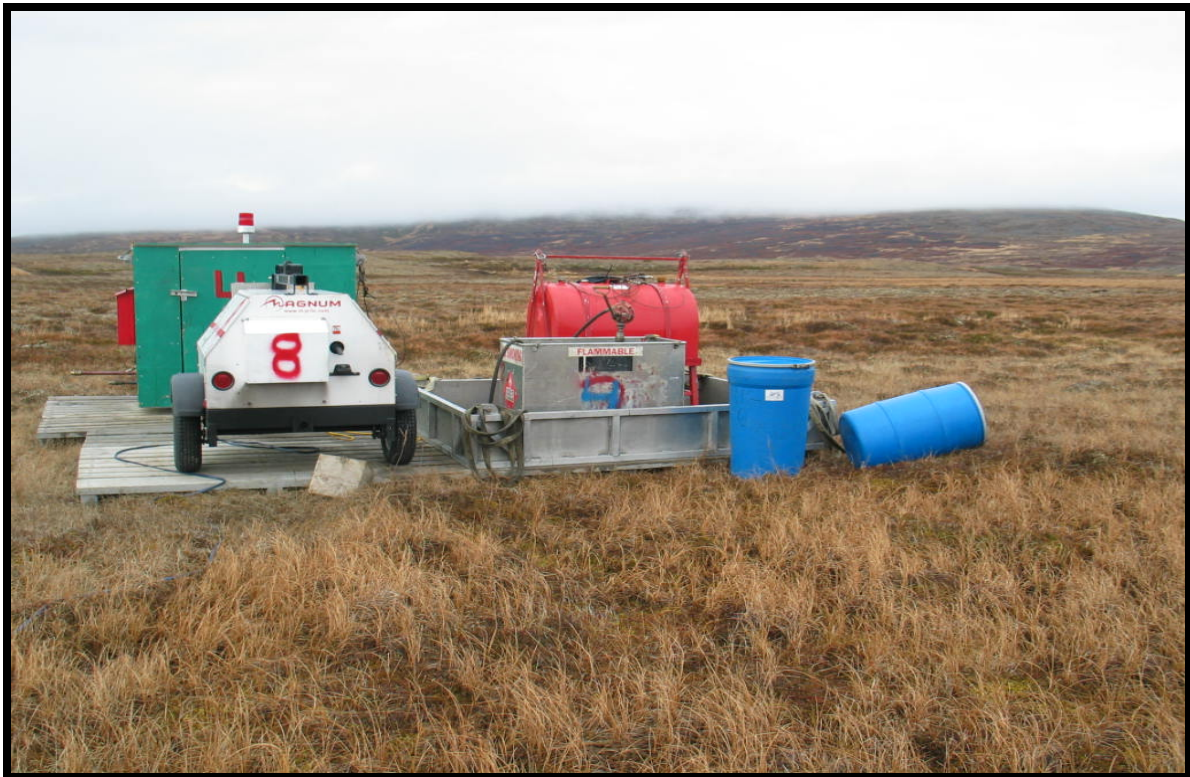
Figure #4: Drill #4. Water pump. Fuel is in containment, with spill kit and scrubber barrel.

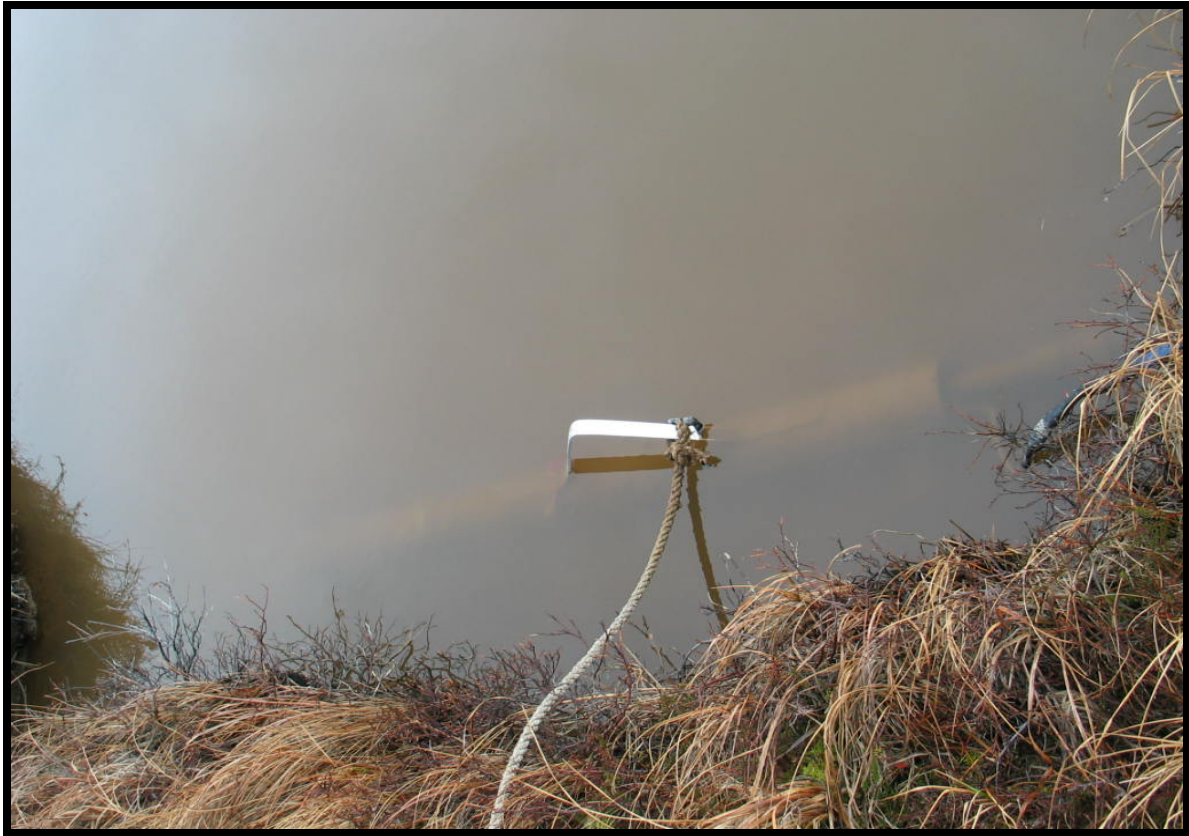
Figure #5: Water intake for Drill #4.

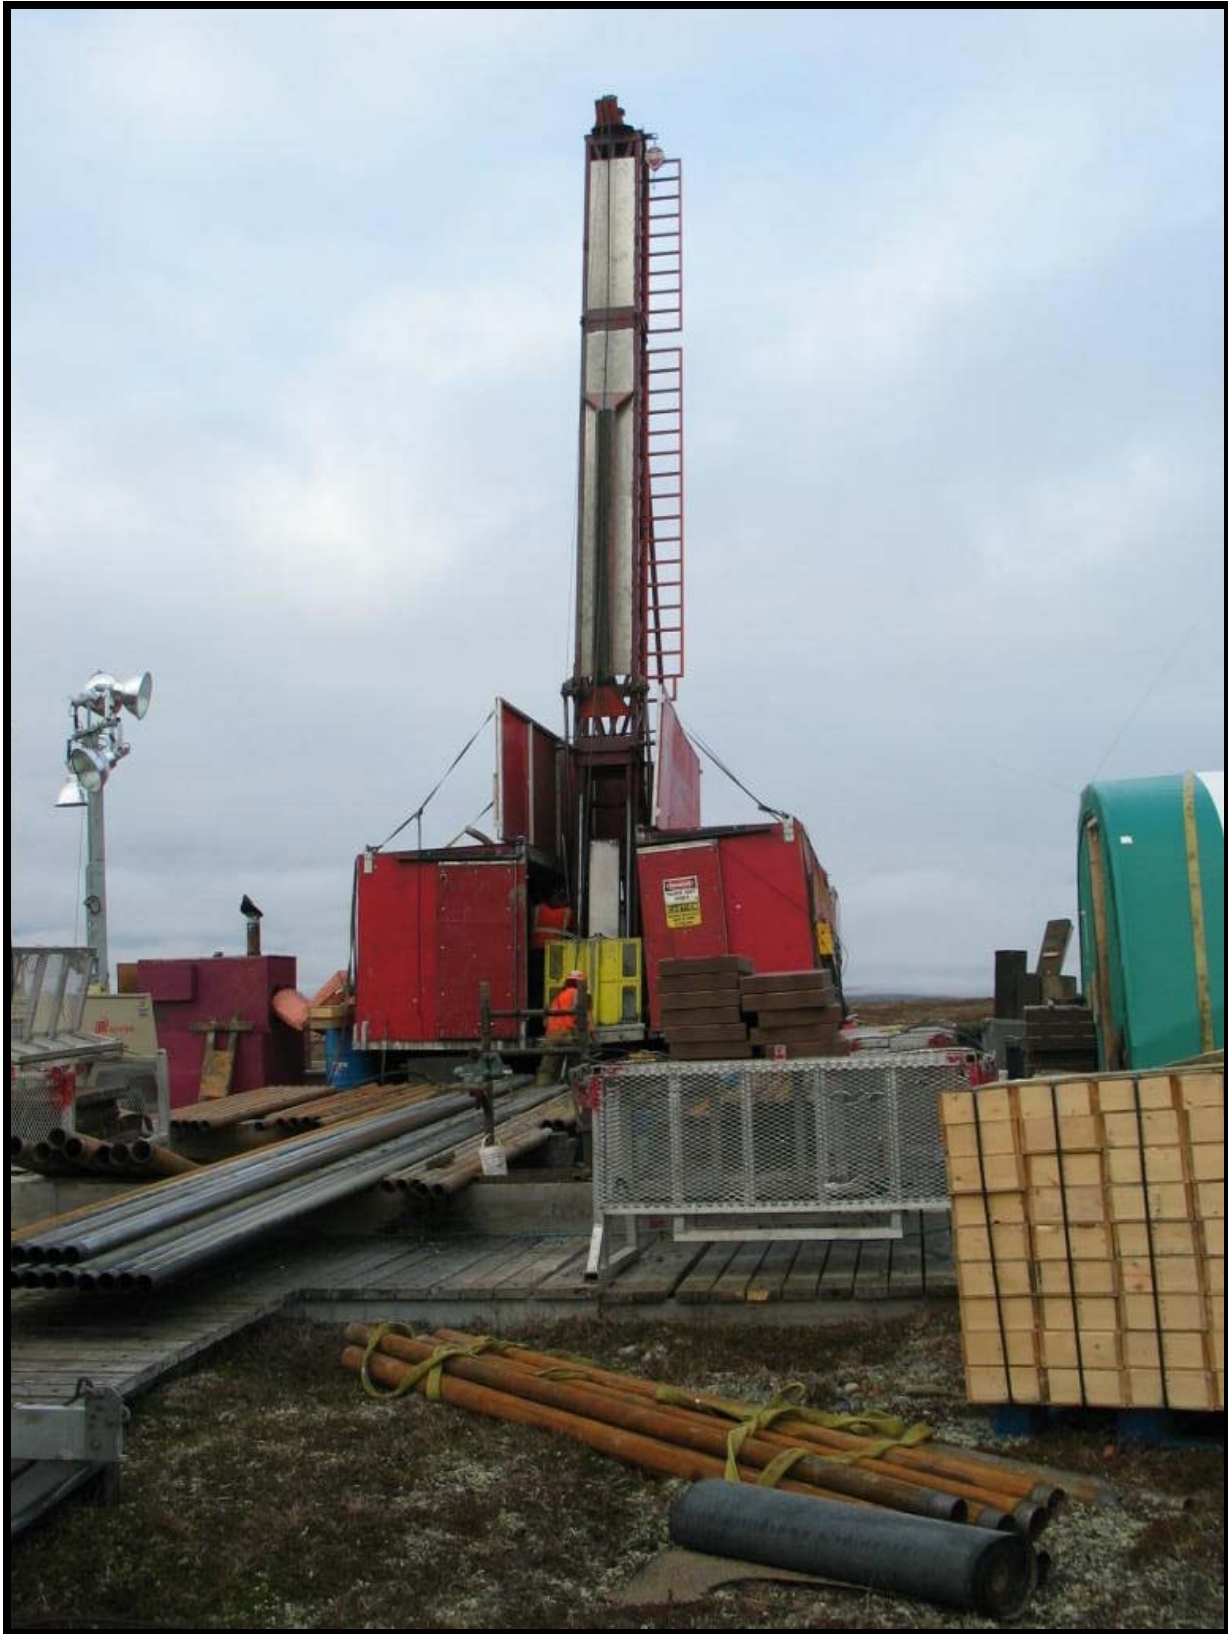
Figure #6: Drill #2 on DDH 9471.

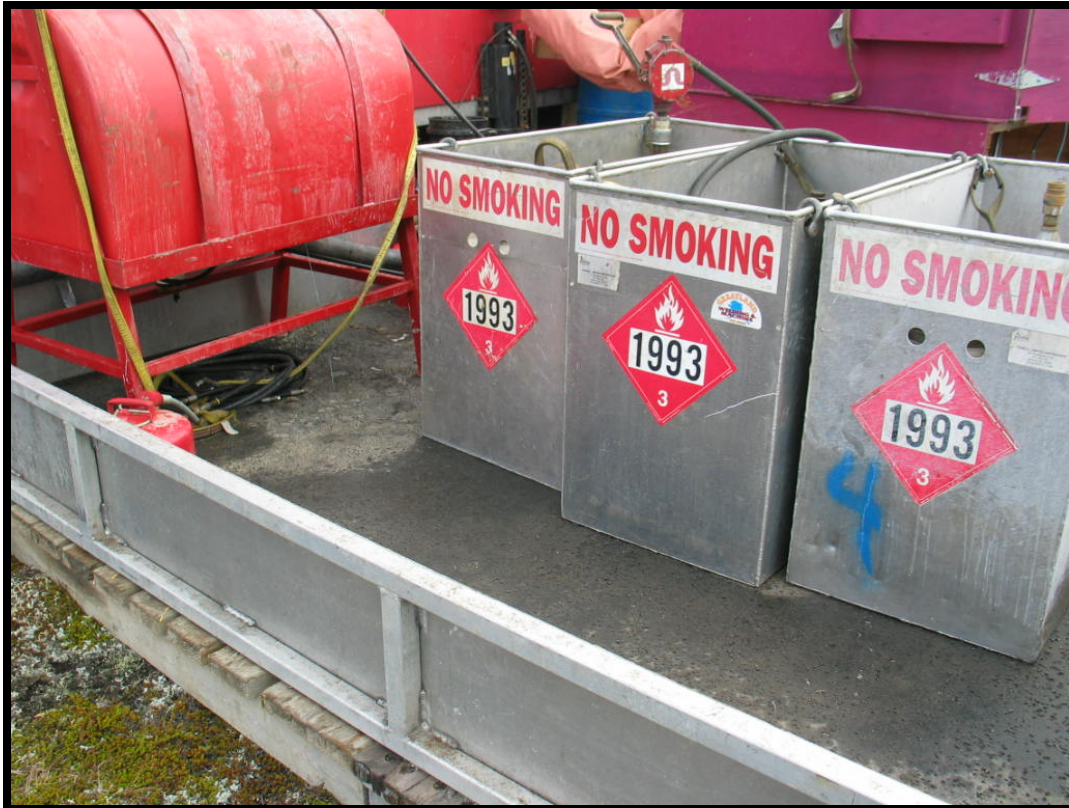
Figure #7: Fuel containment at Drill #2.

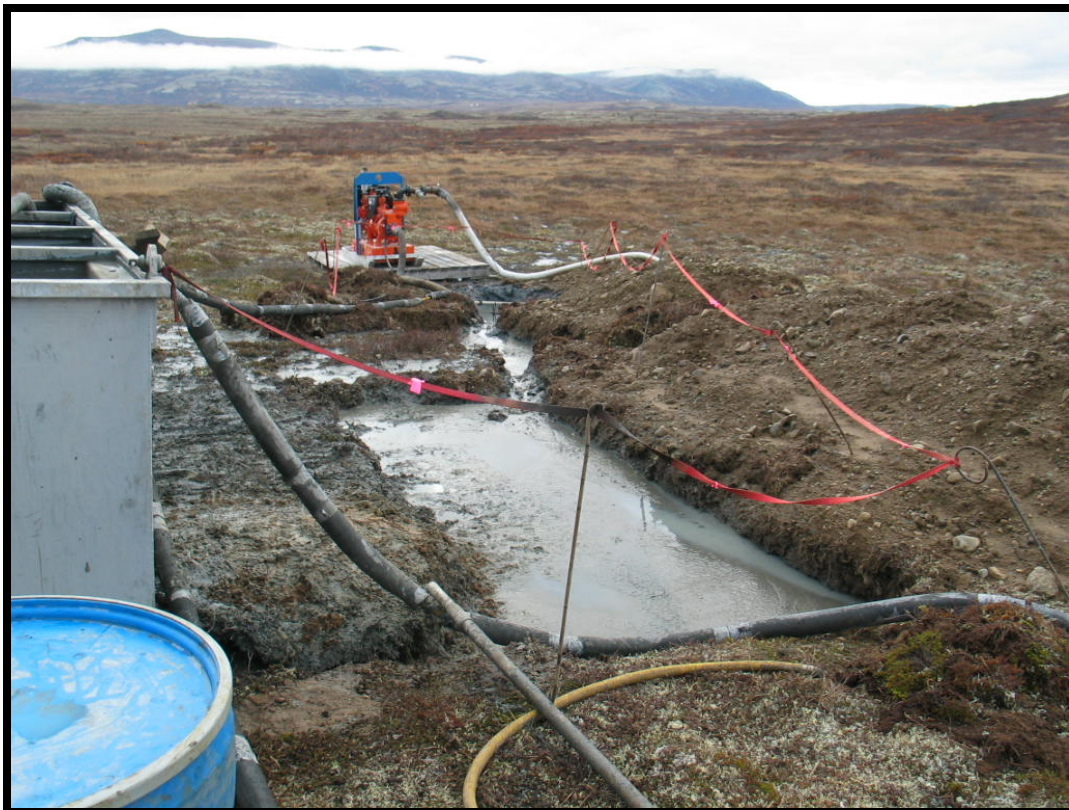
Figure #8: Recirculation tank and sump pits at Drill #2.

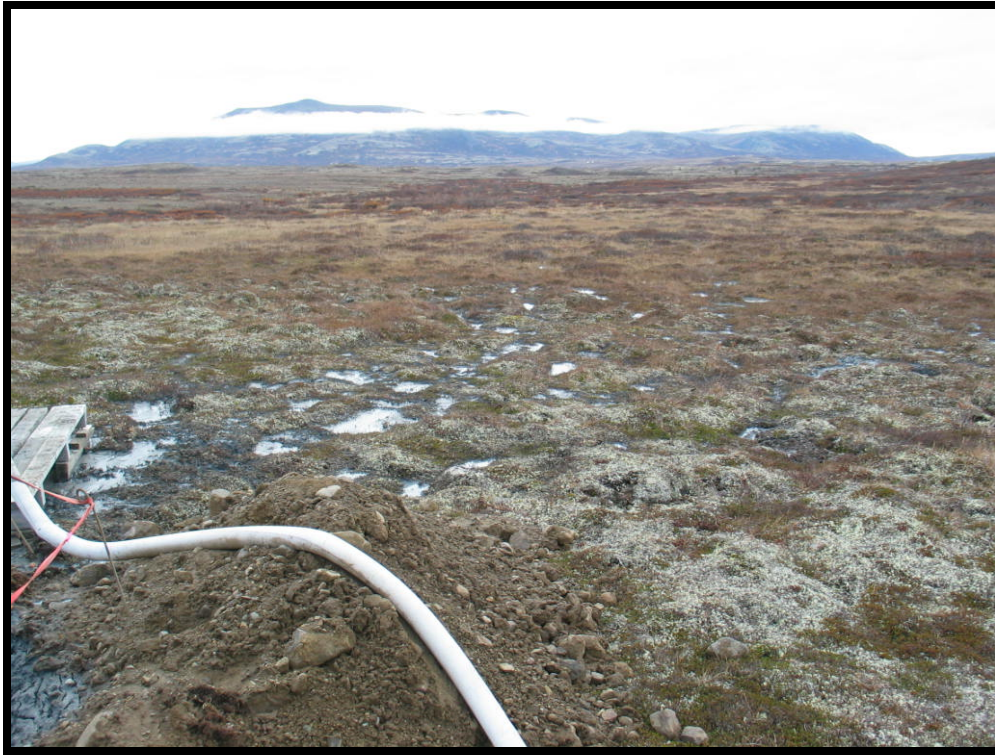
Figure #9: Drilling fluid discharge downhill from Drill #2.

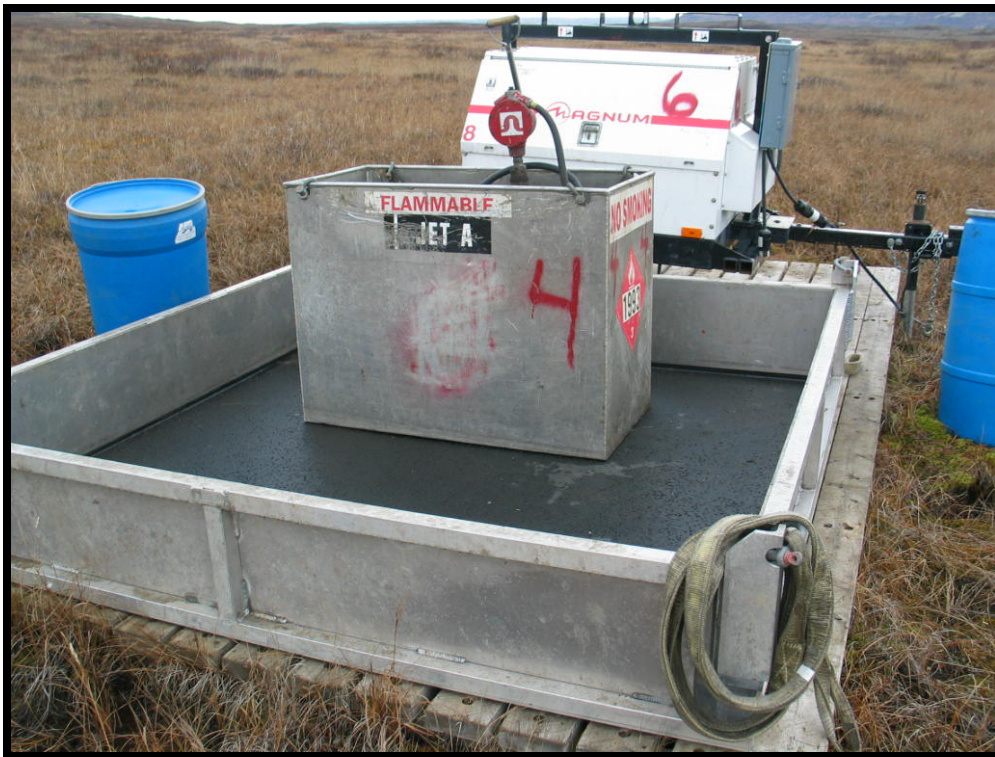
Figure #10: Fuel containment for water pump at Drill #2.

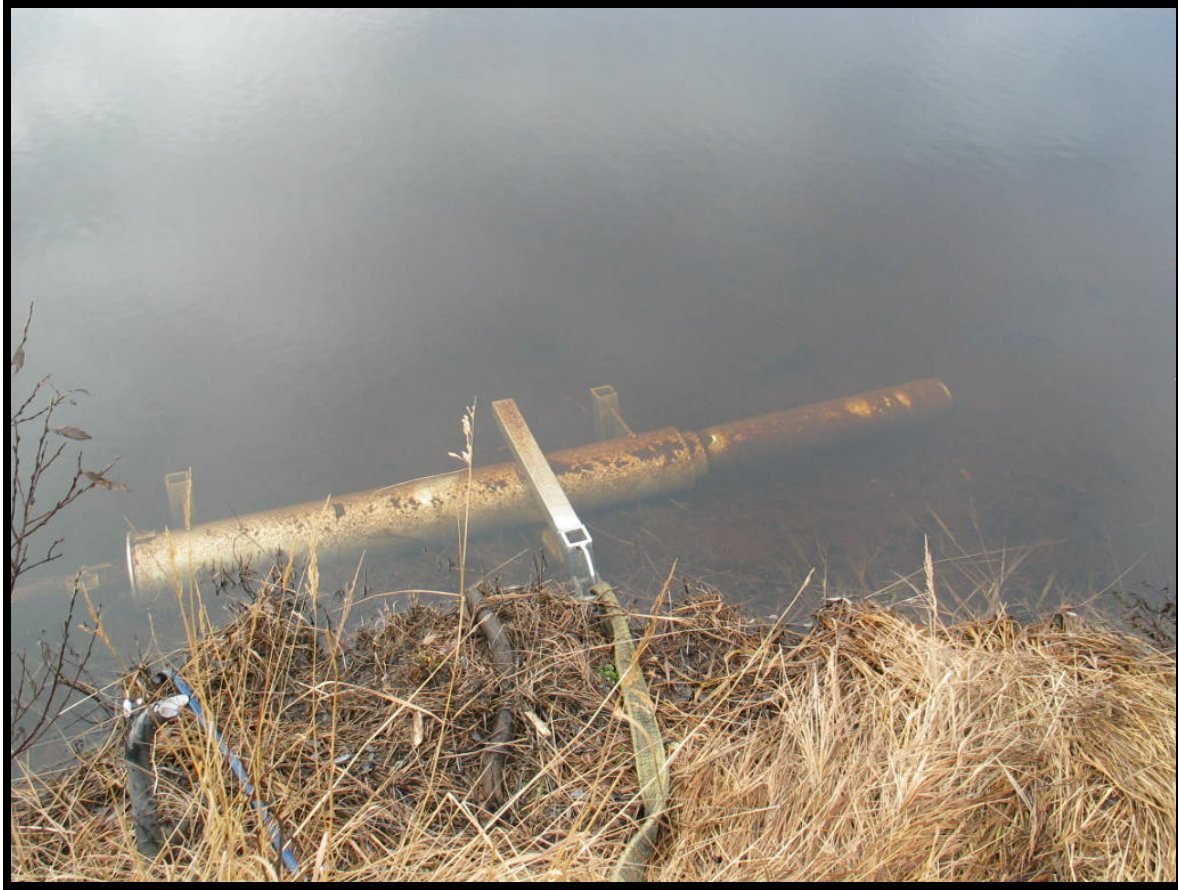
Figure #11: Water intake for Drill #2.

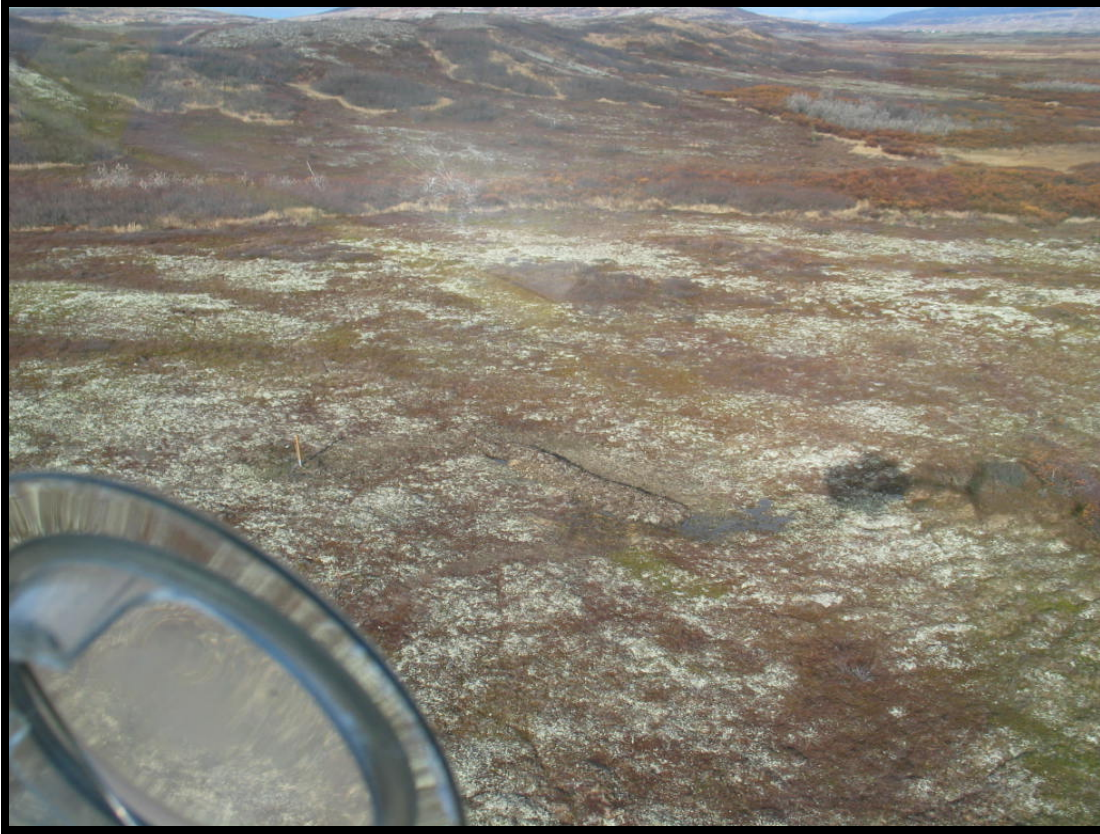
Abandoned Drill Hole/Site No.: 9462	Date: 10/15/2009
<ul style="list-style-type: none"> ■ Plugged: Yes ■ Cemented: Not observed ■ Standing pipe: Yes ■ Sump pit filled in: Pit has not been reclaimed. ■ Water discharge trench filled in: Partially ■ Site revegetated: Natural revegetation, limited reseeding ■ Artesian water present: No ■ Any spills or staining: No ■ Comments/General impression: This hole was recently drilled, and is only partially reclaimed.

Figure 12: Reclaimed DDH 9462.

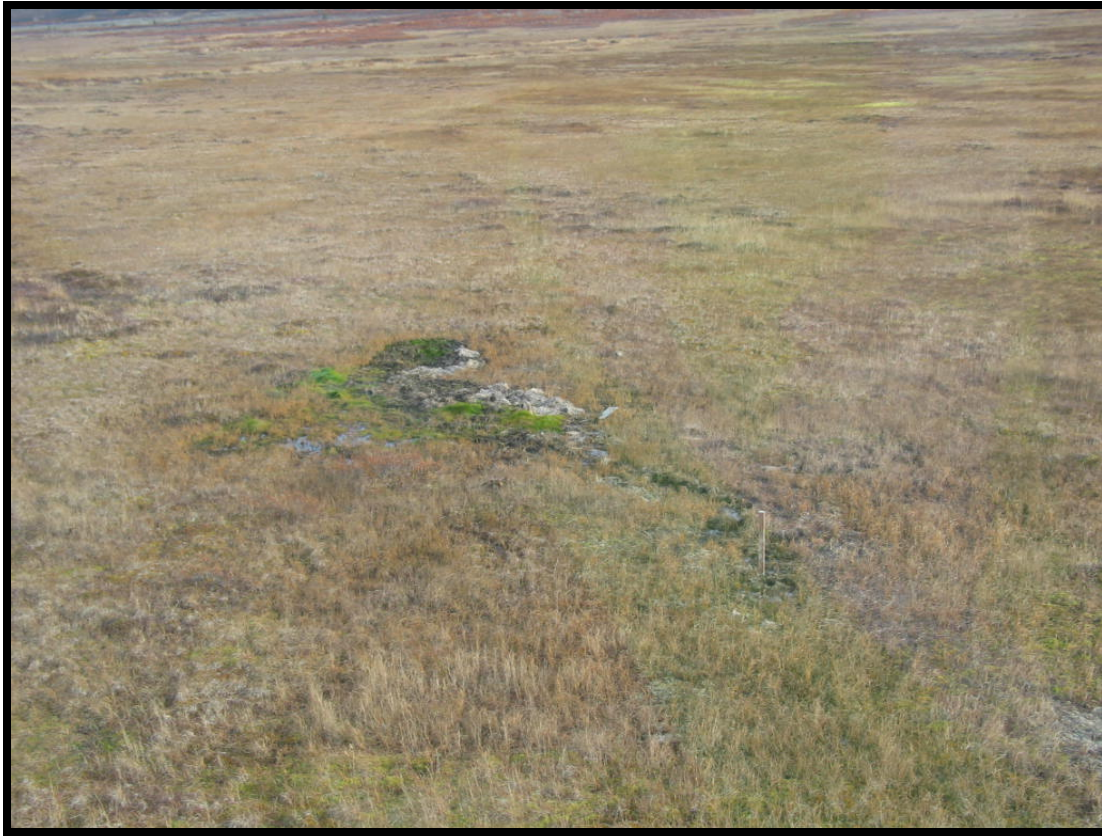
- Plugged: Yes
- Cemented: Not observed
- Standing pipe: Yes
- Sump pit filled in: Yes
- Water discharge trench filled in: Yes
- Site revegetated: Natural revegetation, limited reseeding
- Artesian water present: No
- Any spills or staining: No
- Comments/General impression: 2009 drill site. Recently reclaimed.

Figure 13: Reclaimed DDH 9451.

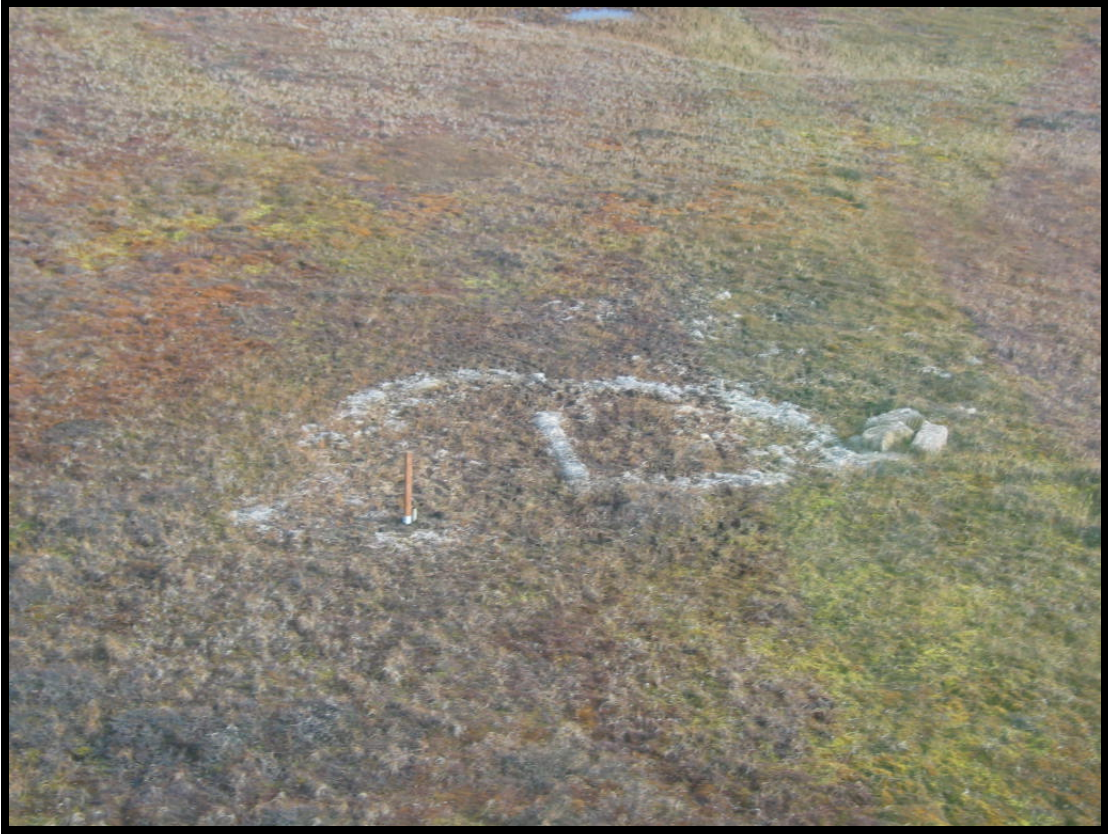
■ Comments/General impression: 2009 hole. Recently reclaimed.

Figure 14: Reclaimed DDH 9448.

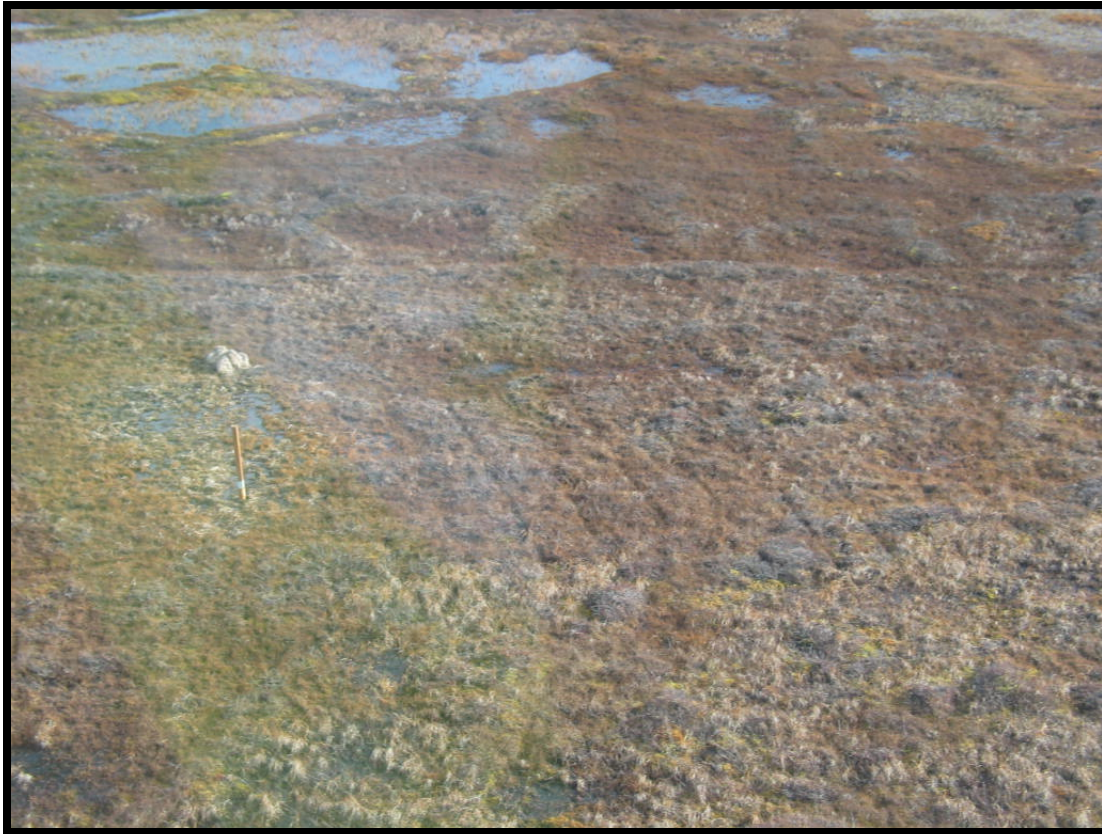
■ Comments/General impression: 2009 hole. Recently reclaimed.

Figure 15: Reclaimed DDH 9445.

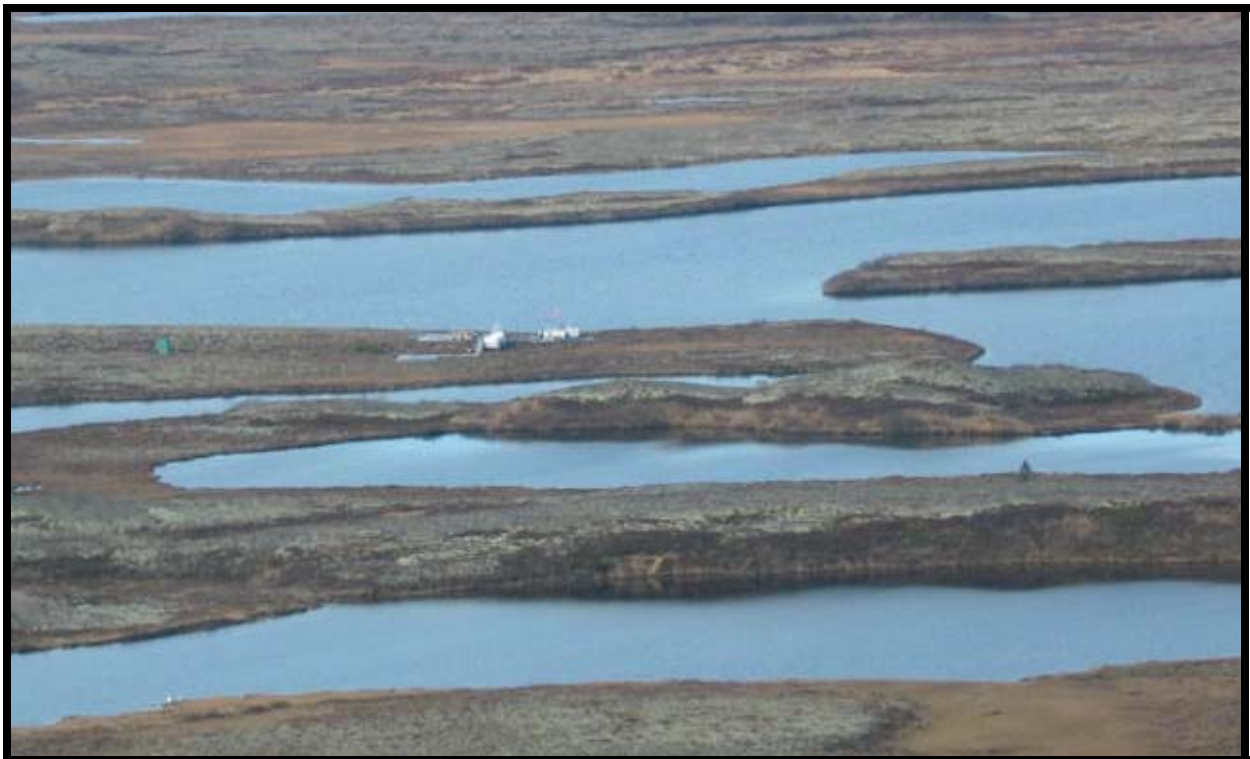
marker posts. Fuel is still being flown into Big Wiggly fuel storage facility using a Beaver on floats. The lake has not begun to freeze. See figures 16-20 for Big Wiggly storage facility.

Figure 16: Big Wiggly Lake and Fuel Storage Facility

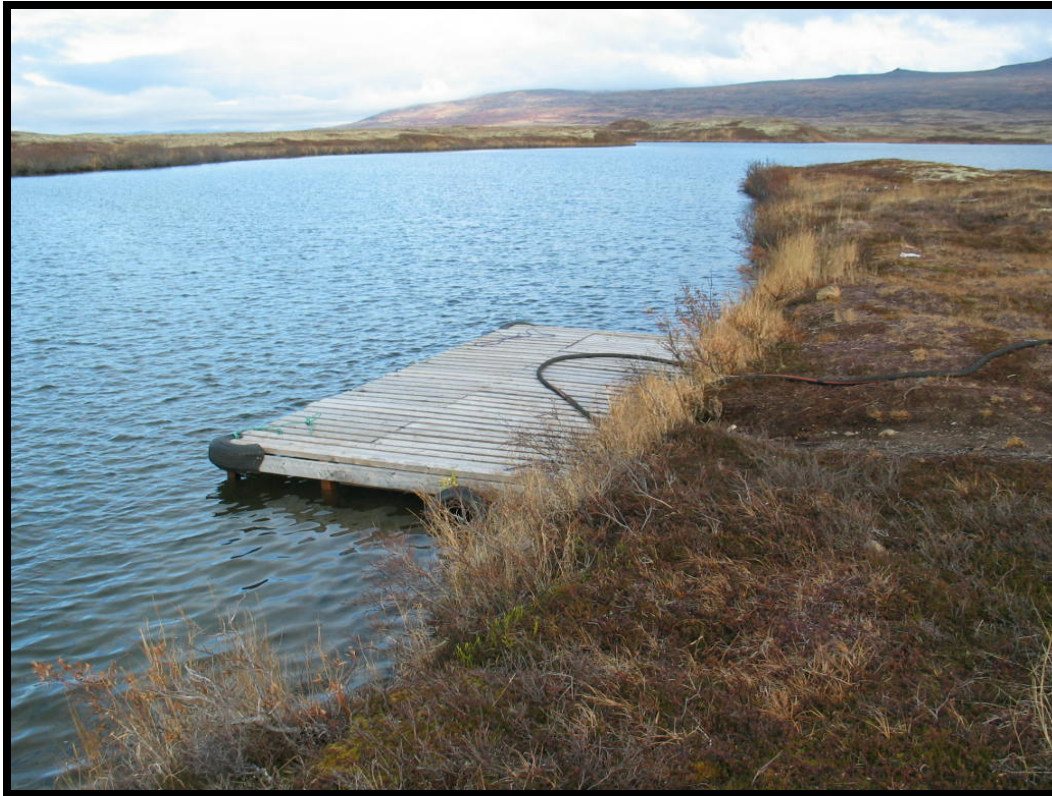
Figure 17: Dock at Big Wiggly Fuel Storage

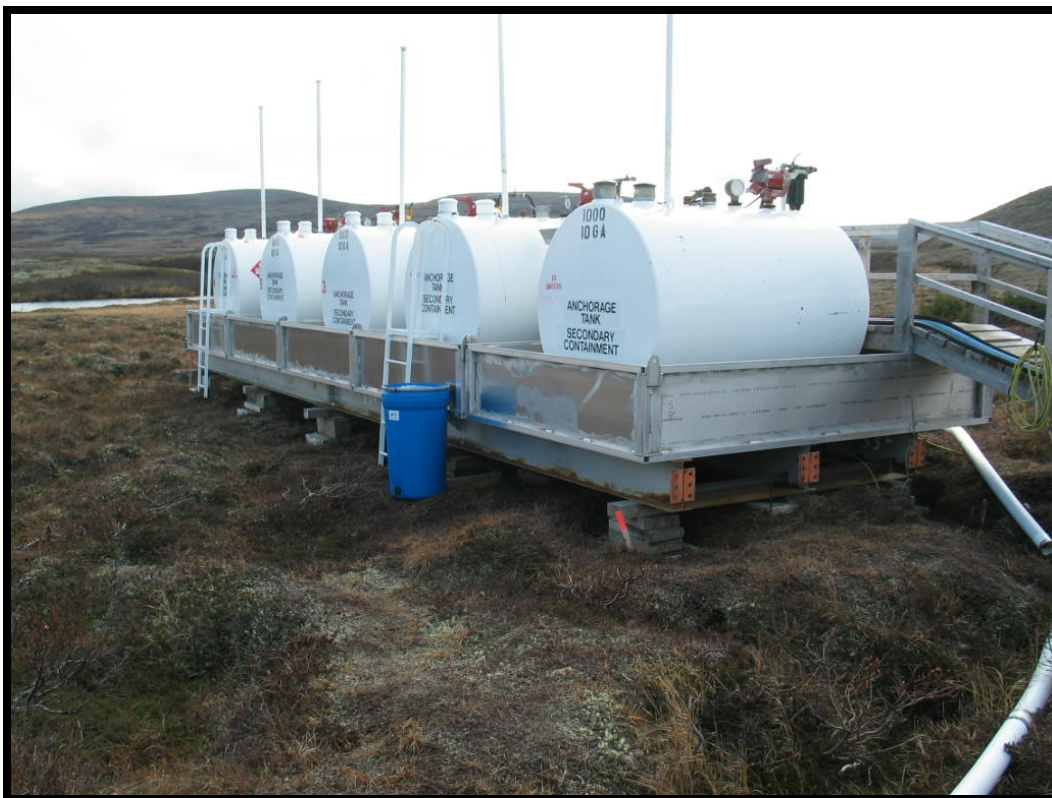
Figure 18: Fuel tanks at Big Wiggly Lake

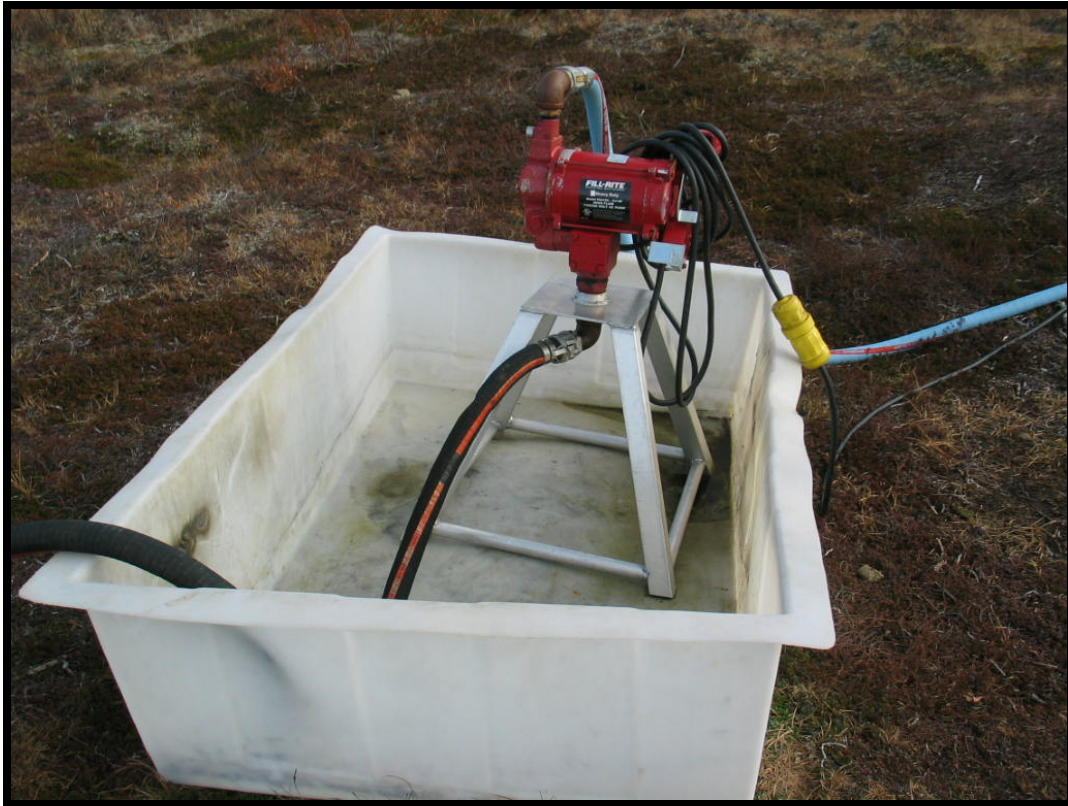
Figure 19: Fuel transfer pump at Big Wiggly

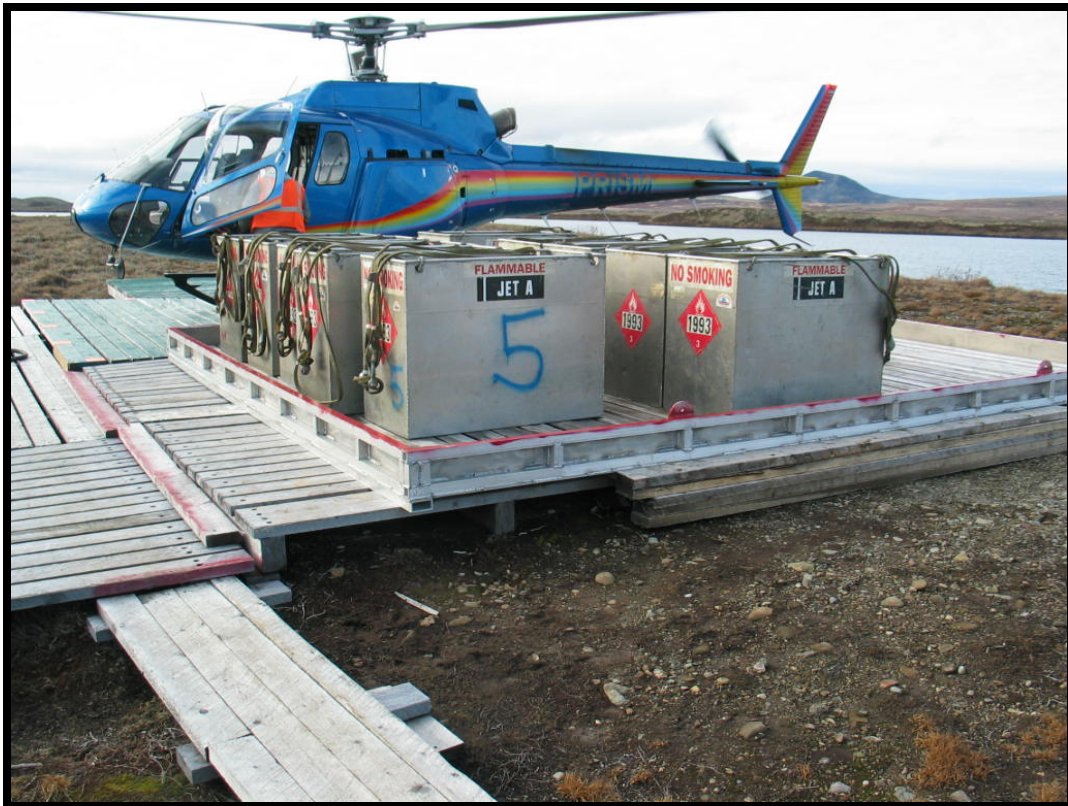
Figure 20: Helicopter refueling at Big Wiggly
