PEBBLE PROJECT

2016 Reclamation Report

MLUP No. 6118

**PREPARED BY:
PEBBLE LIMITED PARTNERSHIP**

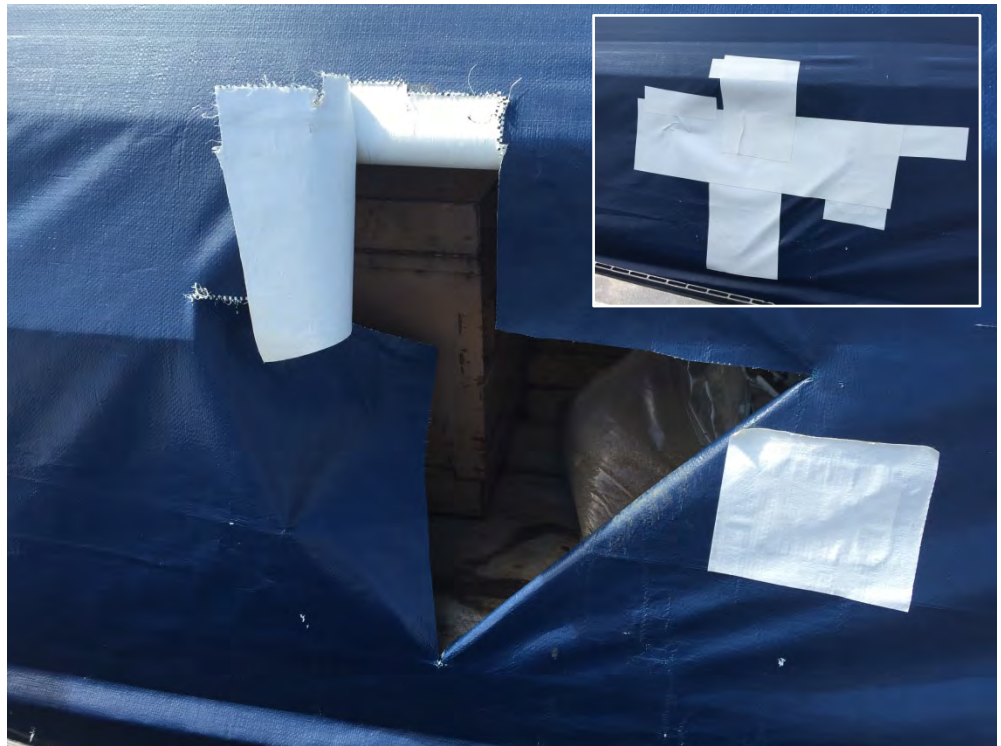
*Main photo: vandalism damage to main supply tent.
Inset: repairs with high-strength adhesive patches.*

New high-strength adhesive patches designed for all-weather exposure were used to repair vandalism damage to the main supply tent (Photo 1).

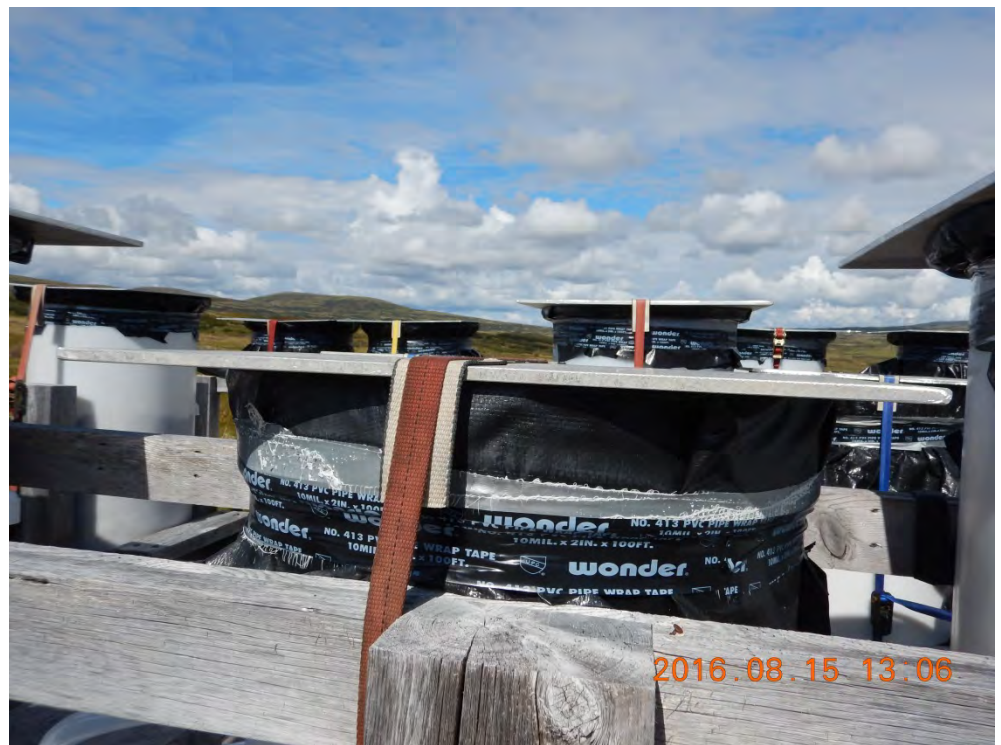
2. ARD Barrels

Close-up of new covers. Most are 3/8-inch aluminum; others are 1/4-inch. New tarps installed prior to fixing covers.

ARD testing is no longer active. Each barrel has been covered with a 40-mil HDPE tarp to prevent water intrusion. Drainage tubes are also sealed to prevent leakage. In August 2016 PLP installed aluminum plates on top of each barrel to guard against wind and wildlife damage. Aluminum plates are either 3/8-inch or 1/4-inch thick and secured with ratchet straps (Photo 2).

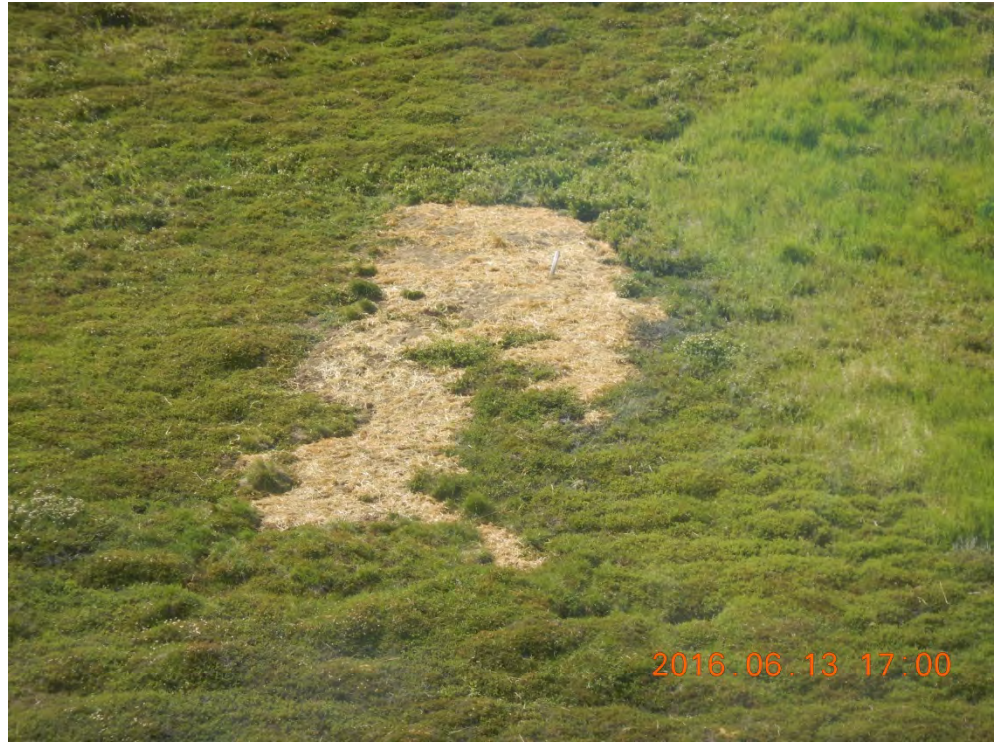
3. 0051/3072
6/13/2016

*Aerial photo after new
topsoil and re-seeding.*

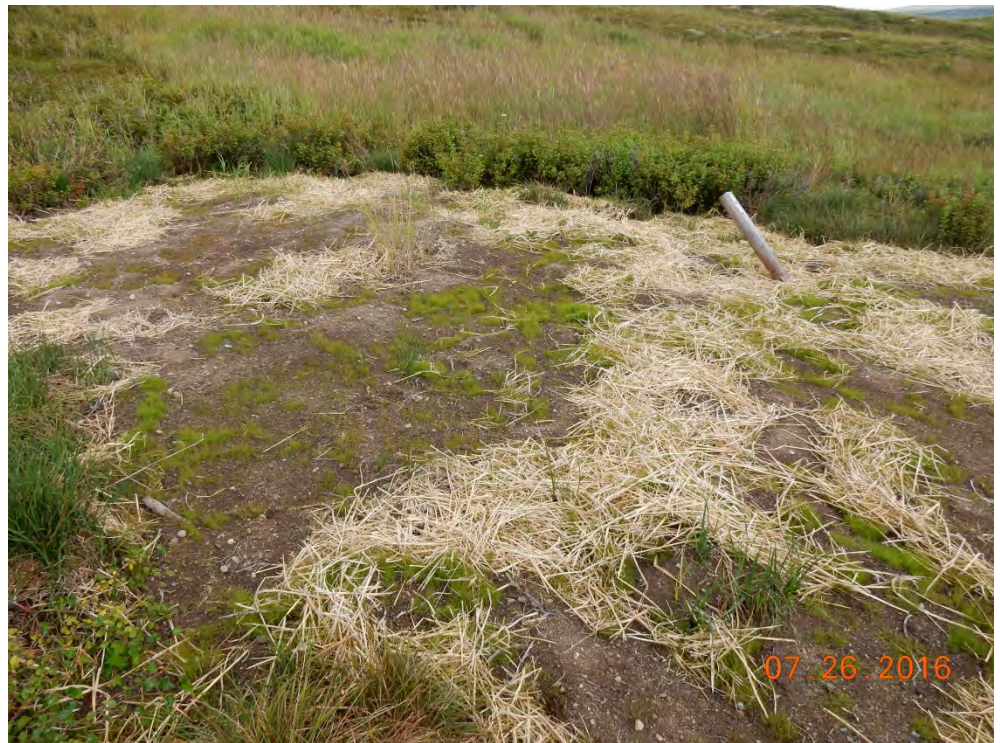
4. 0051/3072
7/26/2016

*New growth visible five
weeks after re-seeding.*

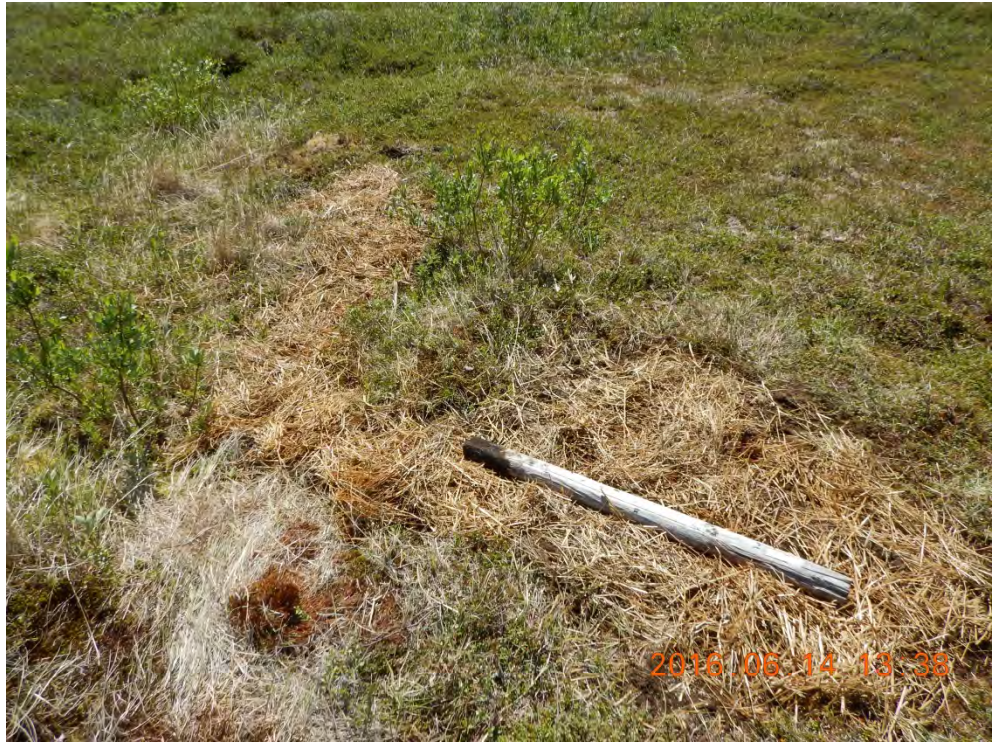
5. 0112
6/14/2016

This site was drilled by Cominco in 1997 and is located one-quarter mile southwest of the MSD in the West Deposit. A wood marker indicates the borehole location. There are no surface structures present. Minor flow (less than 0.5 gallons per minute [gpm]) was observed at the site in May 2016, with characteristics similar to a groundwater seep. Water pooled in a small area around the borehole before dissipating into the surrounding vegetation.

*Area after new topsoil
and re-seeding. Marker
intentionally left on
ground.*

The small area where water had pooled was filled with topsoil, re-seeded and covered with straw (Photo 5). Subsequent inspection five weeks later showed the bentonite seal in place and no evidence of water. Germination and growth were also observed in the re-seeded area.

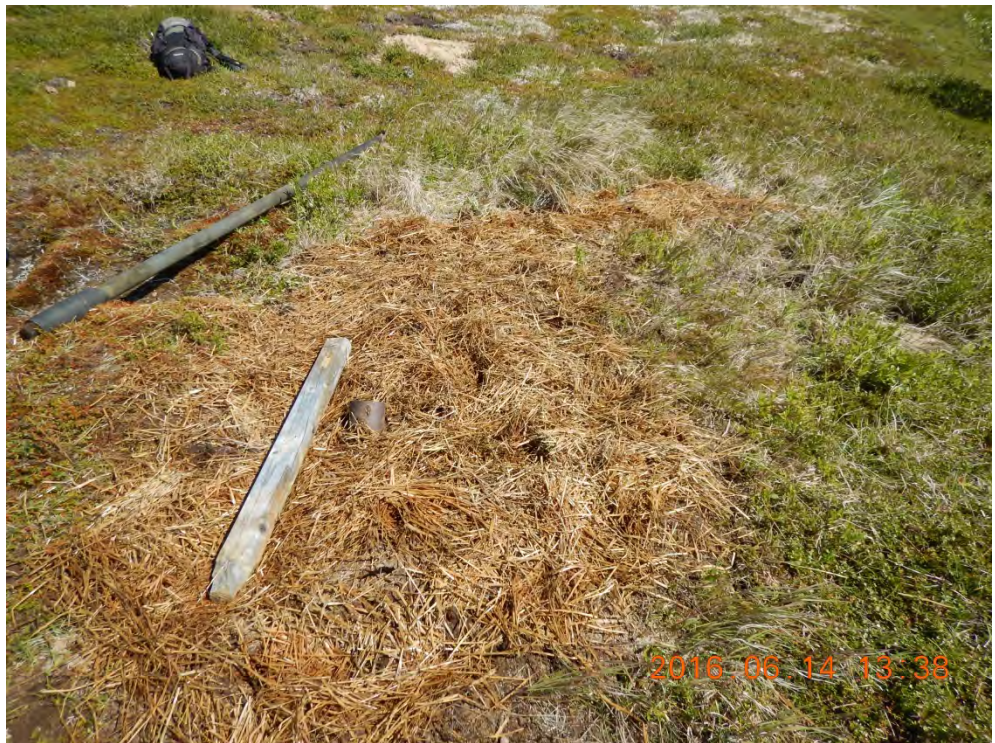
6. 3127
6/14/2016

This site is located one-quarter mile southwest of the MSD in the West Deposit. A wood marker indicates the borehole location. Steel casing extends three inches aboveground at an angle of 49 degrees and was fitted with a Margo plug. A small amount of ponded water was observed in October 2015. A follow-up inspection showed no leaks from the plugged casing. Instead, water was upwelling a few feet from the casing at a rate of approximately 1 gpm.

*Area after new topsoil
and re-seeding. Marker
intentionally left on
ground. Removed
Margo plug visible on
ground at left.*

PLP removed the Margo plug from the casing, which immediately caused the upwelling to stop and all surface water to drain below ground. The casing was allowed to sit open for approximately 45 minutes, during which time no water flow was observed. The Margo plug was not re-installed. Instead, the casing was packed with 1/4-inch time-release bentonite pellets to a depth of approximately one foot below the surface. The small surrounding area was covered with topsoil, re-seeded and covered with straw (Photo 6). Subsequent inspection five weeks afterward showed the bentonite seal in place and no evidence of water. Germination and growth were also observed in the re-seeded area.

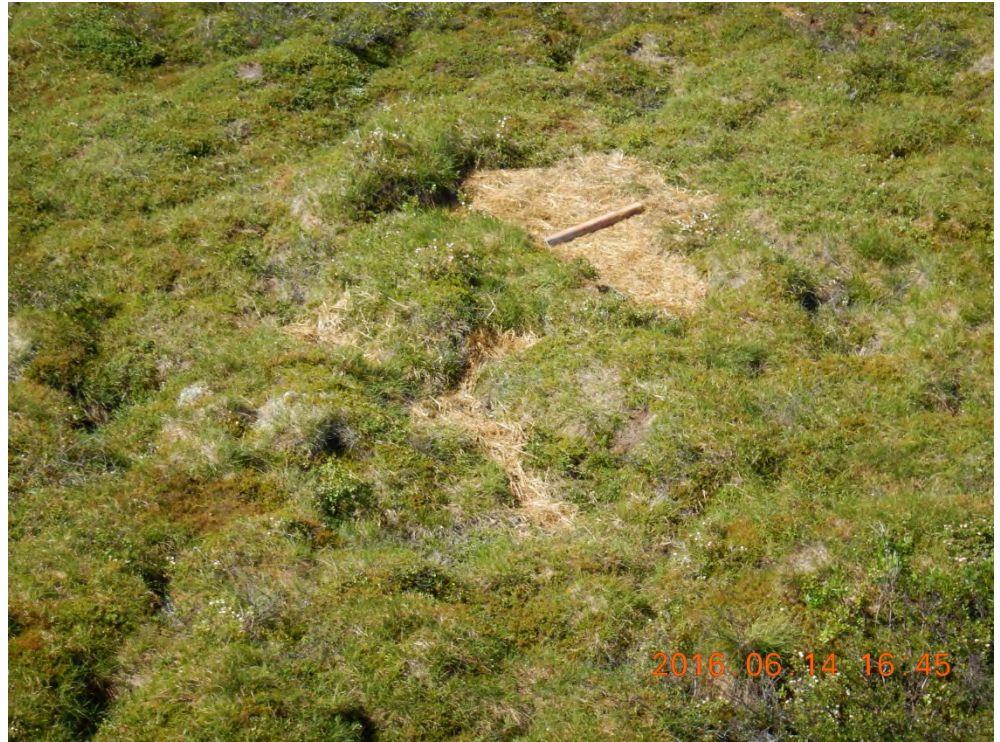
7. 4190
6/14/2016

*Aerial photo after new
topsoil and re-seeding.
Marker intentionally
left on ground.*

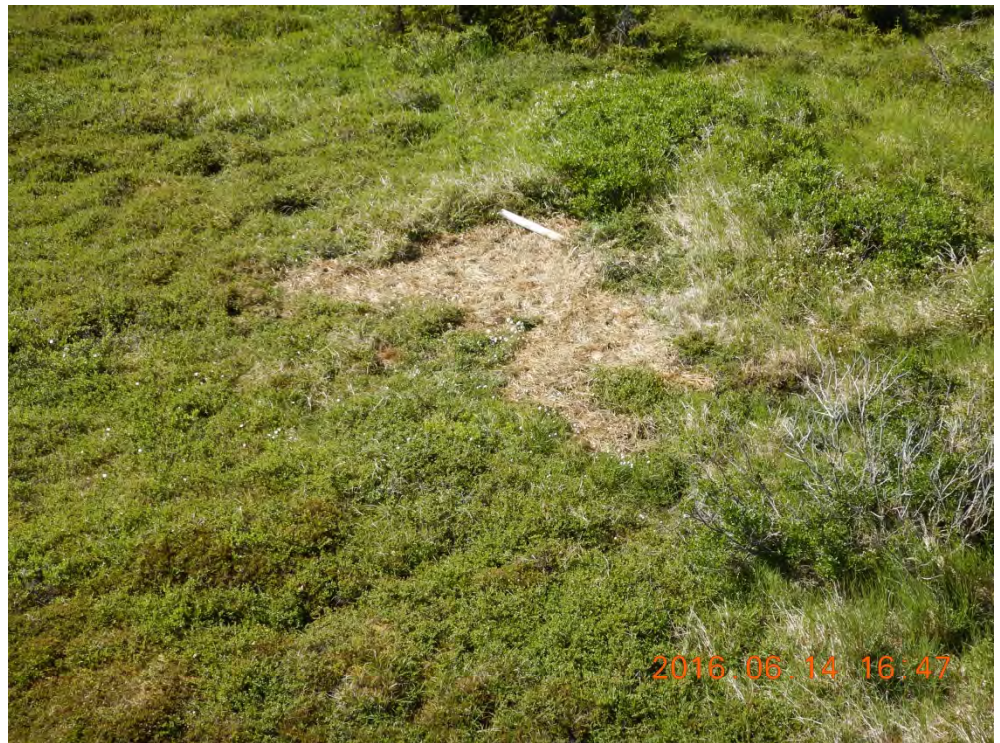
8. 4215
6/14/2016

*Area after new topsoil
and re-seeding. Marker
intentionally left on
ground.*

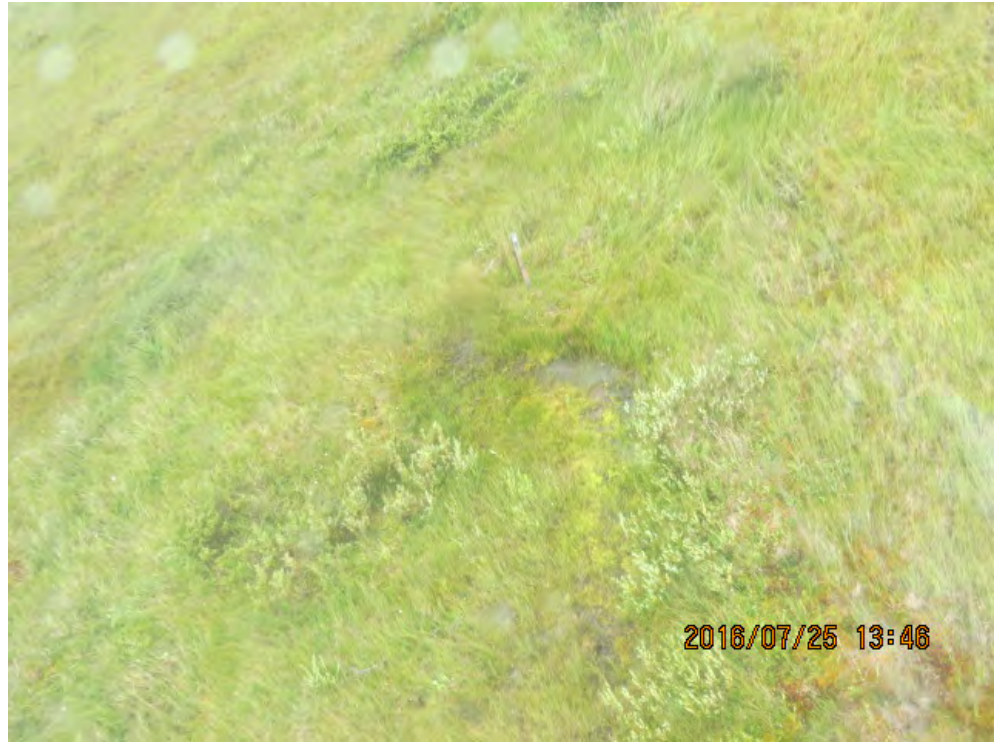
9. 5332

Ponded surface water was observed at the borehole in May 2016. A subsequent ground inspection in June 2016 was able to delineate a hole to a depth of approximately eight feet. PLP backfilled the hole with ¼-inch time-release bentonite pellets to the surface. Water flow appeared to stop, but could not be conclusively determined because the area was flooded at the time. A subsequent inspection in July 2016 showed surface water volume had noticeably diminished (Photo 9).

Area approximately five weeks after borehole filled with bentonite pellets. Water flow appears diminished.

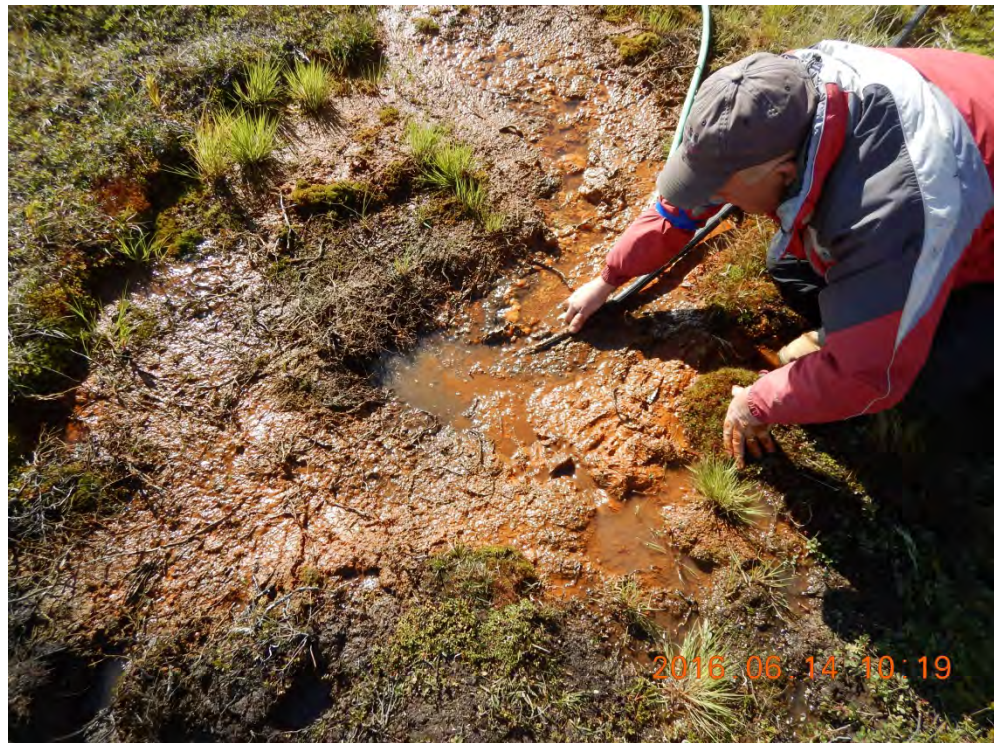
10. 8433M

A potential upwelling from the site was observed in October 2015 and confirmed in May 2016. Water flows consistently at a rate of 1-2 gpm and dissipates into the tundra 12-15 feet away from the borehole. Water runs clear but the presence of iron-fixing microorganisms contributes to the formation of rust-colored mats in the outflow channel.

Borehole after being filled with bentonite pellets. Photo shows technician siphoning remaining surface water to verify seal.

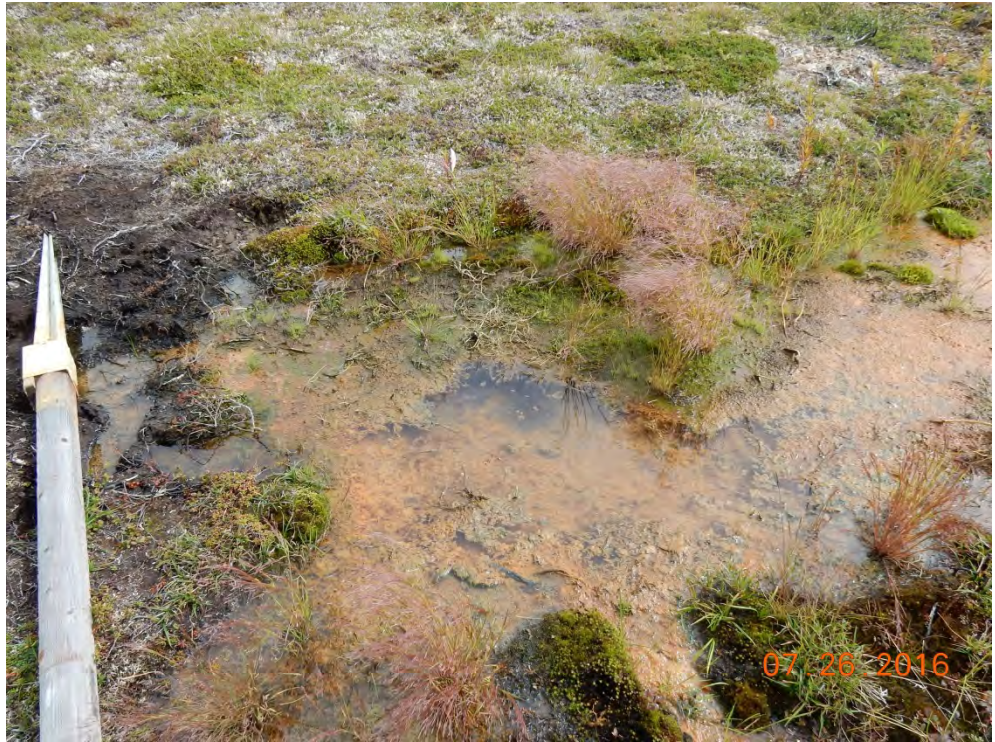
11. 8433M

A follow up inspection in July 2016 showed that the bentonite pellets did not form a competent seal in the borehole. Water had resumed flowing at the same rate prior to the repair effort (Photo 11).

Area approximately five weeks after borehole filled with bentonite pellets. Water flow from borehole has re-established at same rate prior to repair.

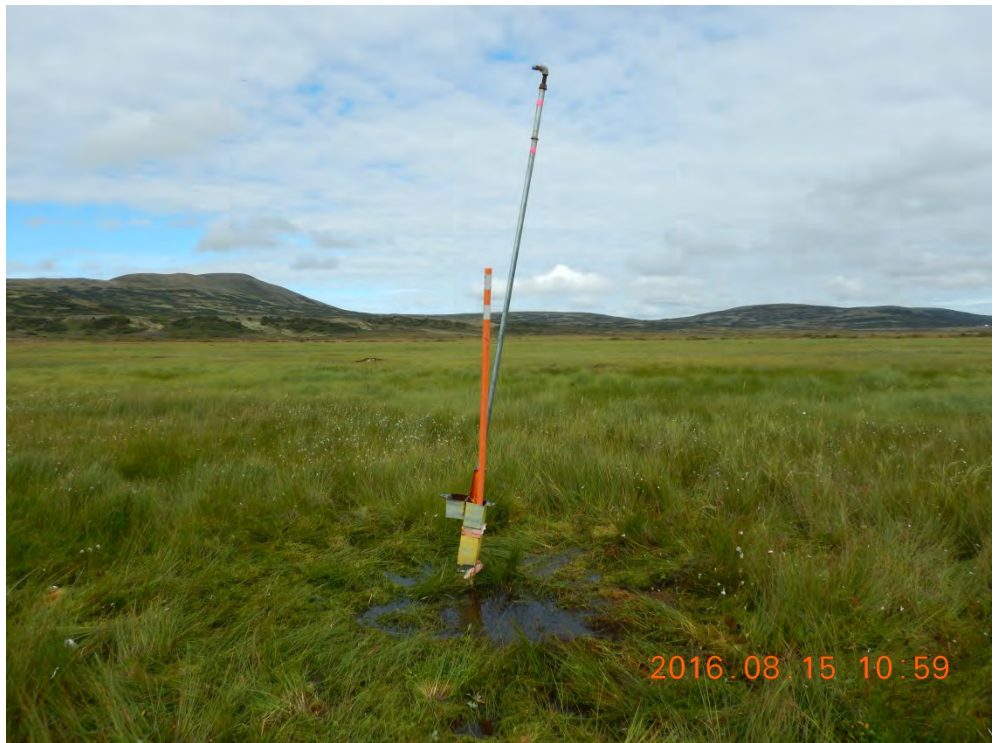
12. GH06-072

This site is located 1.7 miles south of the MSD in a wet area north of Frying Pan Lake. The monitoring well is known to have moderate artesian pressure and is fitted with a Margo plug. An inspection in July 2016 showed that a small volume of water (less than 0.5 gpm) was welling up inside the PVC casing, suggesting the Margo plug had cracked. PLP installed a new Margo plug in August 2016 and cut off all water flow (Photo 12).

Photo shows well after new plug installed. Note that obstruction in casing prevented complete insertion, but seals could still be tightened to stop all water flow.

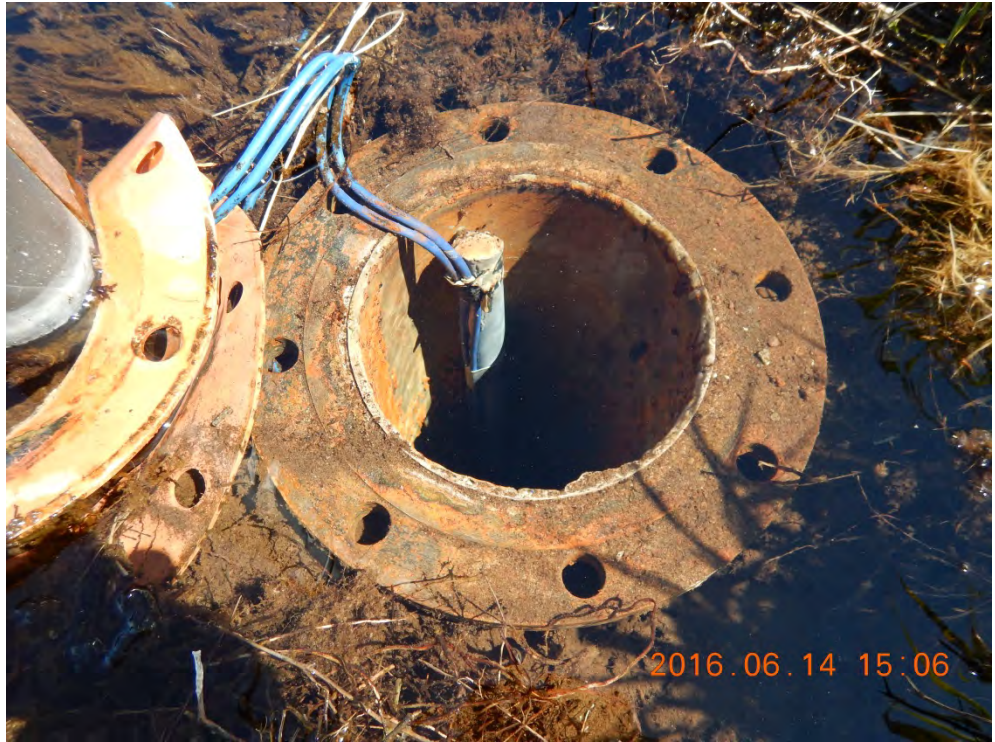
13. GH11-292S
6/14/2016

During a May 2016 inspection, water was observed leaking from between the steel plate and casing at a rate of approximately 2-3 gpm. Piezometer cables running through the gasket created a gap allowing water to flow out of the casing (Photo 13). PLP removed the cables, cleaned the gasket, replaced the water valve with a threaded plug, and re-bolted the steel plate to ensure a proper seal (Photo 14). All water flow was stopped. Water did not adversely affect surrounding vegetation; no additional reclamation required. A subsequent inspection in July 2016 showed that the repairs remain intact and the site remains dry.

Monitoring well with steel plate removed. Although not immediately obvious, photo shows site submerged in clear water. Note location of piezometer cables under gasket.

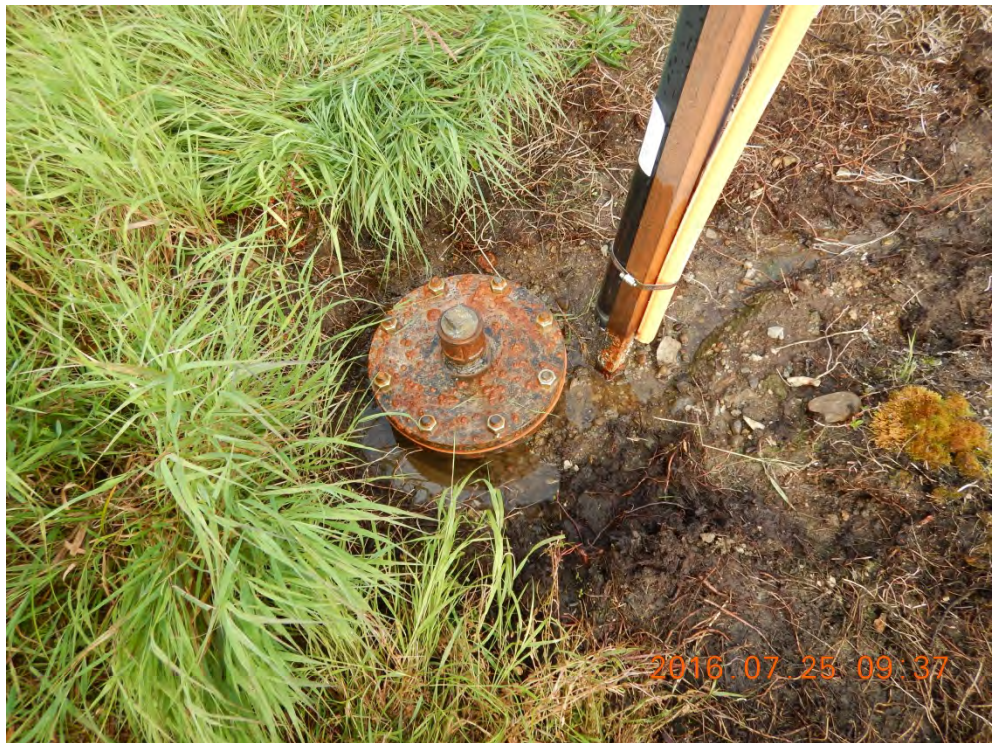
14. GH11-292S
7/25/2016

Monitoring well with steel plate bolted in place. Piezometer cables removed. New threaded plug visible on top.

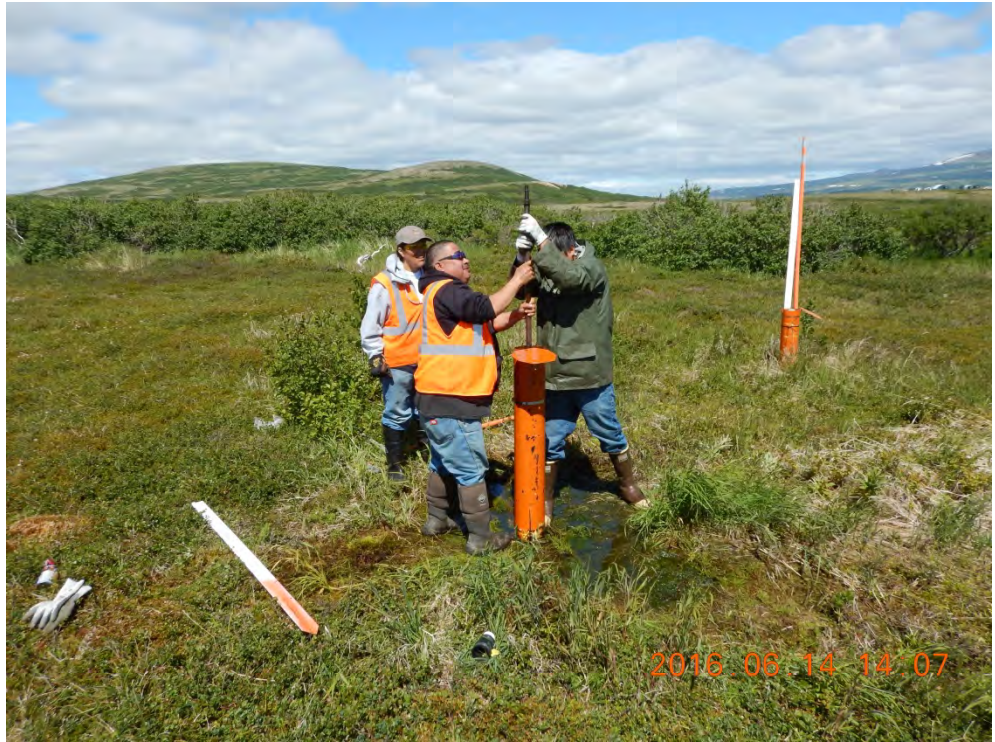
15. SRK-5D
6/14/2016

This site is located 0.4 miles southwest of the MSD in the West Deposit. High artesian pressure has been documented at this monitoring well. An inspection in October 2015 showed water flowing due to a failed plug. PLP installed a new Margo plug in June 2016 to cut off all water flow (Photo 15). Subsequent inspection in July 2016 showed the site remained dry with the plug intact (Photo 16). Revegetation was not needed.

*Technicians installing
new Margo plug.*

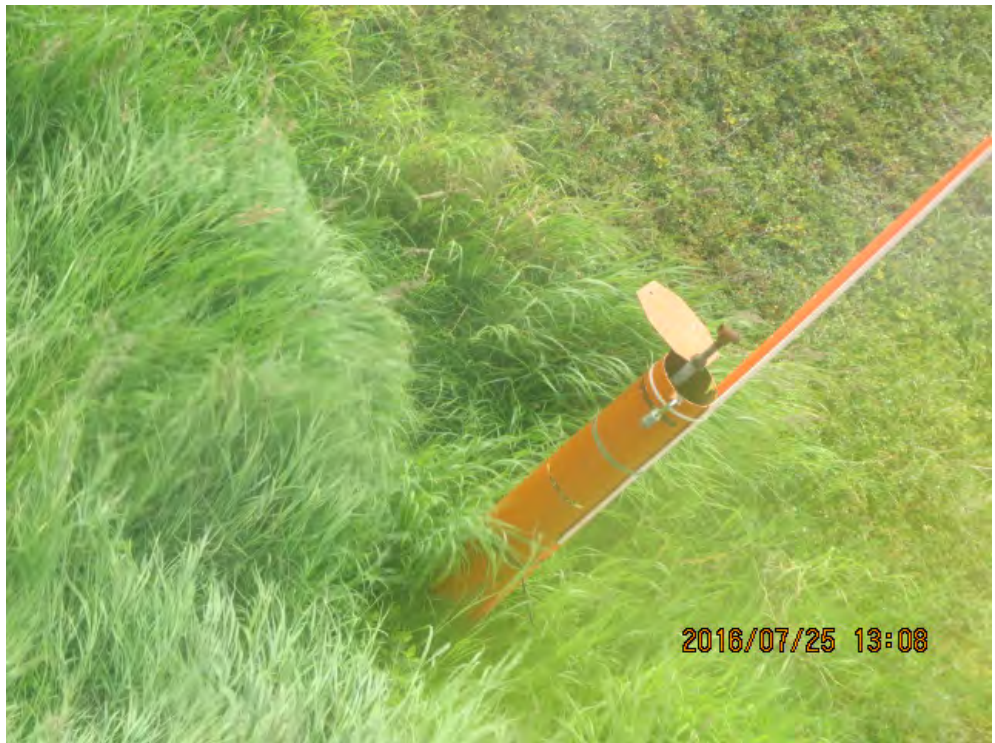
16. SRK-5D
7/26/2016

*Monitoring well with
new Margo plug
installed.*

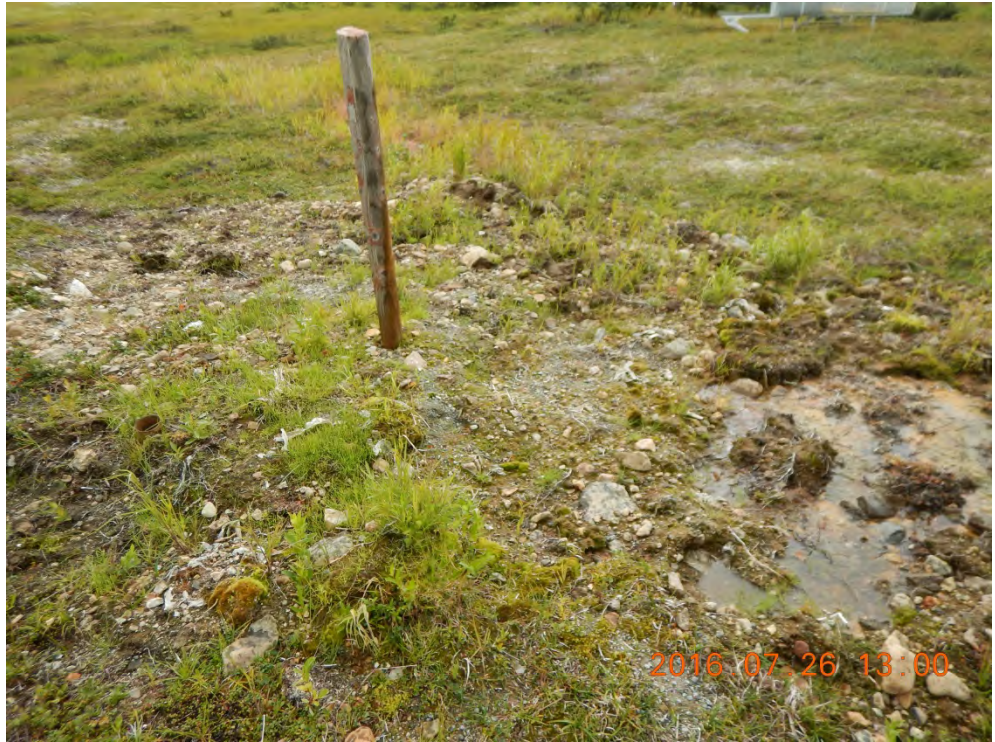
17. 3132

Inspections by PLP and DNR in 2016 observed a small, diffuse upwelling several feet from the 2015 repair location. A consistent flow is visible but too small to quantify. Water dissipates into the surrounding ground within a few feet (Photo 17). The water source has not been determined but may be related to 2015 repair activities. For reporting purposes, inspection and maintenance activity for this upwelling are recorded under Borehole 3132.

Wood post marks location for boreholes 3131 (repaired in 2015) and 3132, which are roughly three inches apart. Wet area to lower right is three feet from marker.

PLP will continue to investigate the water source and potential repair options. Prior to the 2017 field season, PLP will submit a work plan to DNR outlining the inspection, monitoring, and maintenance activities for this location.

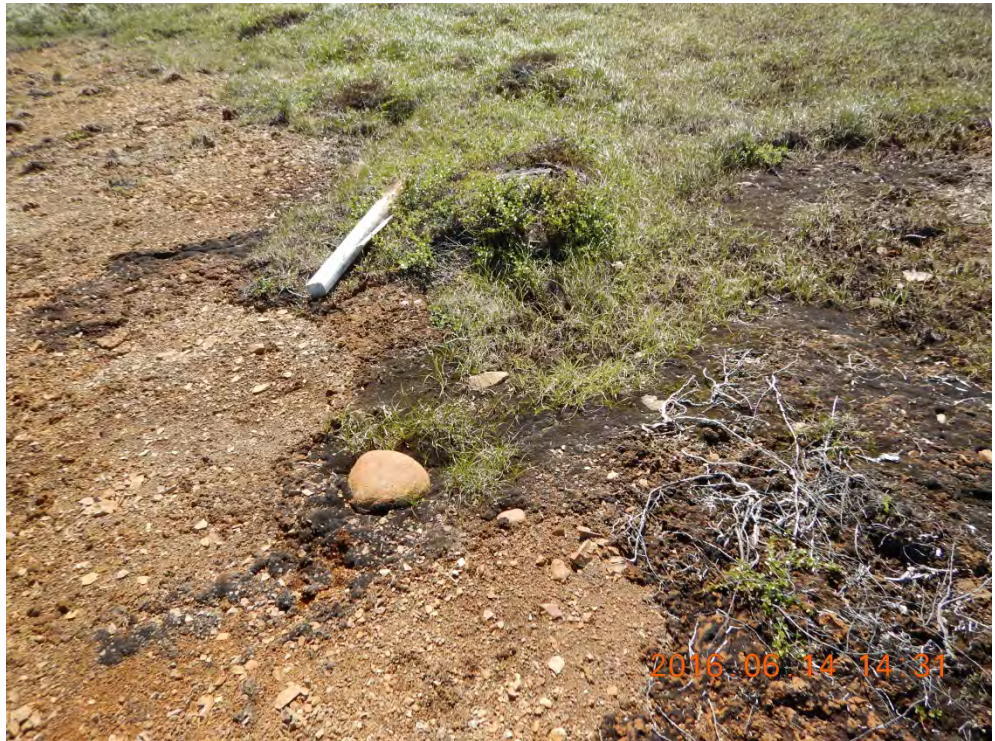
18. 4279

The site is located on the edge of wide, flat area north of the MSD that acts as a natural flood plain to an ephemeral stream. Seasonal precipitation routinely causes surface water to pond across the area. Photo 18 was taken during early summer when the area is typically driest. No water is visible in the photo, although the extent of previous flooding is evident by the growth of mosses and lichens. Photo 19 shows how the area floods following late season rains.

Borehole area during relatively dry period. Note absence of surface water. Darker areas are mosses/lichens that generally represent extent of flood during rain events.

PLP will periodically inspect this site to confirm these findings. No repairs are planned at this time.

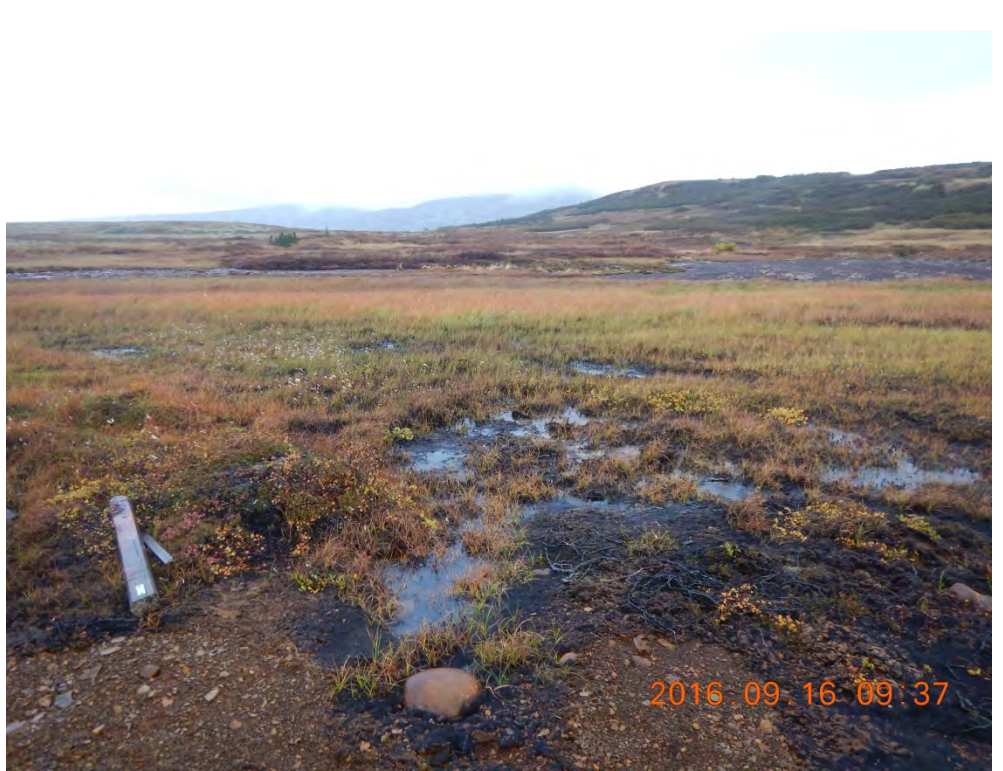
19. 4279

Borehole area after late summer rains. Note extent of surface water ponding.

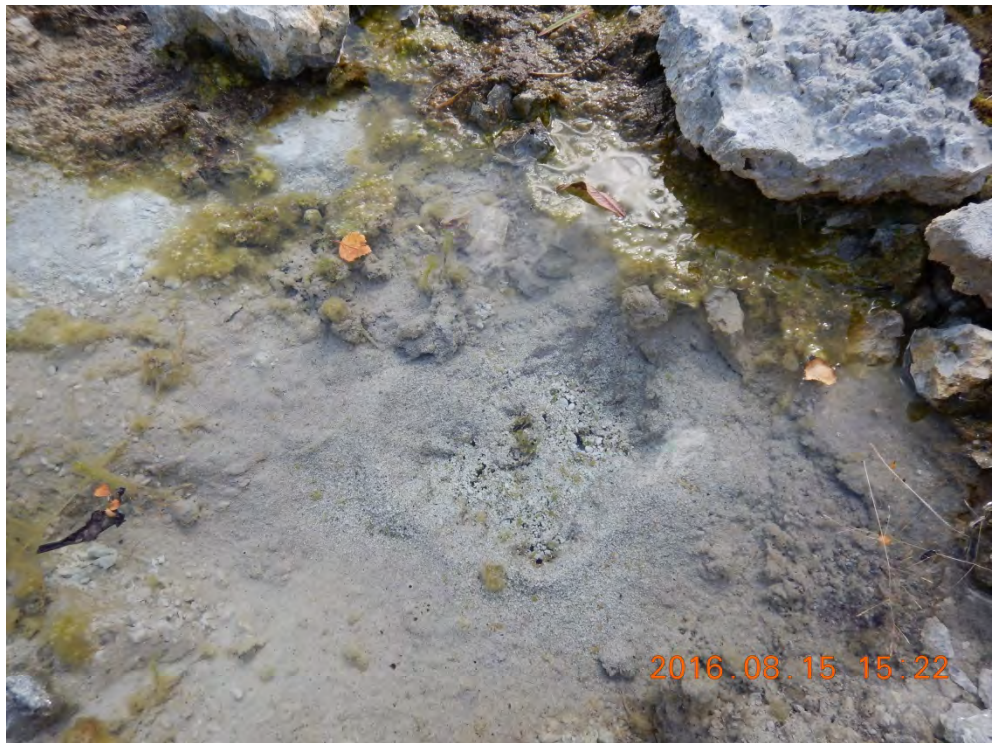
20. Borehole 7386

Close-up of upwelling (hexagonal area near center). Water flows clear at consistent rate of less than 1 gpm.

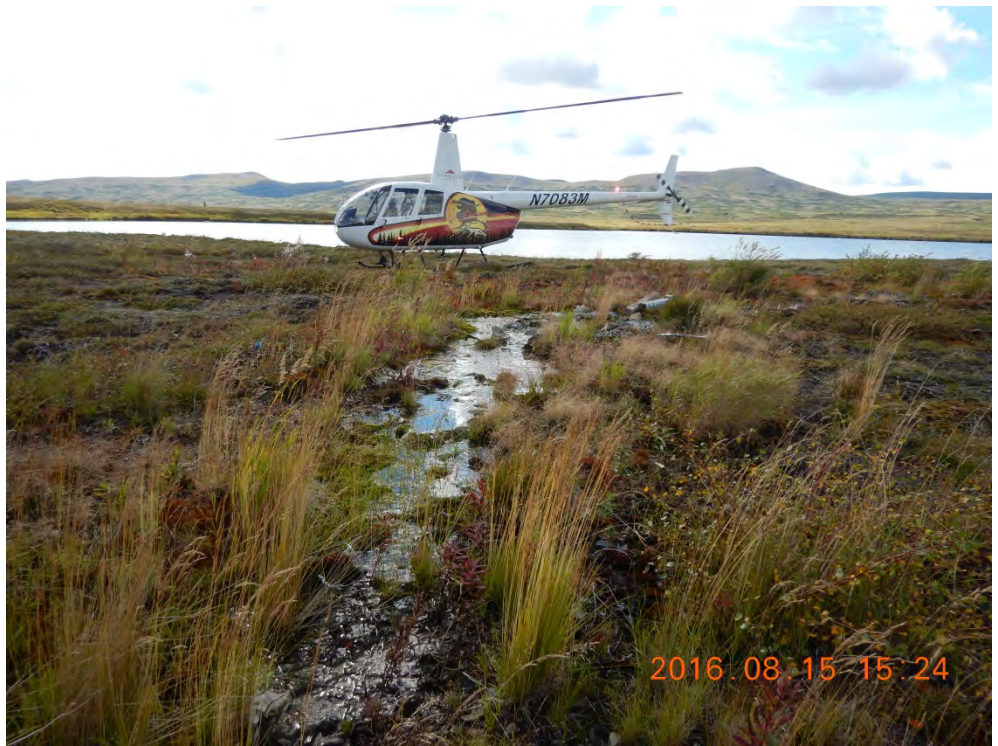
21. **Borehole 7386**
8/15/2016

*View of outflow channel
towards water source.*

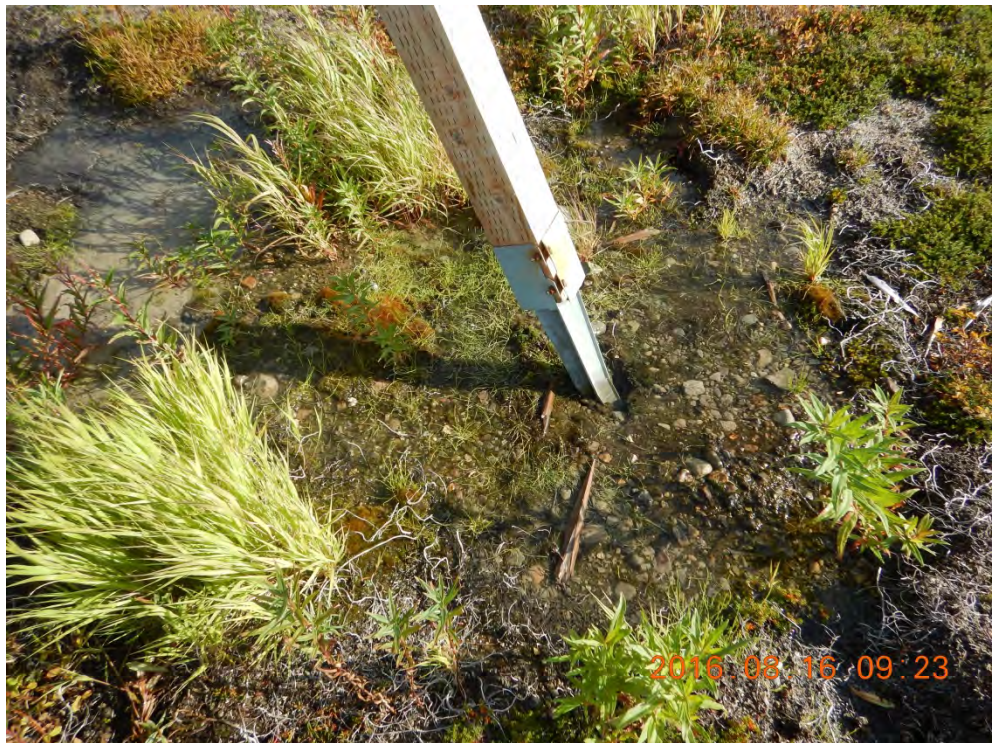
22. **Borehole 11538**
8/16/2016

*Close-up of upwelling.
Water flows clear at
rate of less than 1 gpm.*

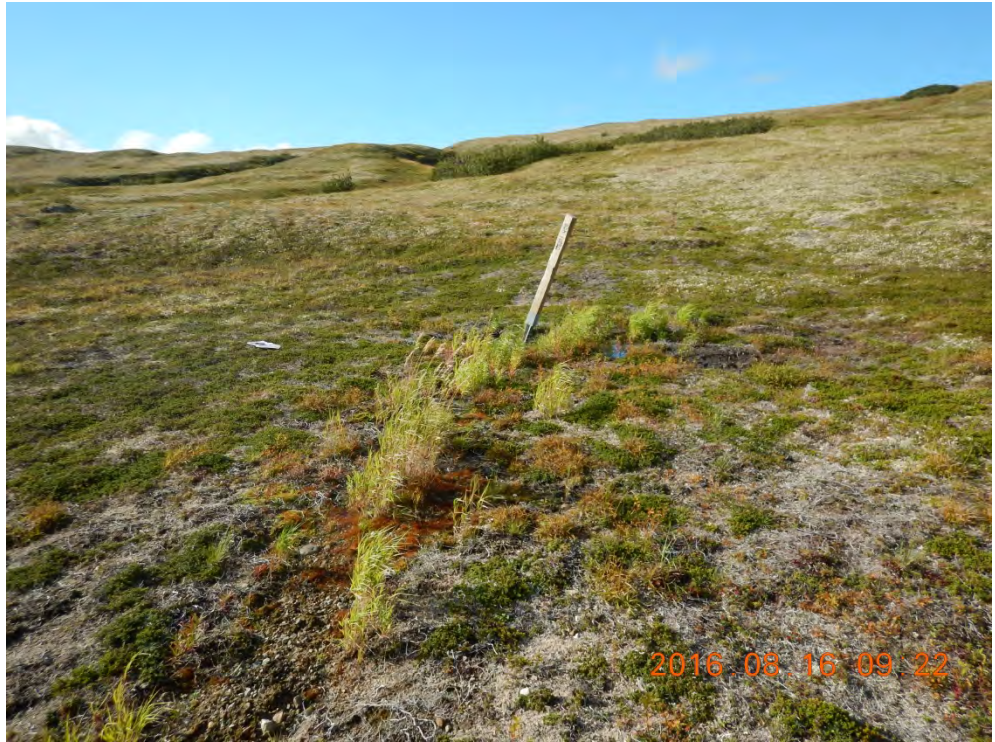
23. Borehole 11538
8/16/2016

View upslope towards borehole. Water volume does not create distinct channel, but vegetation growth indicates general flow pattern.

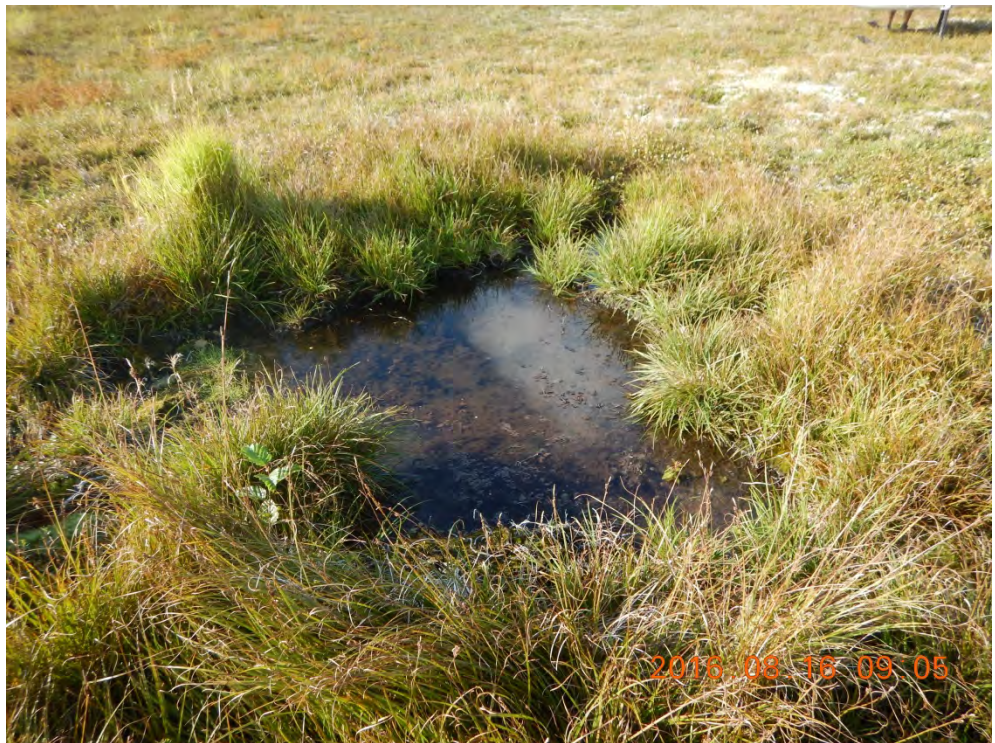
24. Borehole 12550
8/16/2016

Ponded water around borehole location. No upwelling or outflow observed. Discrete borehole could not be identified.
