## **PEBBLE PROJECT**

### **2017 Reclamation Report**

**MLUP No. 6118**

**DECEMBER 31, 2017**

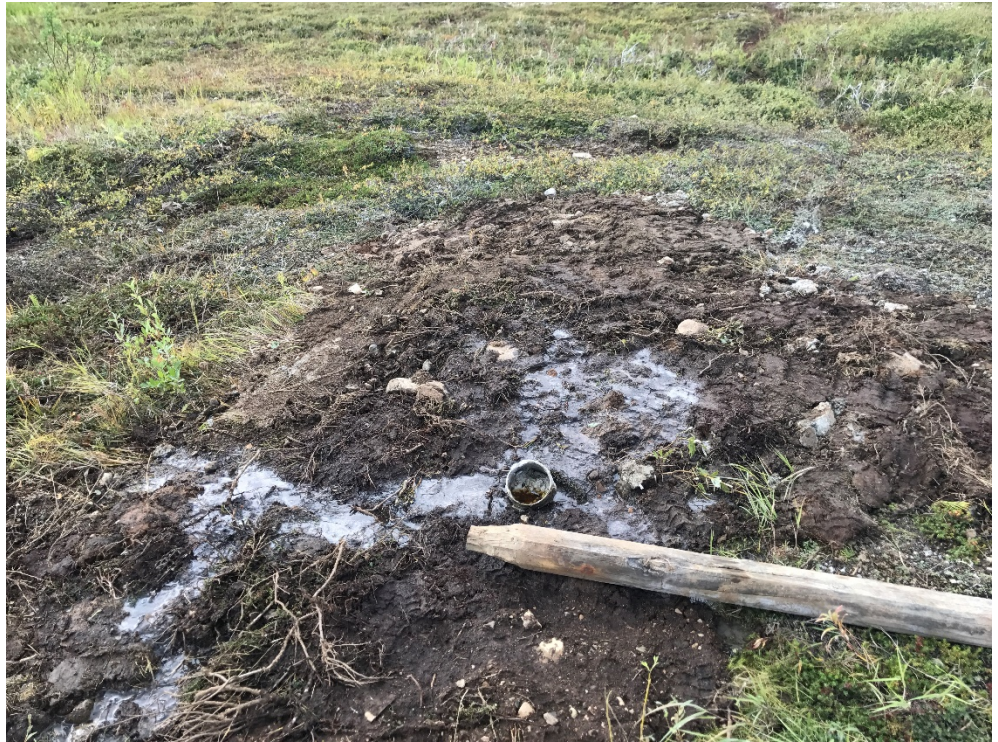
1. Borehole 3127

This site was first repaired in 2016 by backfilling with bentonite pellets (see 2016 Annual Reclamation Report). These repairs were initially successful but subsequent inspection in spring 2017 showed that minor upwelling (approximately 1 gallon per minute [gpm]) had recurred. Water quickly dissipates into the surrounding tundra.

PLP's drilling contractor (Foundex Pacific) made two attempts to re-drill and grout the site in 2017, with limited success. Water flow was reduced but not completely cut off. Foundex advised that the site would be better addressed with an alternate rig configuration that can more accurately adjust to the borehole's initial drilling angle (-49°). After consultation with DNR, PLP decided to forgo a third attempt in 2017 and instead plans to implement the contractor's recommendation in 2018.

*Minor upwelling shown following second repair attempt.*

Approximately 160 square feet were disturbed during repair efforts. The site was reclaimed and stabilized to minimize erosion, but was not reseeded in anticipation of additional repair work in 2018. PLP will continue to monitor the site and report changes to DNR.

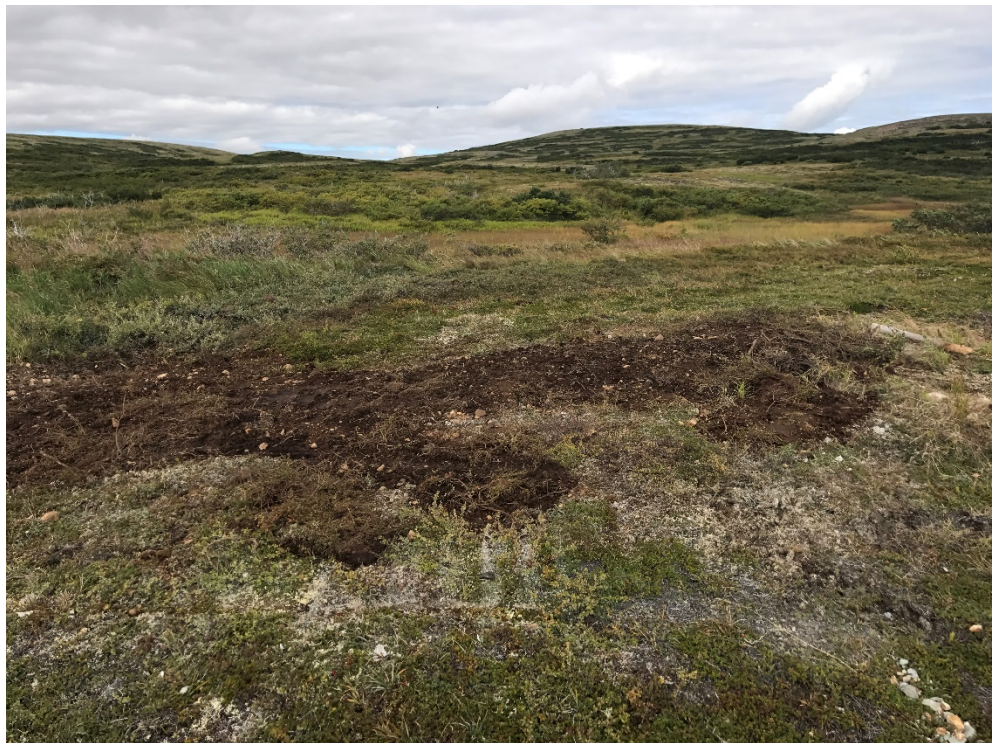
2. Borehole 3132

Borehole 3132 is co-located with Borehole 3131, which was successfully re-drilled, grouted, and closed in 2015. Inspection in 2016 showed a small, diffuse upwelling that quickly dissipated into the surrounding ground. The water volume was too small to quantify, but appeared consistent. The exact source or point of origin could not be determined.

*Work site after repair and reclamation complete.*

The original borehole was drilled to a depth of 71.5 feet and grouted to the surface with approximately 60.8 cubic feet of grout mix (dry volume). All water flow was successfully cut off. No casing or surface structures were left in place.

All heavy equipment and materials were set on tundra pads. A small area of approximately 120 square feet, including a small sump to manage excess water, was excavated to complete repairs. Disturbed areas were then reclaimed and regraded to minimize erosion. The site will be re-inspected in 2018 to verify repair success and seeded with an approved seed mixture if appropriate.

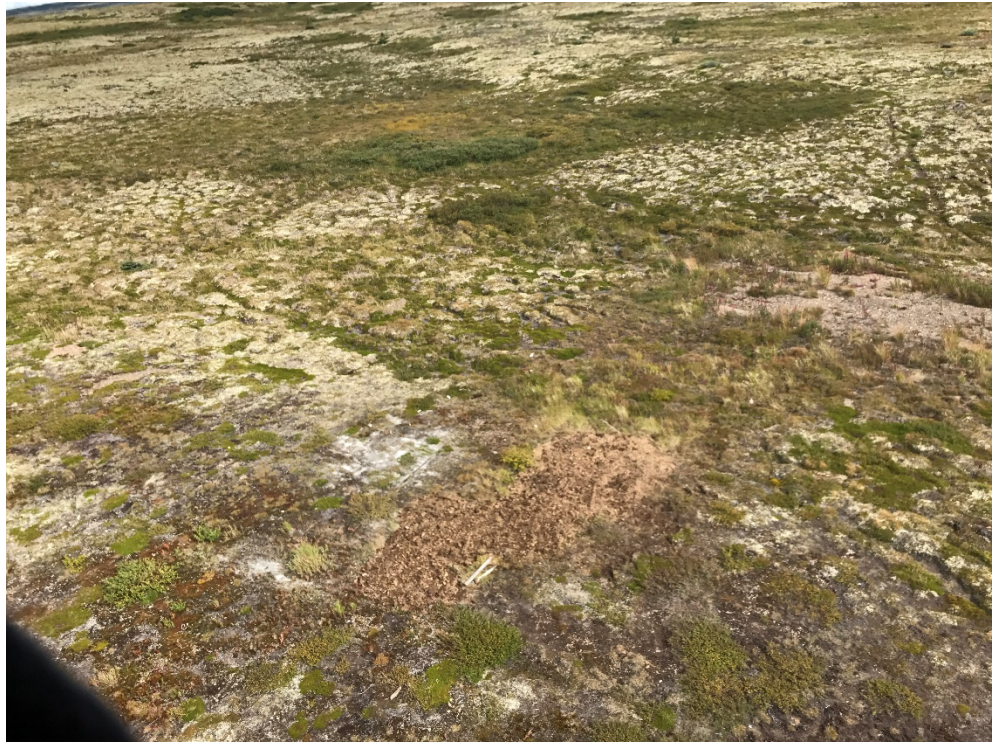
3. Borehole 7386

This site is located in the West Deposit area and is co-located with Borehole 7380. A clear, consistent upwelling (less than 1 gpm) was observed in 2016. Water flowed downhill in a discrete channel before dissipating into the surrounding ground.

*Aerial photo of work site after repair and reclamation complete.*

The original borehole was drilled to a depth of 162.67 feet and grouted to the surface with approximately 65.8 cubic feet of grout mix (dry volume). All water flow was successfully cut off. No casing or surface structures were left in place.

All heavy equipment and materials were set on tundra pads. A small area of approximately 160 square feet, including a small sump to manage excess water, was excavated to complete repairs. Where present, existing vegetation was preserved for re-use. Disturbed areas were then reclaimed and regraded to minimize erosion. The site will be re-inspected in 2018 to verify repair success and seeded with an approved seed mixture if appropriate.

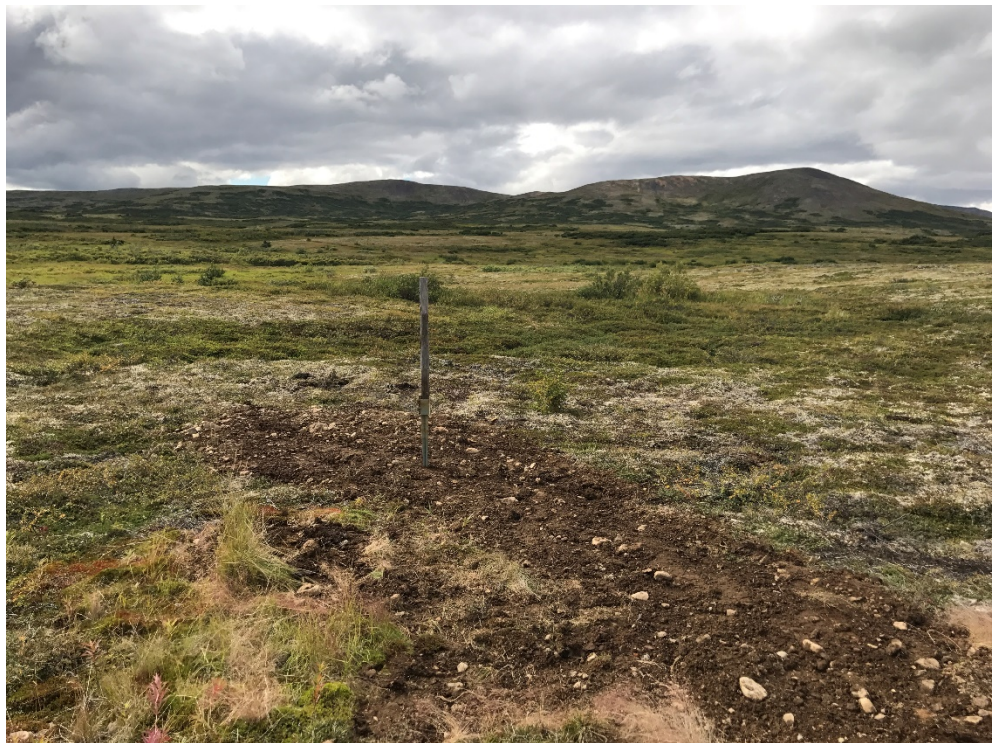
4. Borehole 8433M

This site is located approximately 800 feet southwest of the MSD in the West Deposit. No surface structures are present. The 2016 inspection observed water flowing consistently at a rate of 1-2 gpm and before dissipating into surrounding ground. A previous attempt to cut off water flow using bentonite pellets in 2016 was unsuccessful.

*Work site after repair and reclamation complete.*

The original borehole was drilled to a depth of 51.5 feet and grouted to the surface with approximately 21 cubic feet of grout mix (dry volume). All water flow was successfully cut off. No casing or surface structures were left in place.

All heavy equipment and materials were set on tundra pads. A small area of approximately 60 square feet, including a small sump to manage excess water, was excavated to complete repairs. Where present, existing vegetation was preserved for re-use. Disturbed areas were then reclaimed and regraded to minimize erosion. The site will be re-inspected in 2018 to verify repair success and seeded with an approved seed mixture if appropriate.

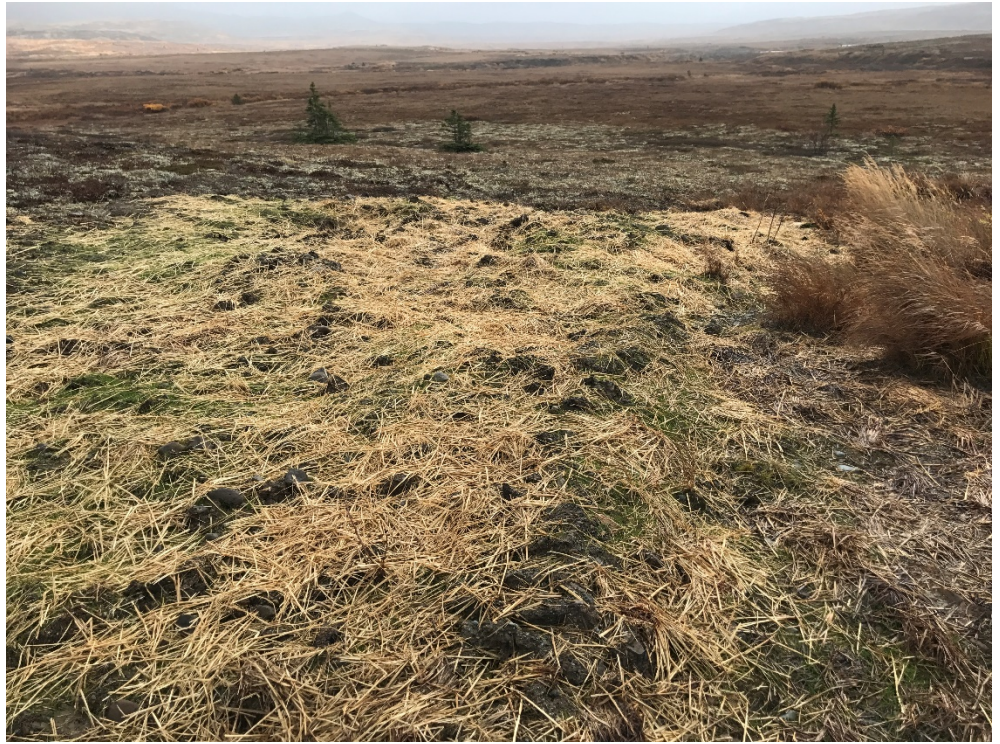
5. Borehole 9475

This site is located in the East Deposit area and was previously used for long-term monitoring. Upwelling was first observed in 2014, with an initial repair attempt made in fall 2015. Repairs at that time were unsuccessful, as upwelling had resumed by spring 2016. Prior to 2017 repairs, water was observed flowing at a rate of approximately 2-3 gpm before dissipating into the ground approximately 130 feet downgradient.

*Work site after repair  
and reclamation  
complete.*

The original borehole was drilled to a depth of 102.33 feet and grouted to the surface with approximately 160 cubic feet of grout mix (dry volume). All water flow was successfully cut off. The existing casing was removed.

All heavy equipment and materials were set on tundra pads. An area of approximately 1000 square feet, including a two-stage sump to manage excess water, was excavated to complete repairs. Existing vegetation from a portion of the site was preserved for re-use. Disturbed areas were then reclaimed by regrading, re-seeding with an approved seed mixture and covering with straw to minimize erosion.

The site will be re-inspected in 2018 to verify repair success and determine the need for additional reclamation measures, if any.
