## **ROCK CREEK MINE & BIG HURRAH PROJECT**

2009 ANNUAL REPORT

March 5, 2010

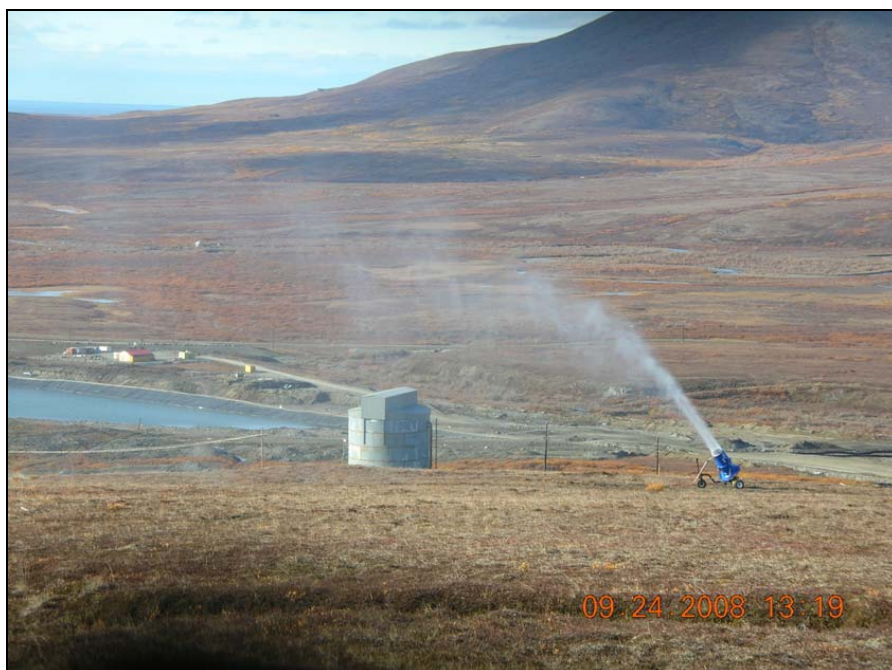
Figure 5: Land Shark in Operation

Initially, land application occurred only during daylight hours and only when the ambient air temperature was above 35 °F. The Land Shark units, however, proved to be more efficient at producing a very fine mist than anticipated and achieved notable evaporation even at relatively low temperatures (~40 °F). The actual spray field area was also larger than the original estimate and notably aided by higher wind speeds, which also increased the evaporation rate. Based on this information, ADEC modified the original approval and authorized land application during freezing conditions provided there is no appreciable accumulation of snow. Figure 5 shows a

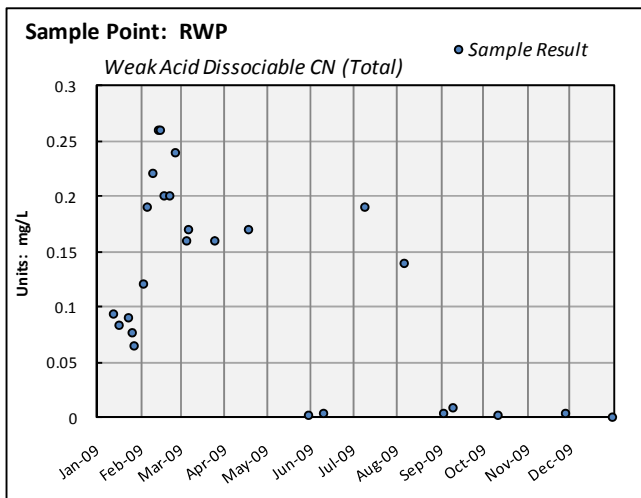
Figure 9: RWP WAD Cyanide

Water contained in the RWP may not exceed WAD cyanide levels of 25 mg/L for any one sample, nor may the 90<sup>th</sup> percentile of all samples exceed 10 mg/L (WMP Section 1.2.4). All RWP samples showed WAD cyanide levels well below this requirement (Figure 9). Samples collected from the RWP Underliner were also well below the permit limits (Figure 10). A single sample of the RWP sludge analyzed for WAD cyanide collected on October 12, 2009 showed a concentration of 0.11 mg/L. A comparison of RWP and RWP Underliner analytical data demonstrate that RWP water is not breaching the liner system or adversely impacting groundwater quality, despite the concerns over groundwater infiltration discussed above.

Analytical data for RWP and RWP Underliner monitoring samples are reported in appendices A2 and A3. No adverse trends were identified.

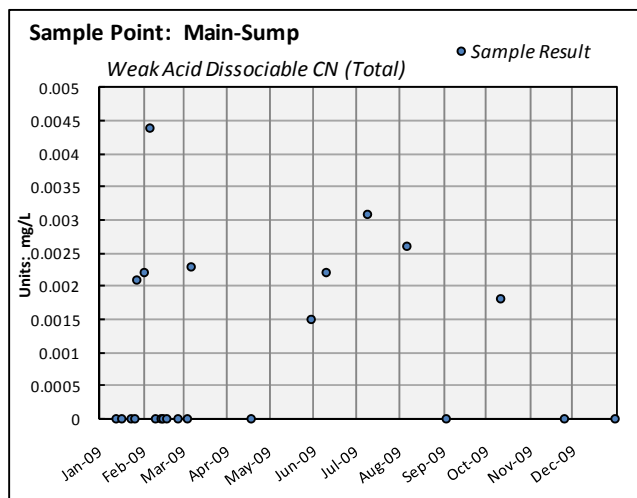
Figure 11: RWP WAD Cyanide

Water recycled to the TSF may not exceed a WAD cyanide level of 25 mg/L for any one sample, nor may the 90<sup>th</sup> percentile of all samples exceed 10 mg/L (WMP Section 1.2.4). Water samples collected from the Main Sump have routinely shown WAD cyanide concentrations well below the permit limits (Figure 11). There are no other permit limits that apply to the sump water.

Analytical data for Main Sump and South Sump monitoring samples are reported in appendices A4 and A5. These data are primarily used to monitor their input to the TSF, and thereby project potential changes in TSF water chemistry that could affect WTP treatment performance.

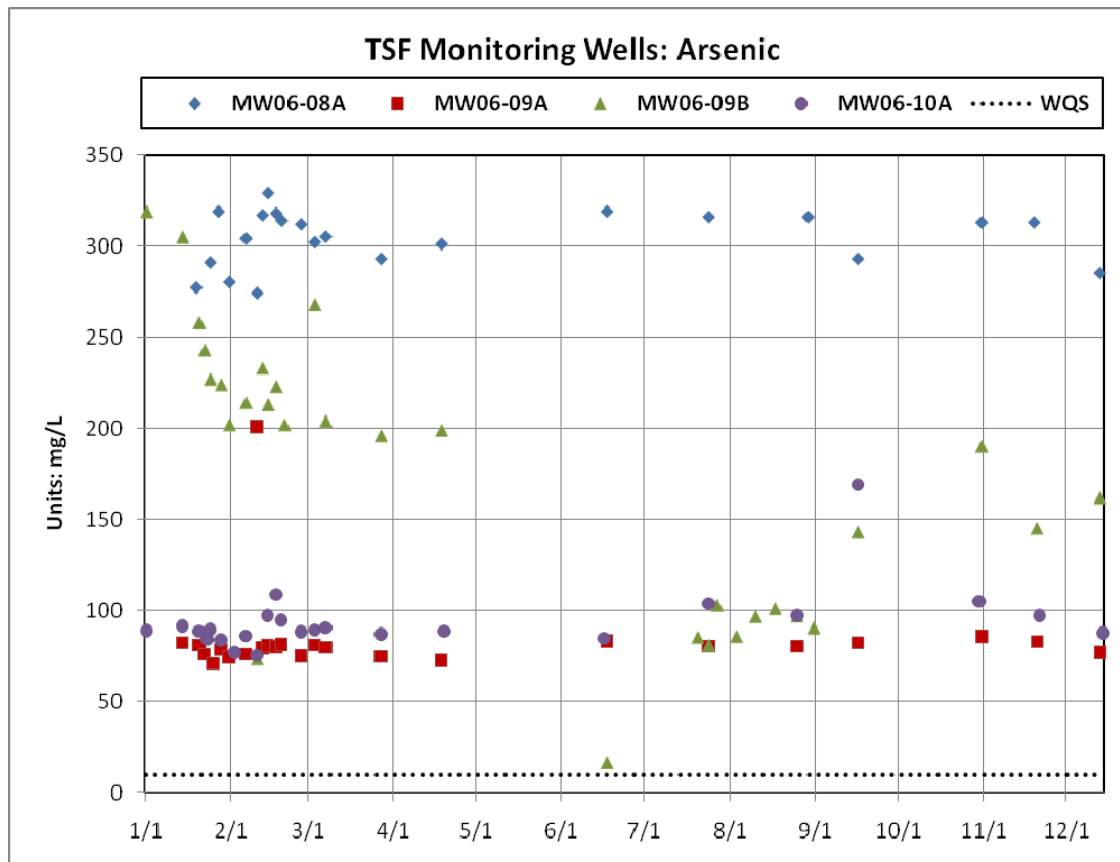
**Figure 12: Arsenic Sample Data (TSF Monitoring Wells)**

Sampling data from the TSF monitoring wells have shown elevated levels of key constituents above the applicable water quality standards (Table 14 **Error! Reference source not found.**). Arsenic, for example, was present at elevated levels in nearly every sample collected at each sample point (Figure 12).

Tetra Tech, Inc., under contract to AGC, conducted a detailed statistical analysis of baseline conditions for each well. Contrary to the 2008 SRK analysis, which aggregated groundwater data from all TSF monitoring wells, Tetra Tech's study reviewed data for each well individually to account for the potential differences in geochemistry and hydrology at each location. The resulting analysis demonstrated the strong influence of background groundwater concentrations on the observed exceedances in each well. In fact, nearly all sample results from the TSF wells, when considered against the more accurate natural conditions for each well, are well within normal ranges for the Snake River valley.

As required under WMP Section 1.2.10, AGC implemented a corrective and investigative action plan consisting of accelerated monitoring and further statistical analysis. This plan is designed to more accurately determine the extent to which observed exceedances in the TSF monitoring wells are the result of natural background conditions rather than any influence from the TSF, and whether there have been any adverse impacts to groundwater. AGC notes that the TSF has received only a small volume of tailings during the limited operating period, with no tailings placed in the TSF since 2008.

AGC submitted the detailed results of the Tetra Tech study to ADEC on April 27, 2010. This submittal proposes specific trigger levels for each well based on the higher of water quality standard or the well-specific background level. In the future, AGC would only perform further corrective action beyond monitoring when these levels have been exceeded.

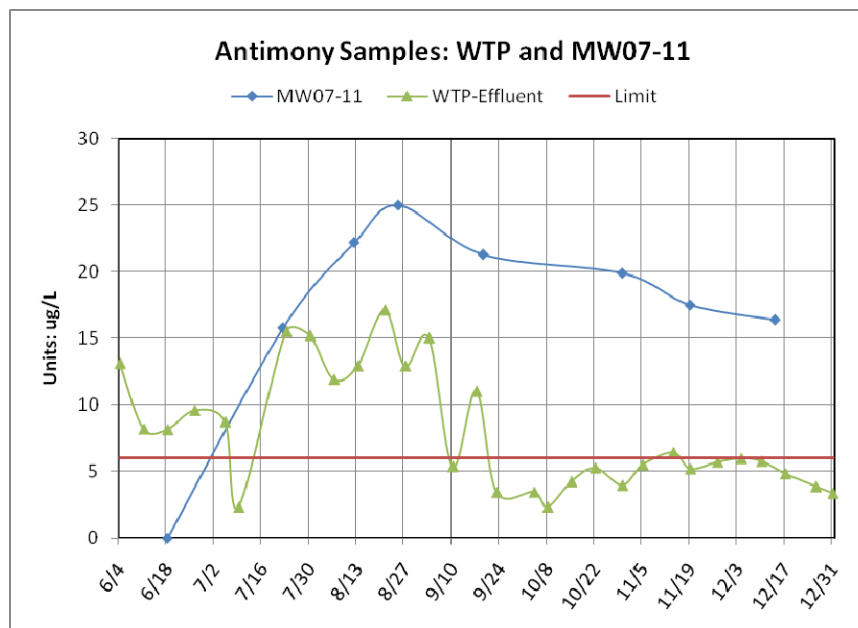
Figure 13: WTP and MW07-11 Antimony Samples

As required under WMP Section 1.2.10, AGC implemented a corrective and investigative action plan consisting of accelerated monitoring and further statistical analysis to more accurately determine the extent to which observed exceedances in the IWF monitoring wells are the result of natural background conditions rather than any influence from injection. Tetra Tech, under contract to AGC, conducted a detailed analysis of IWF groundwater data and concluded that, with the exception of antimony, the observed water quality standard exceedances in Table 15 were the result of natural background concentrations present in the groundwater rather than any influence from injection.

AGC submitted the detailed results of the Tetra Tech study to ADEC on April 27, 2010 along with a proposal to adopt trigger levels for monitoring well MW07-11 that reflect natural conditions.

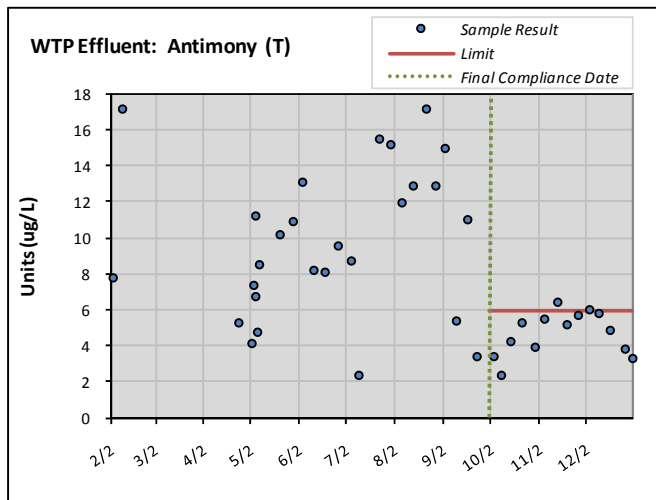
Figure 14: WTP Effluent (Antimony)

Since October 1, 2009, weekly sampling data have shown that apart from isolated issues concerning antimony and manganese, the WTP has performed as intended and satisfied COBC requirements. After October 1, 2009 AGC observed 1 minor antimony exceedance (Figure 14) and 3 minor manganese exceedances (Figure 15). Each exceedance was related to unanticipated malfunctions with the ozone generation system, which failed to inject ozone at the expected rate

thereby reducing oxidation in the reaction tank. While oxidation is not essential to metals removal in the system, it generally improves the efficiency with which they are removed. AGC has documented these issues and notified ADEC by memorandum dated December 2, 2009. AGC continues to monitor the ozone system and began introducing supplemental oxidants to the WTP on December 20, 2009 to ensure adequate metals removal.

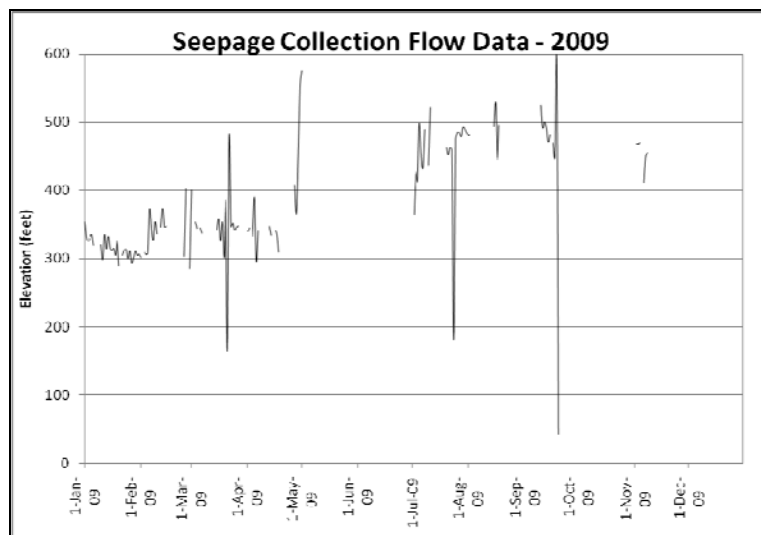
Figure 16: Seepage Collection System Flow Data

The TSF seepage collection system (main and south sumps) was visually inspected each day by the process operator to ensure that no abnormal event has occurred. The sumps, pipe line and the pumps were inspected each day. Flow meters were read and recorded.

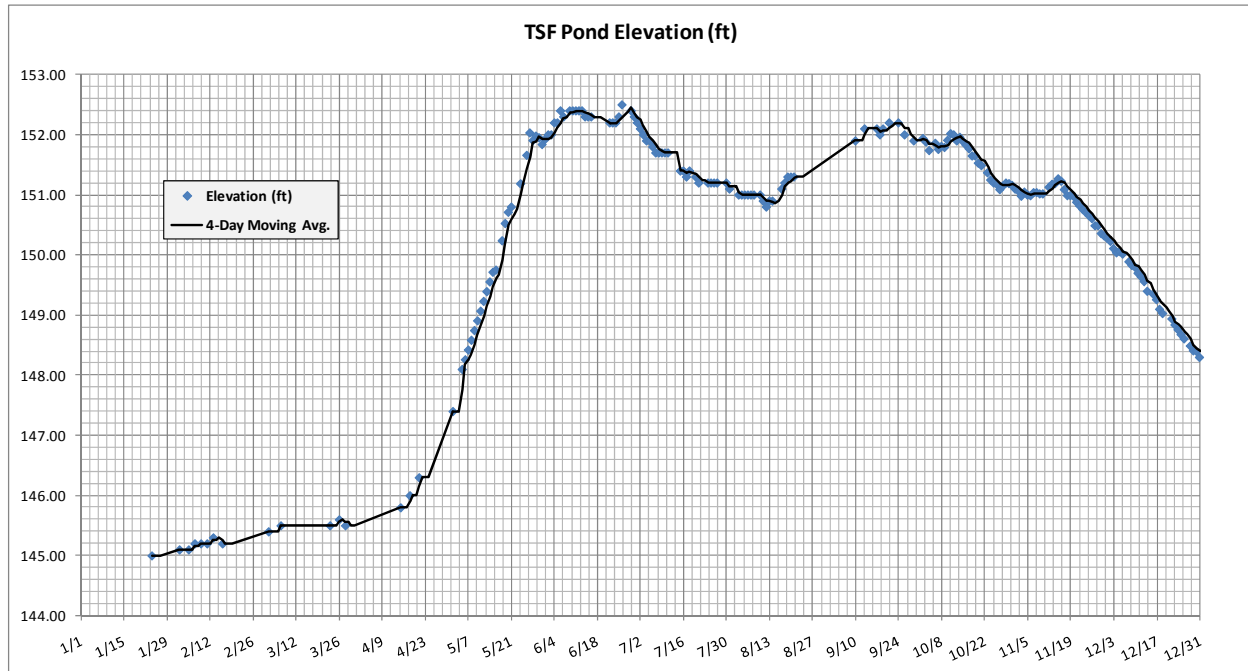
Figure 17: TSF Pond Elevation

The water surface elevations have been recorded on the daily TSF inspection log as per the Rock Creek Tailing O&M manual. After the expanded well field became fully operational in November 2009, the water level in the TSF has consistently been lowered at a higher rate than predicted by the theoretical site water balance. The COBC will terminate when the TSF water elevation falls below 140 feet.

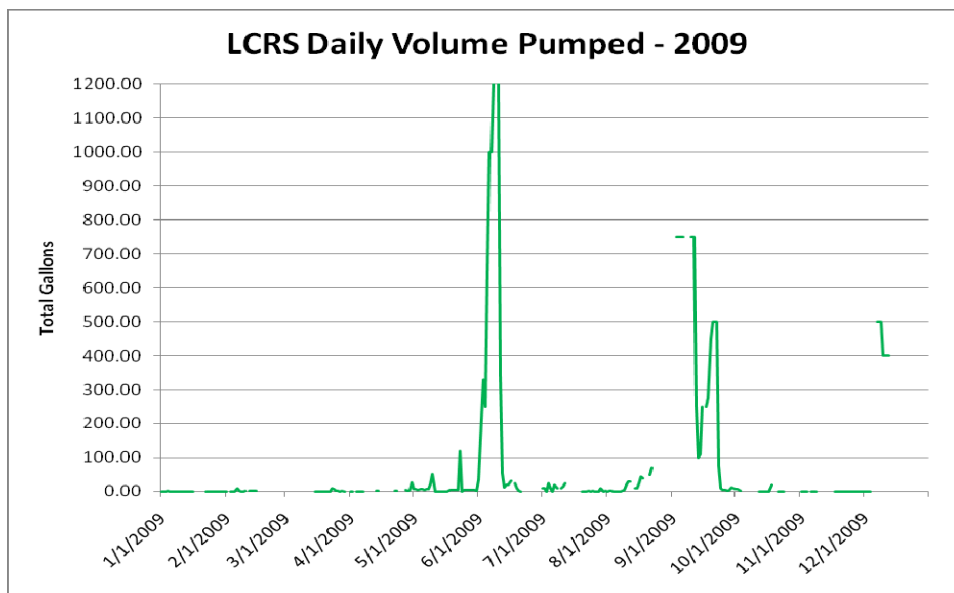
Figure 18: LCRS Pumped Volume

Flow at the LCRS is measured daily. The pumped volume is recorded on the RWP monitoring sheet along with notes from the visual inspection (Figure 18).

There is a direct correlation between the ground water level and the LCRS volume. At the 123-foot elevation, groundwater begins to infiltrate the LCRS. This is controlled with the pumping of the RPW-02 and the RWP Underliner pump. There were maintenance problems with both of these pumps throughout 2009. Specifically, the RPW-02 pump froze and the RWP Underliner pump failed in November 2009. Both pumps have since been repaired.

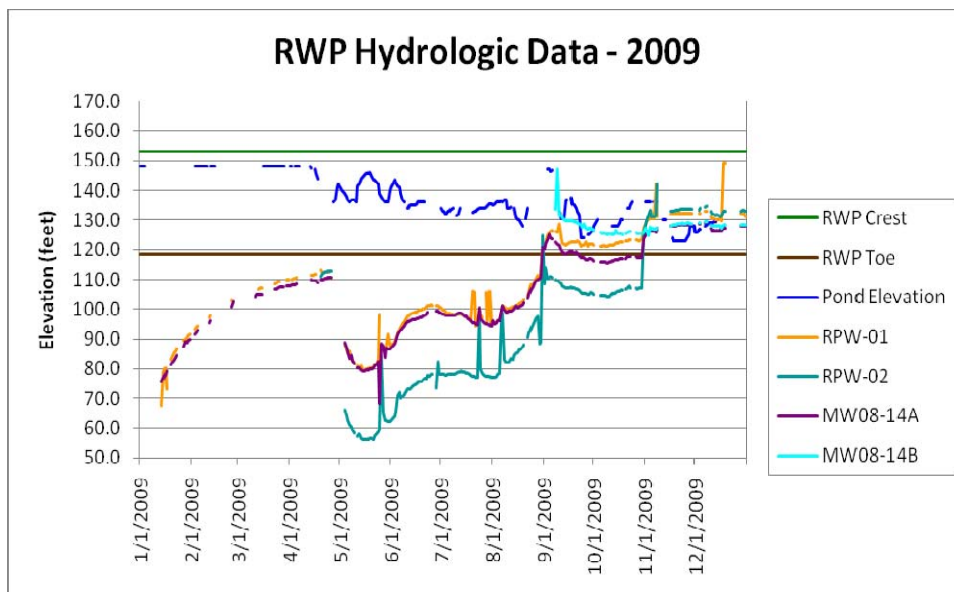
Figure 19: RWP Elevation Data

The surface of the water is monitored and recorded on the RWP monitoring sheet (Figure 19). During 2009, the RWP water elevation has occasionally exceeded the target level of 139 feet specified in the TCP. In late 2009, AGC specifically took steps to provide for removal of water and solids from the RWP and allow for pumping of well water to the WTP for treatment and injection. These actions, which will be completed during early 2010, will ensure adequate capacity for spring 2010 inflows to the RWP.

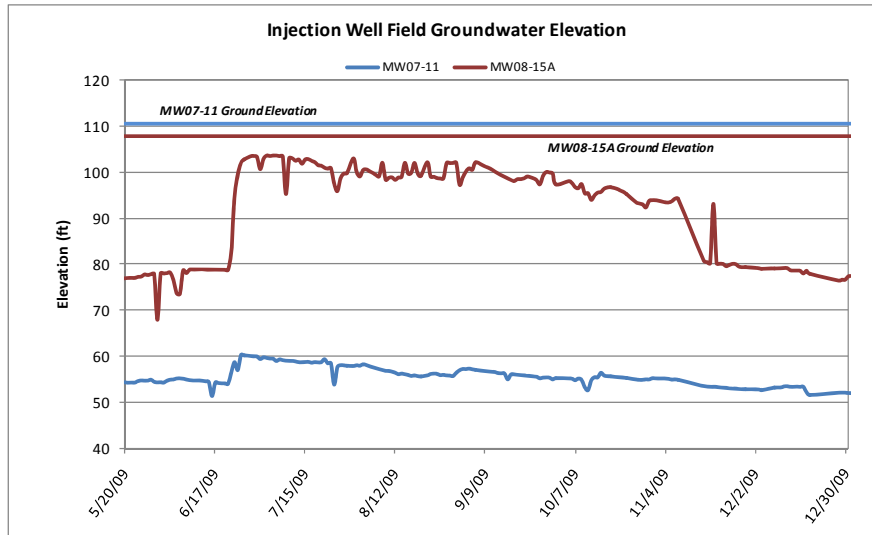
Figure 20: MW07-11 and MW08-15A Groundwater Elevations

Prior to treated water injection, water levels in the monitoring wells were stable at an approximate elevation of 54 feet in MW07-11 and 78 feet in MW08-15A (Figure 20). By the end of June 2009, the water level in well MW07-11 had risen from 54 feet to 60 feet amsl, while the increase in well MW08-15a rose from 79 feet to 102 feet amsl. From July through December water level elevations in both wells slowly decreased to 55 feet (MW07-11) and 77 feet (MW08-15A).

Water levels in the monitoring wells have always been below the ground surface elevation, indicating that the injection activities have not over pressurized the ground water system.

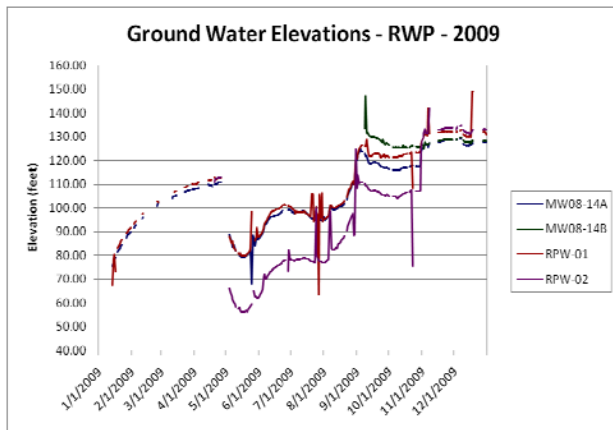
Figure 21: RWP Groundwater Elevations

AGC also monitors groundwater elevations at monitoring wells below the RWP and TSF. No anomalies or upwellings were observed.
