APMA A20166118 and A20142788 – Field Monitoring Report

Amended November 3, 2016

APMA A20146118 and A20142788 - FIELD SUMMARY REPORT

Inspection Date: 26 July – 27 July 2016
Weather: Overcast Skies with Moderate Ceiling, Intermittent Rain Squalls, Variable East Wind at 5-10 kt, Air Temp. Approx. 58° F
Time of Inspection: 26 July: 0930-1630, 27 July: 0830-1230
Agency Personnel: Hollie Chalup (Mining Section), Marty Lentz (Mining Section), David Schade (Water Resources Section)
Operator Contact: Tim Havey, Env. Manager, Pebble Limited Partnership
Pilot: John Baechler, Jr.
Inspection Objectives: Annual Inspection and Follow-Up Compliance Inspection

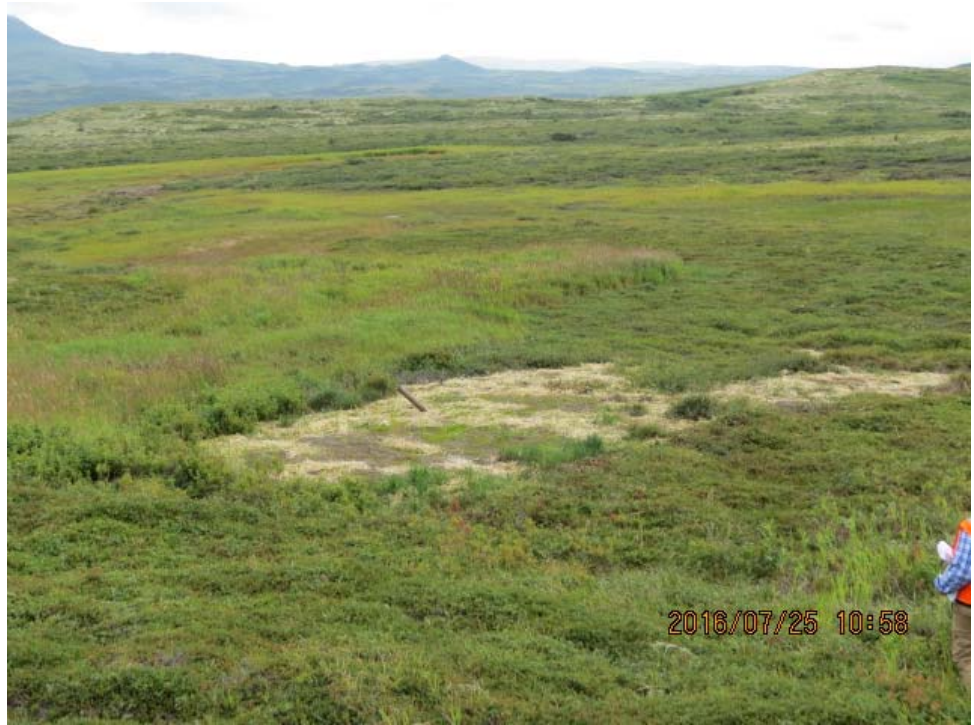
**17. Borehole
0051/3072**
26 July 2016

Easterly view of rehabilitated area in the vicinity of borehole 0051 and 3072. The wood marker indicates location for 3072.

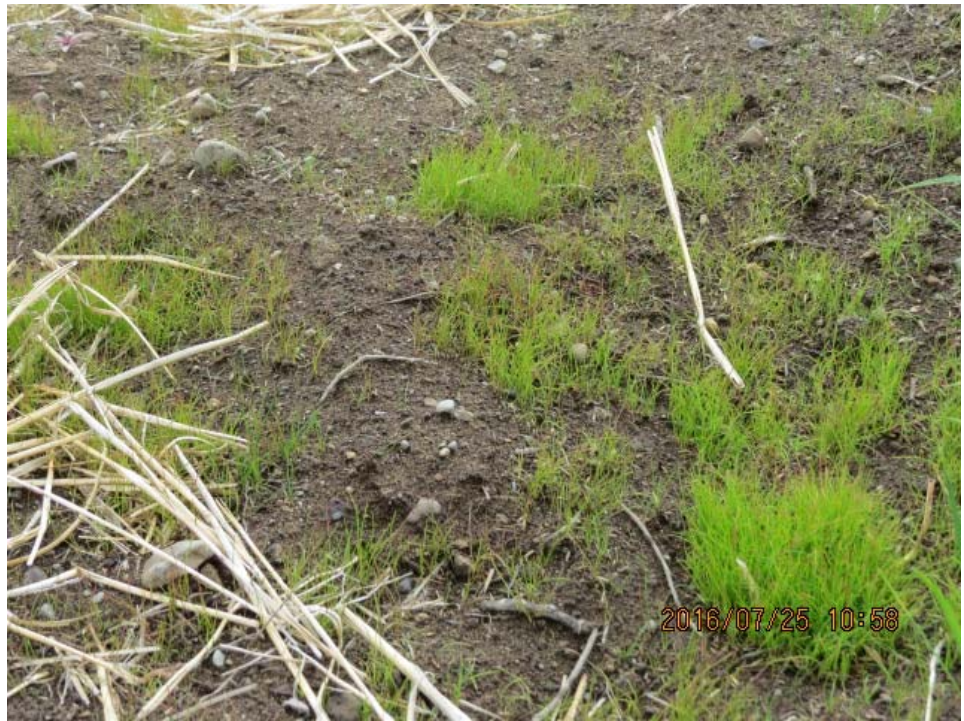
**18. Borehole
0051/3072**
26 July 2016

New growth from spring 2016 reseeding effort. *Gramineae* family species have established and growth was documented between 2" and 6" tall in discontinuous tufts.

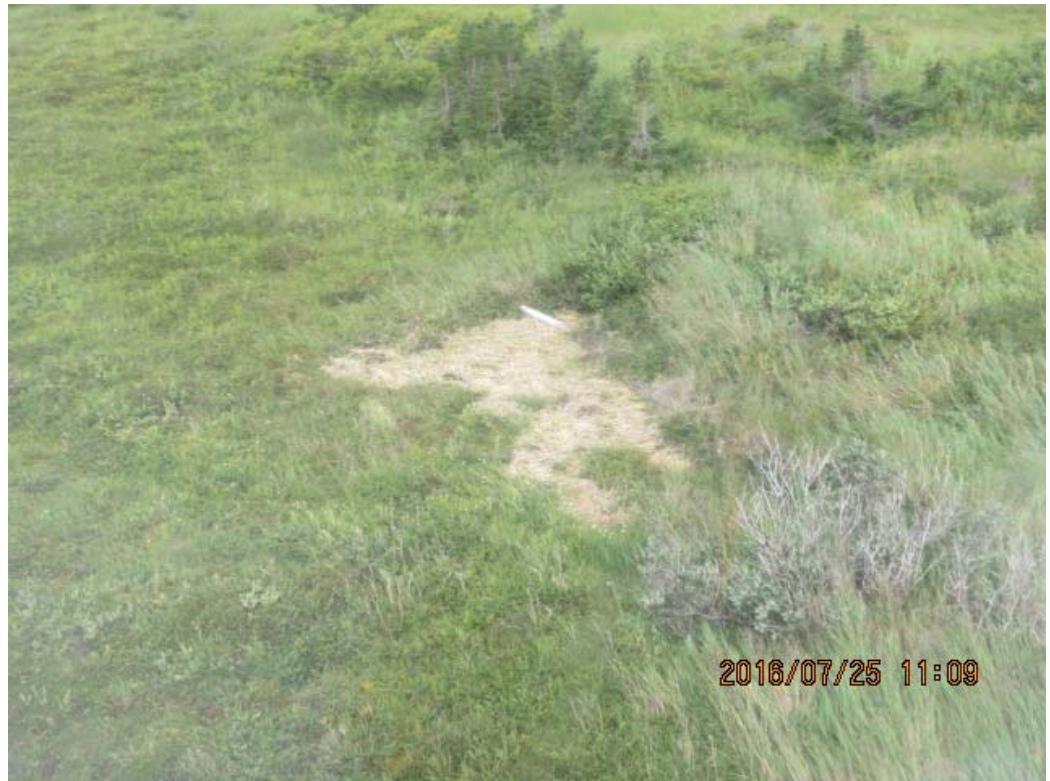
**19. Borehole
4215**
26 July 2016

Area was
reseeded during
spring 2016
restoration
efforts.

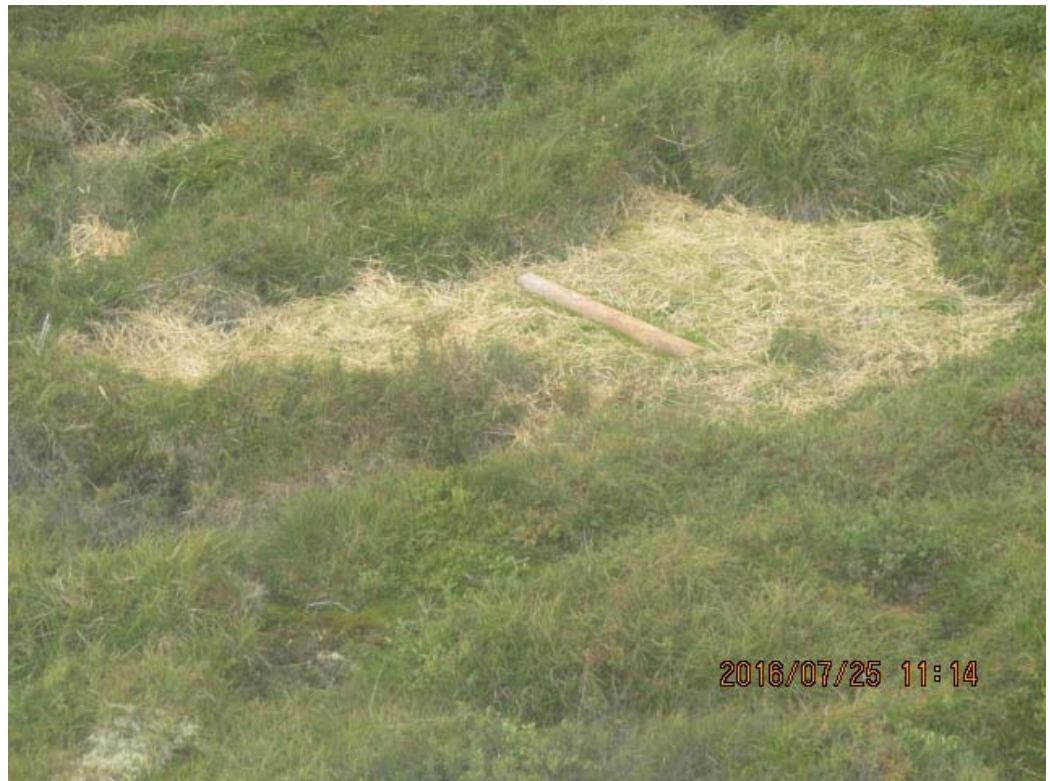
**20. Borehole
4190**
26 July 2016

Area was
reseeded during
spring 2016
restoration
efforts. New
growth was
observed.

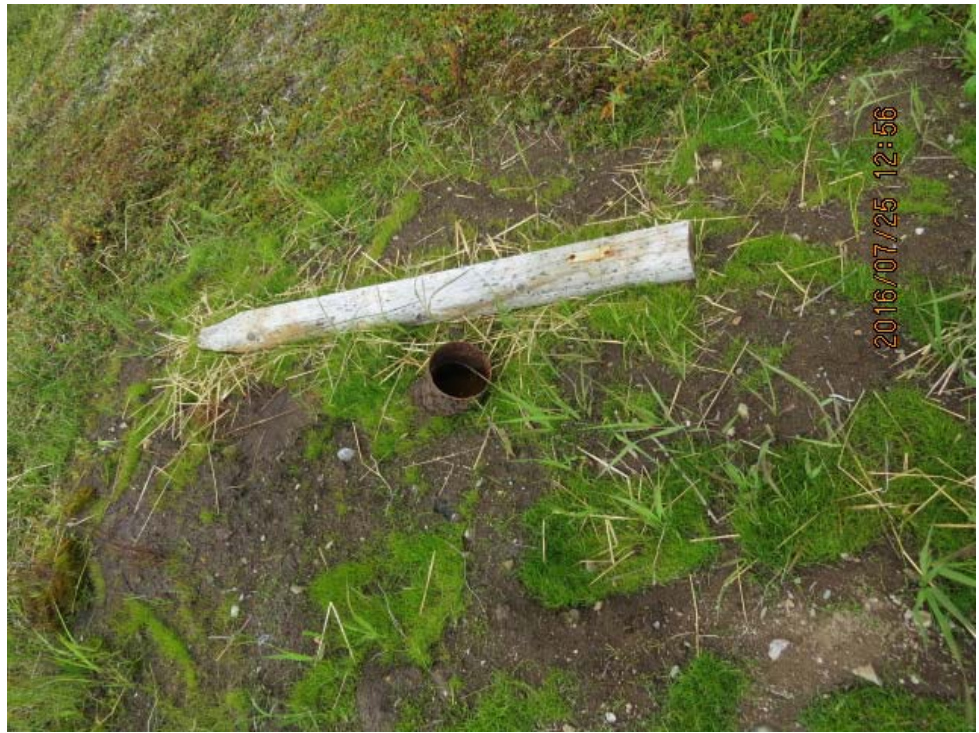
**21. Borehole
3127**
26 July 2016

Area was reseeded during spring 2016 restoration efforts. *Gramineae* species have grown in discontinuous tufts between 1" and 7" tall.

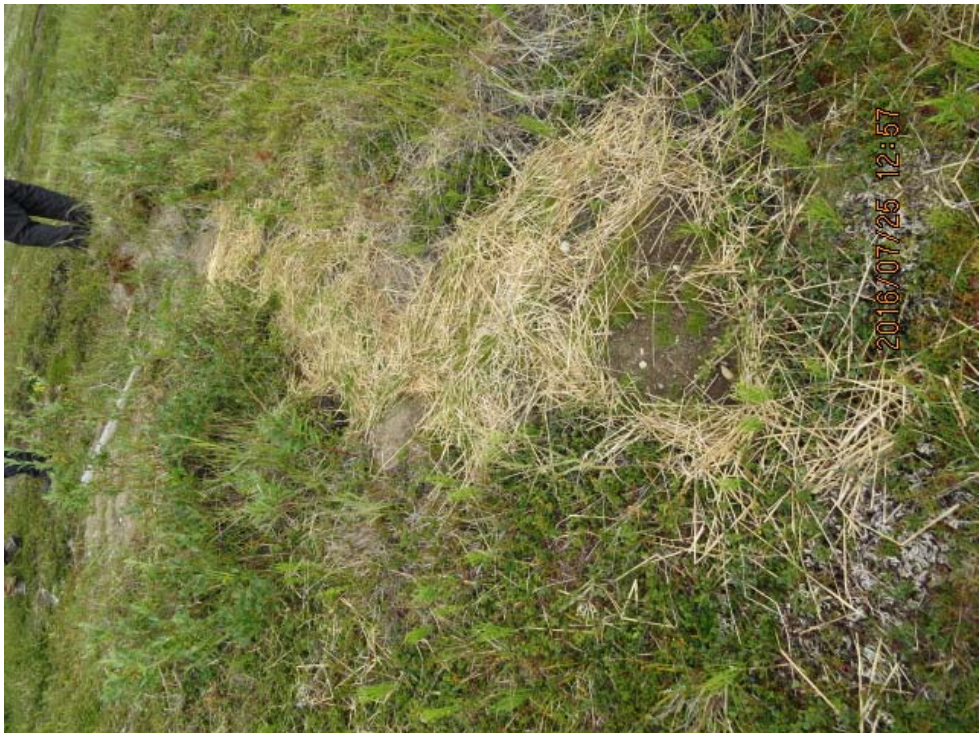
**22. Borehole
0112**
26 July 2016

Area was reseeded during spring 2016 restoration efforts. *Gramineae* species have begun to establish. Growth is estimated between 2-4".

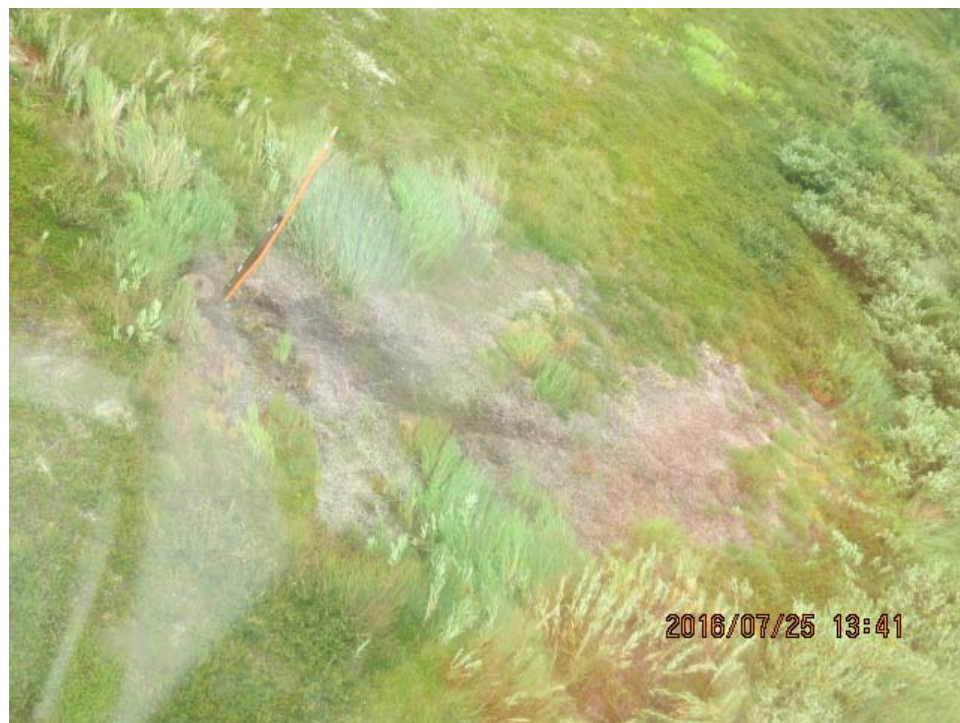
**24. Borehole
GH11-292S**
26 July 2016

Borehole GH11-292S was repaired in July 2016. Area was also reseeded in July 2016.

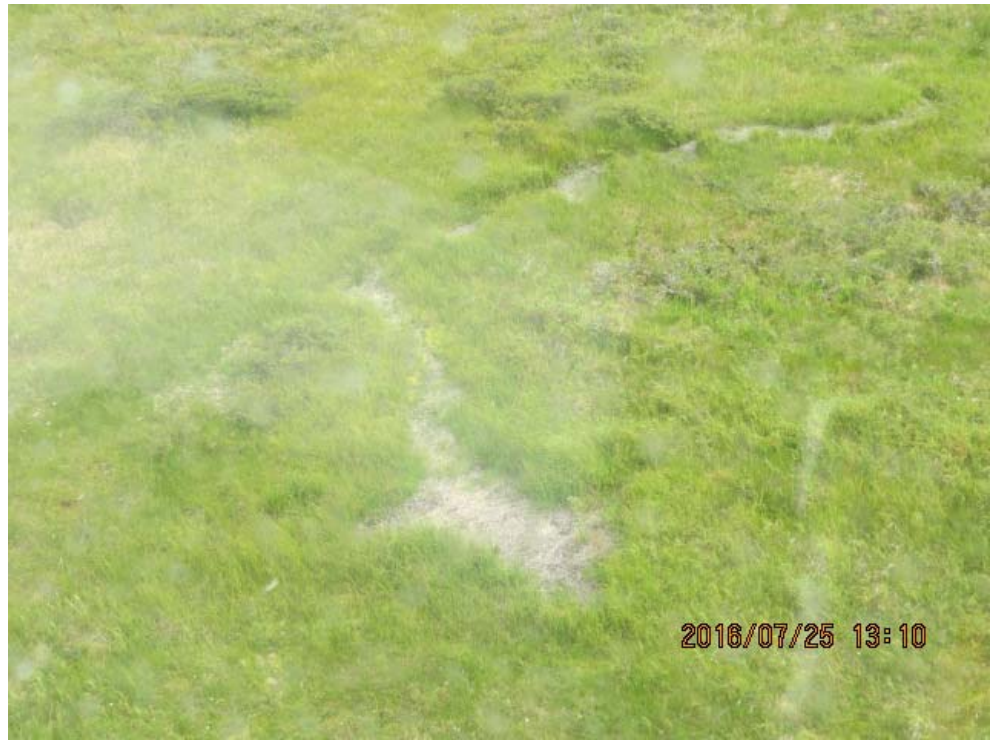
**26. Borehole
0040**
26 July 2016

Area was reseeded with native grass seeds from surrounding species.

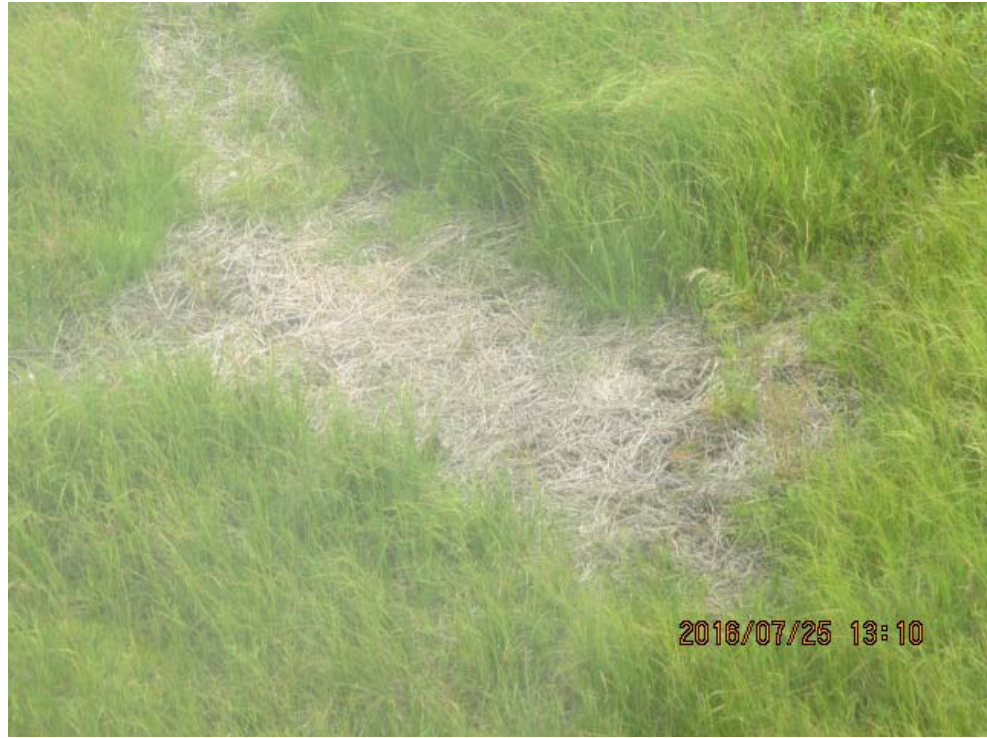
27. Borehole

Area was reseeded using grass seeds in the immediate vicinity to the restoration area. Some areas have established new growth.

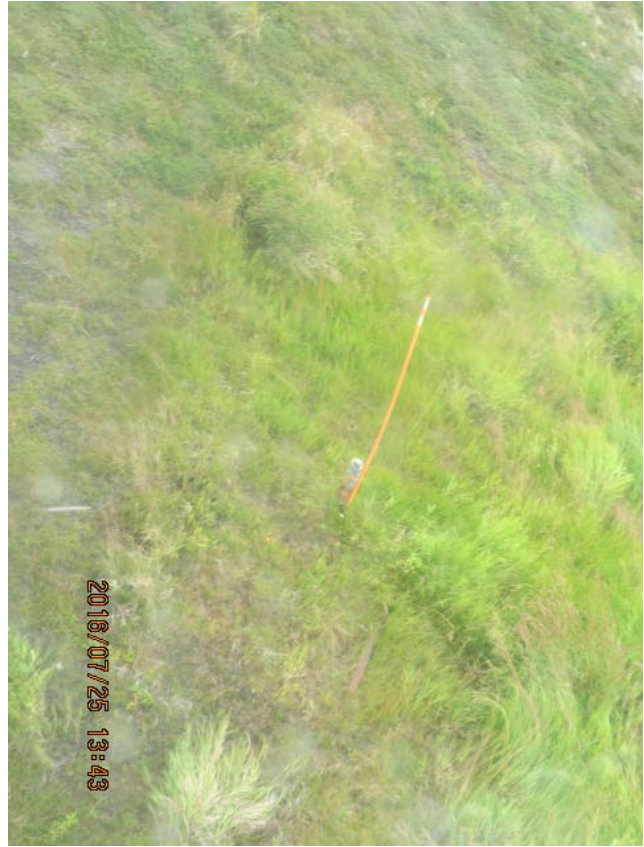
Borehole 6343 was repaired in 2015 by placement of a new Margo plug. The casing was subsequently sealed and wrapped. *Gramineae* growth is well established.

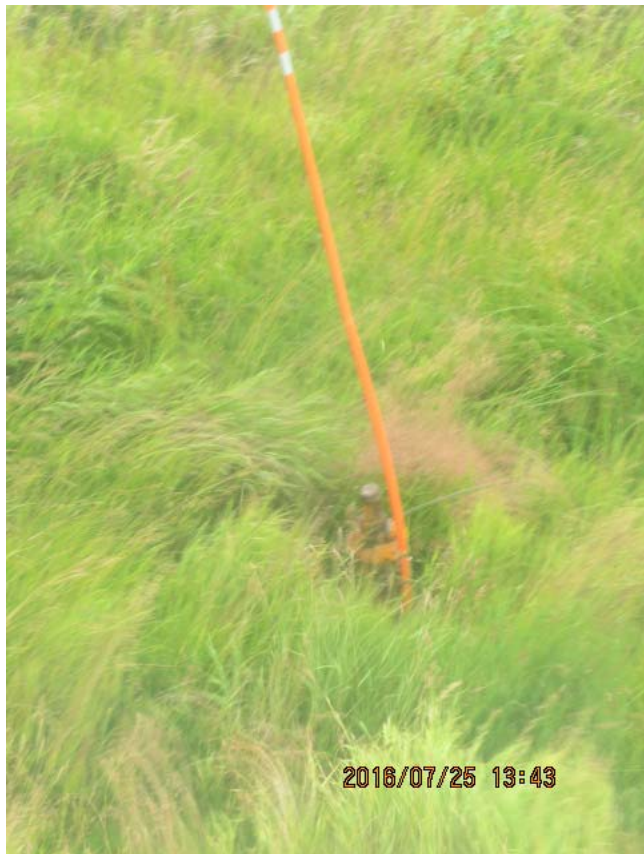
30. Borehole

A new Margo plug was placed in 2015 and the casing was spray-foamed to prevent water penetration. Repairs were successful and surrounding vegetation appears unaffected.

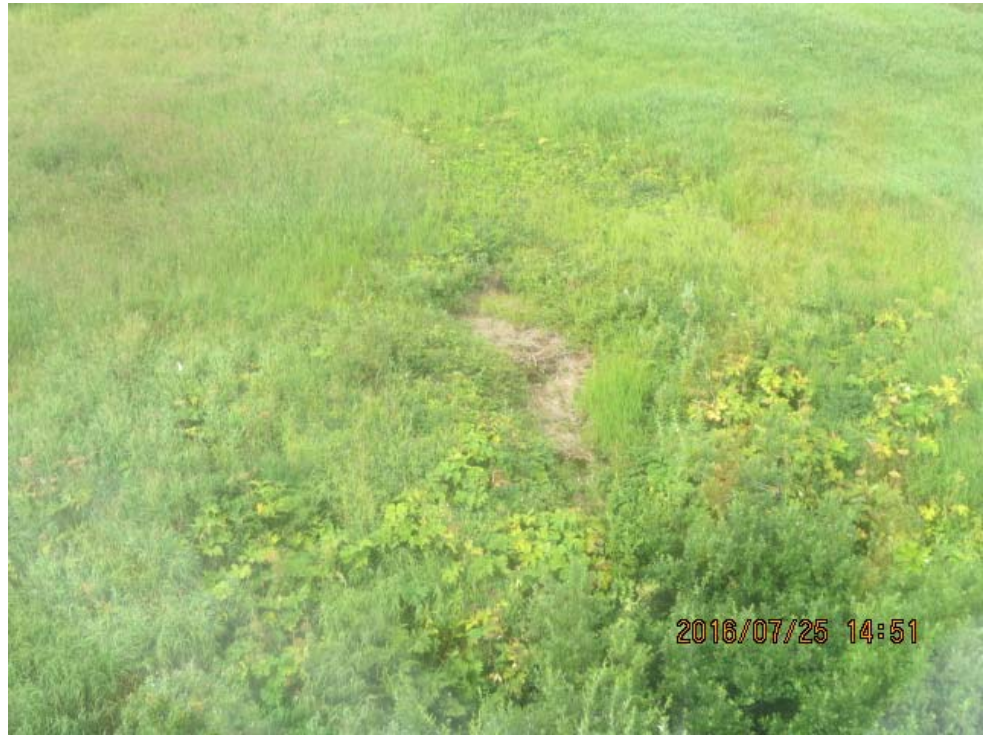
**31. Borehole
0009**

Borehole 0009 was regouted and abandoned in 2015. Repairs to stop water flow were successful. Natural *Gramineae* seeds were cast in the outflow channel.

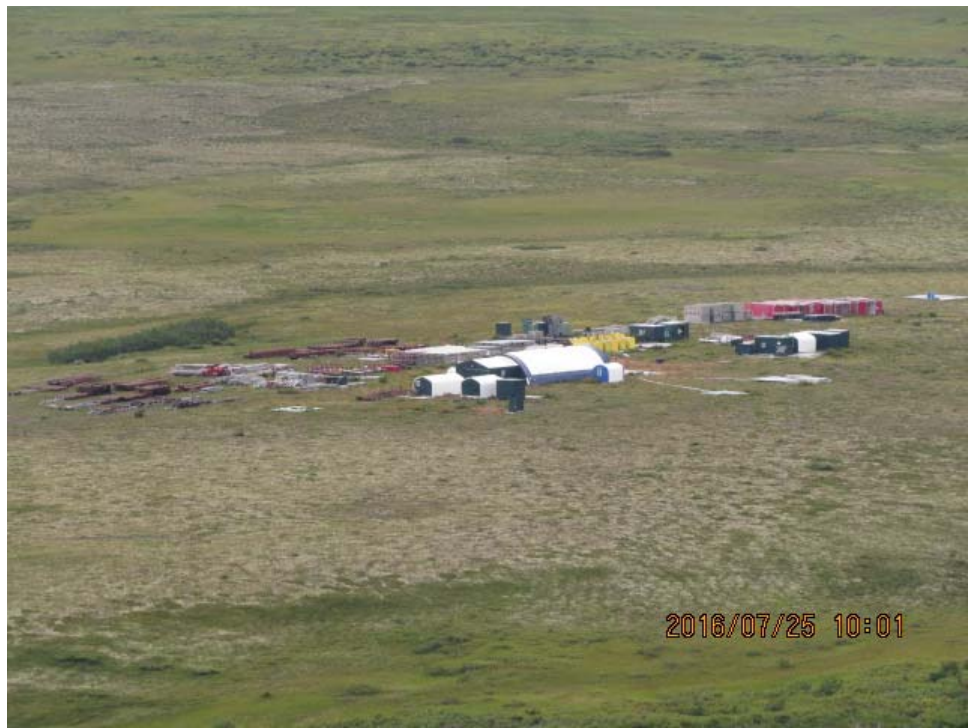
**32. Main Supply
Depot**

Southeasterly overview of Main Supply Depot.

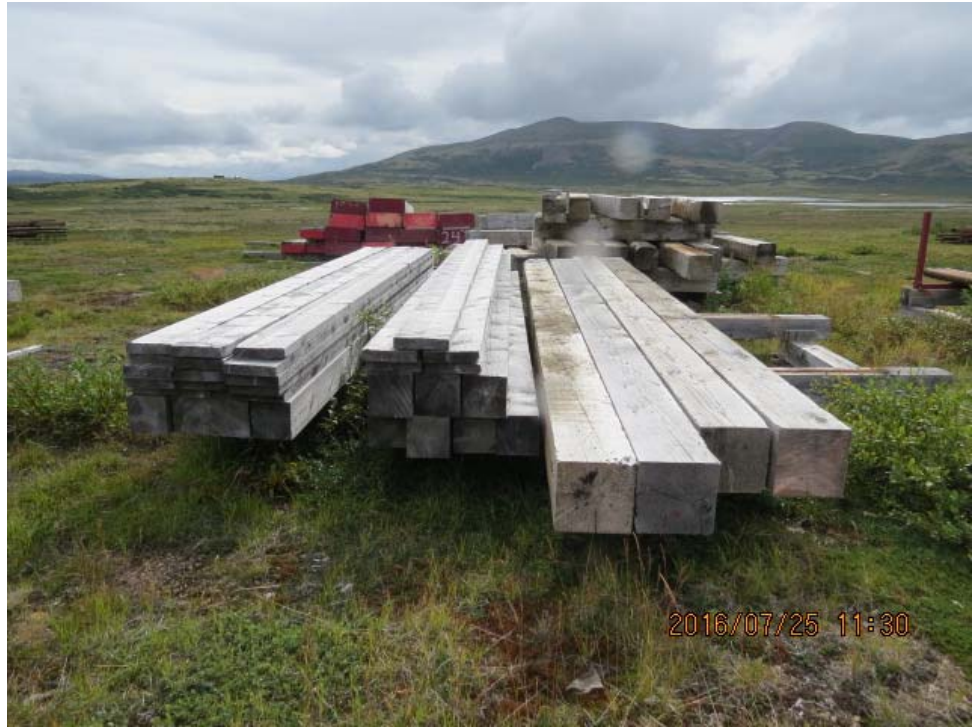
**33. Main Supply
Depot Dunnage**
26 July 2016

Orderly dunnage
laydown yard. All
dunnage is
elevated on tundra
pads or platforms.

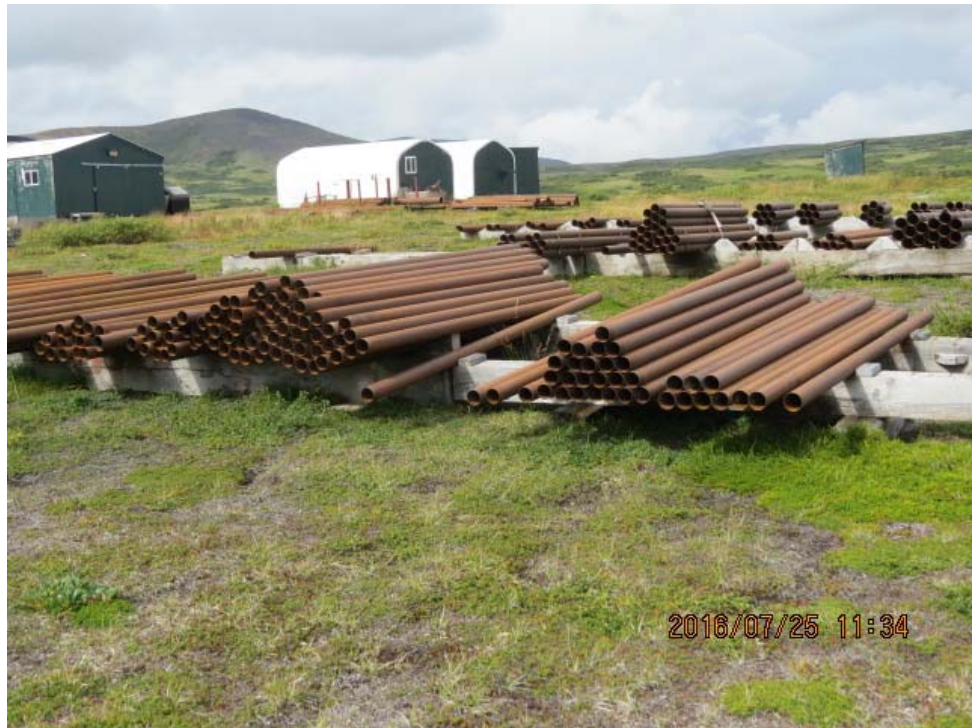
**34. Main Supply
Depot Drill Steel**
26 July 2016

Orderly laydown
area for drill steel.
All steel is sorted
and kept on
elevated platforms
to minimize
footprint.

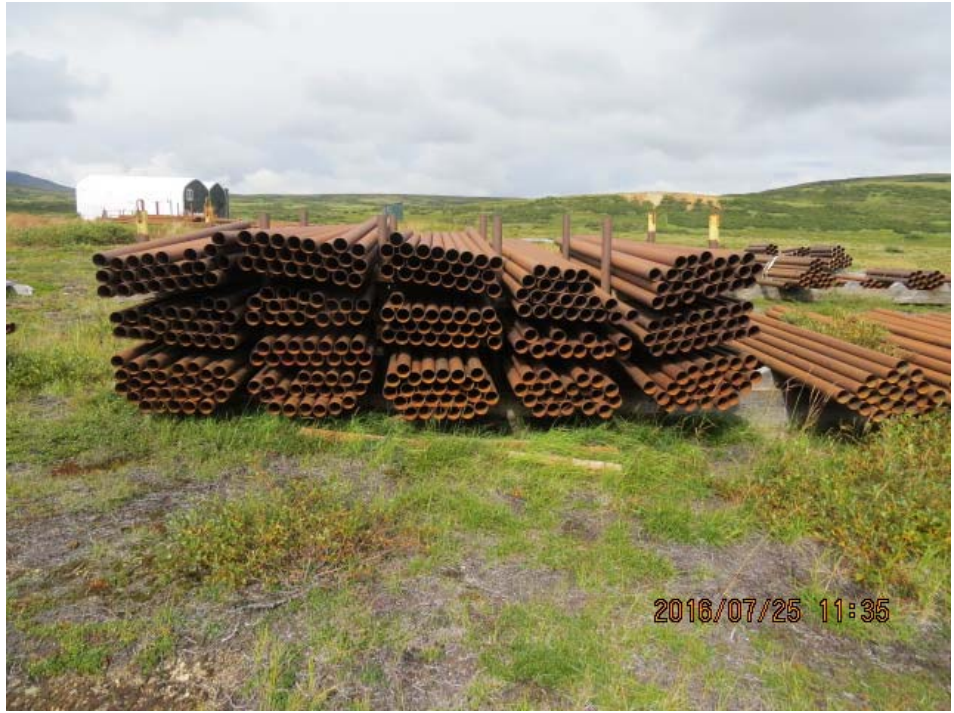
**35. Main Supply
Depot Drill Steel**
26 July 2016

Drill steel laydown area. All steel is sorted and stored on elevated platforms.

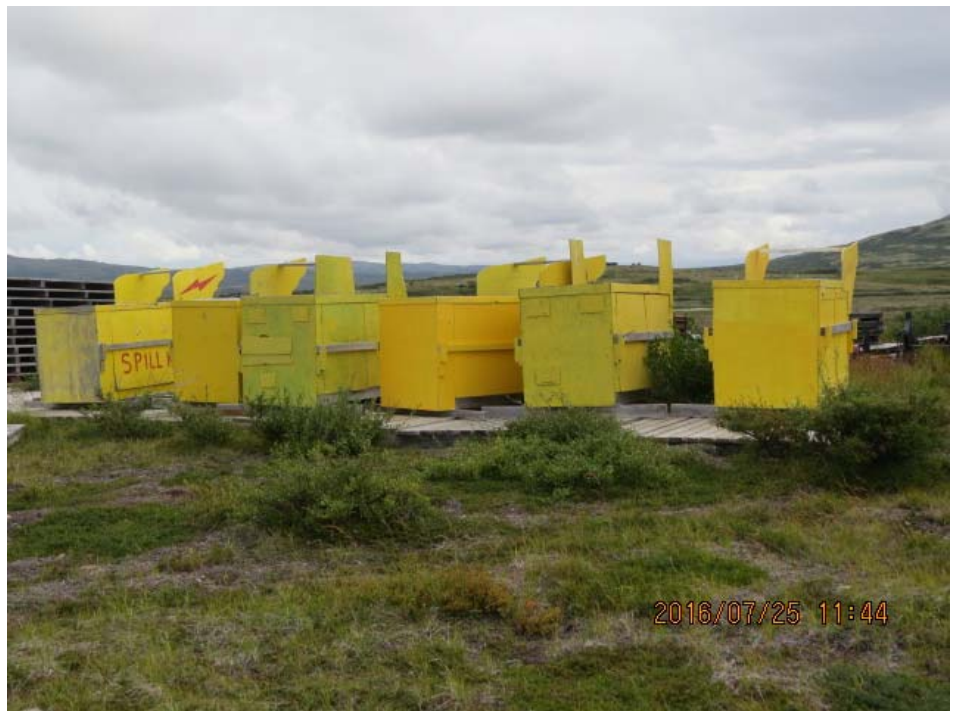
**36. Main Supply
Depot Fly Boxes**
26 July 2016

Fly boxes housing spill kits. Wings on boxes increase stability of sling loading during transport.

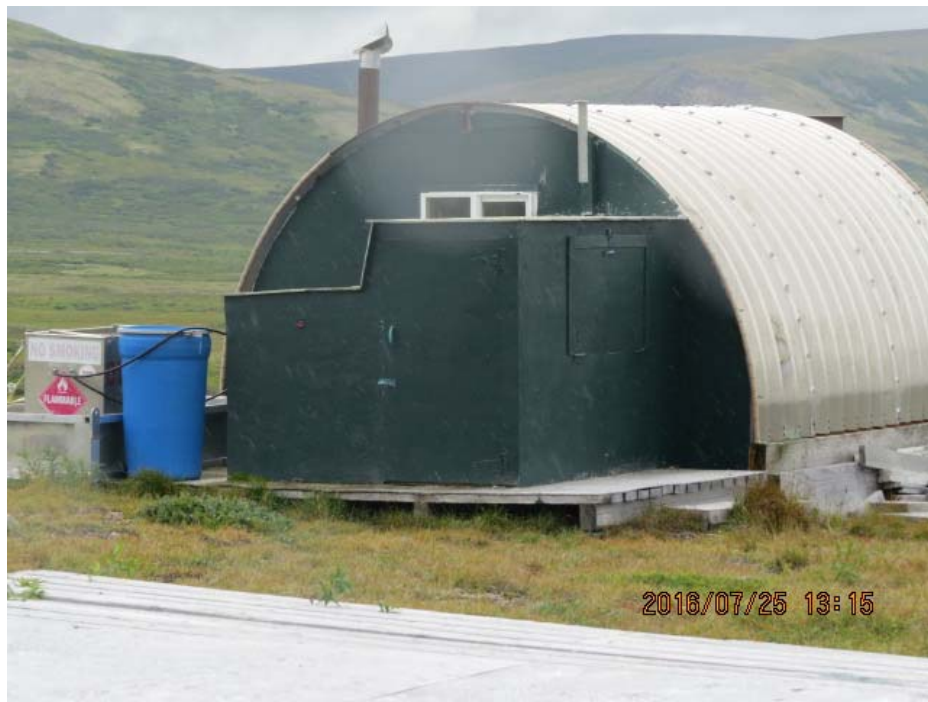
37. Watershed

The Watershed site is in good condition and houses remediation and emergency response supplies. A fuel tank with aluminum containment is present, but stored empty.

Watershed site houses remediation and emergency response supplies. Fuel container is present but stored empty.

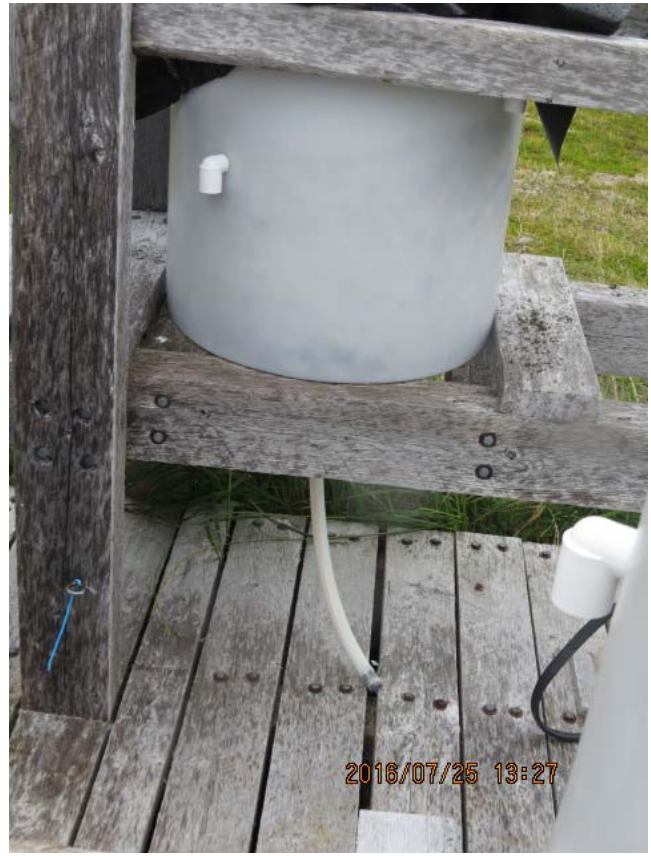
Barrel outlets were adequately sealed. No evidence of leaking was observed.

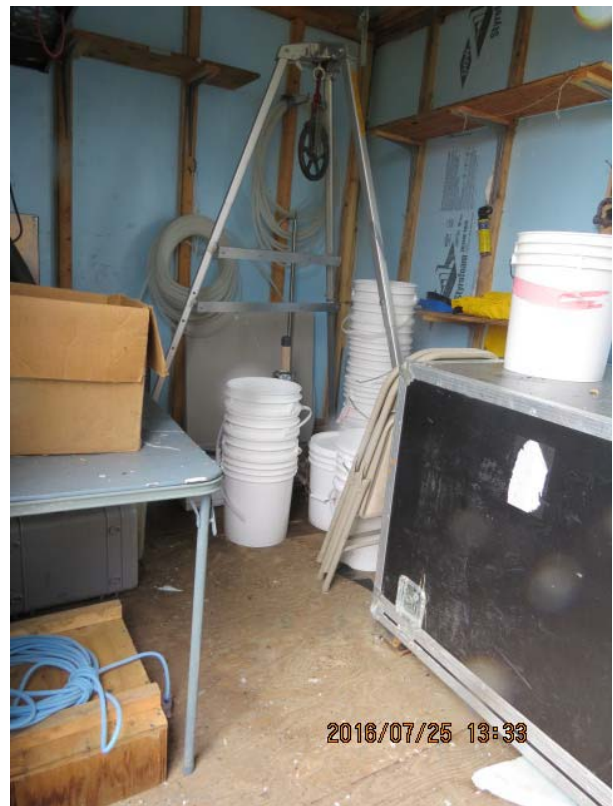
40. Westbay 1 Interior

Westbay 1 well study support structure. Contents of structure were benign in nature and kept in orderly condition.

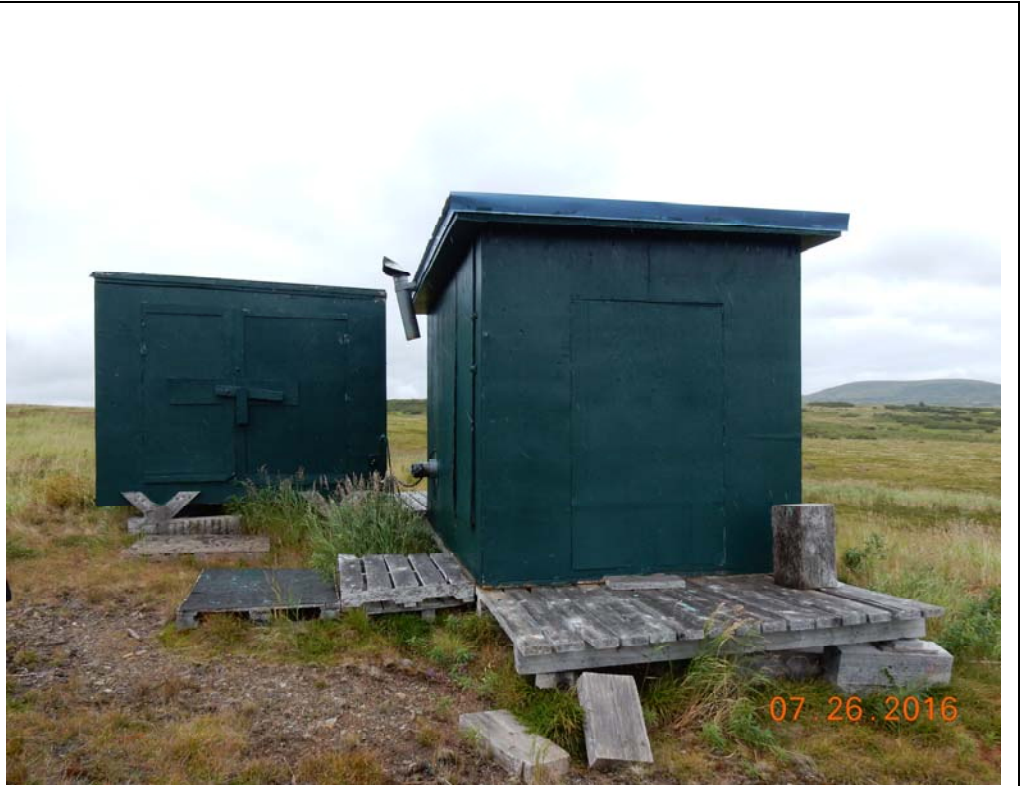
41. Westbay 1 Exterior
26 July 2016

Westbay 1 exterior is orderly and in acceptable condition. Structures are elevated on tundra pads.

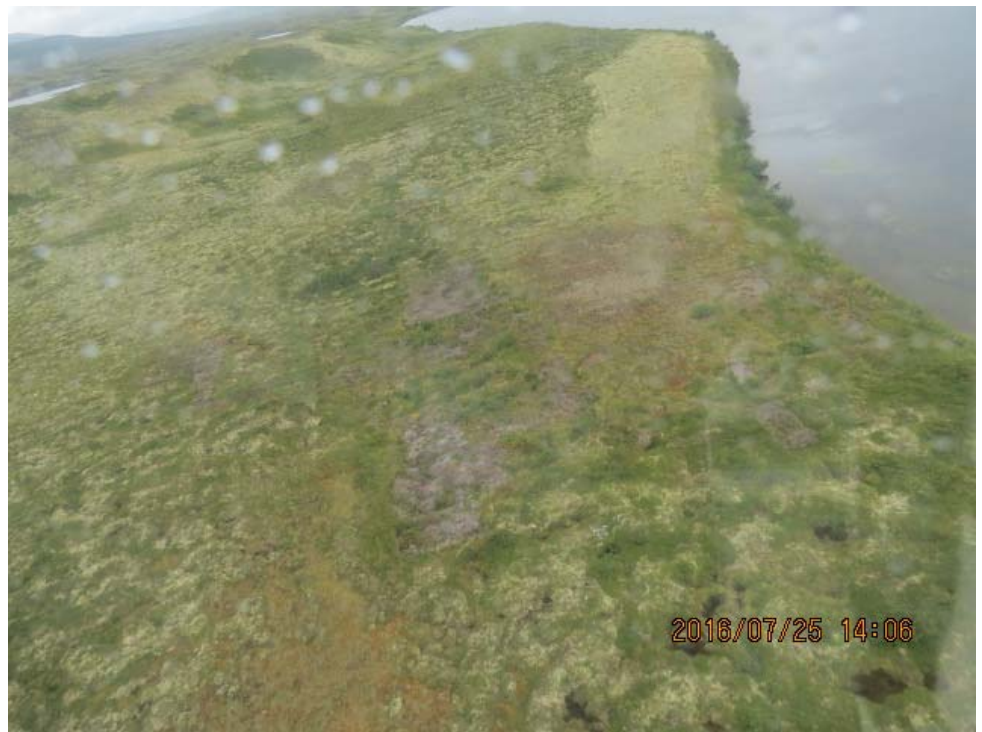
**42. Wiggly Lake
Fueling Depot
Reclamation**
26 July 2016

Observed ongoing revegetation of the Wiggly Lake Fueling Depot. Area is fully reclaimed and monitored for continued growth.

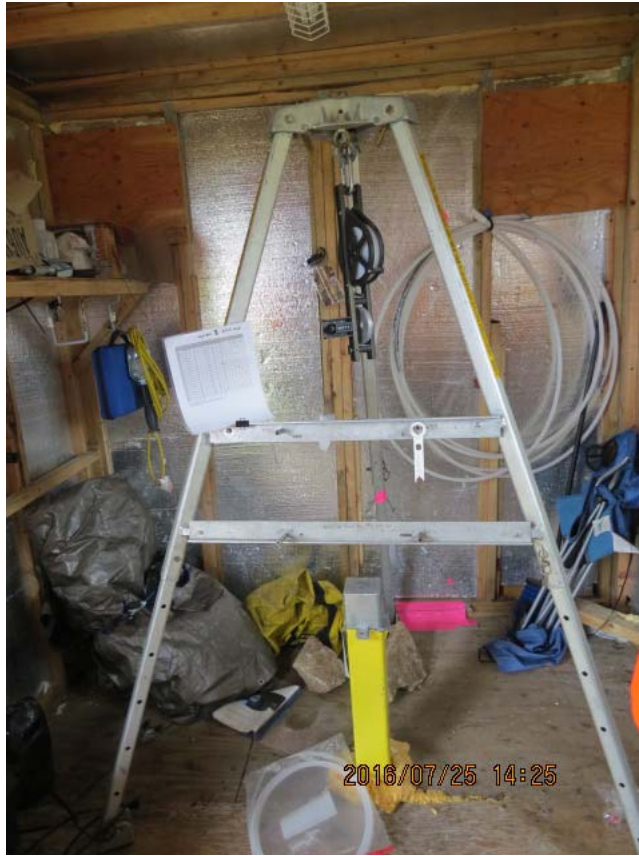
**43. Westbay 3 and
GH10-220**

Ongoing study well and support structure. All materials housed in Westbay 3 were documented as benign in nature. Temporary well cap is intact.

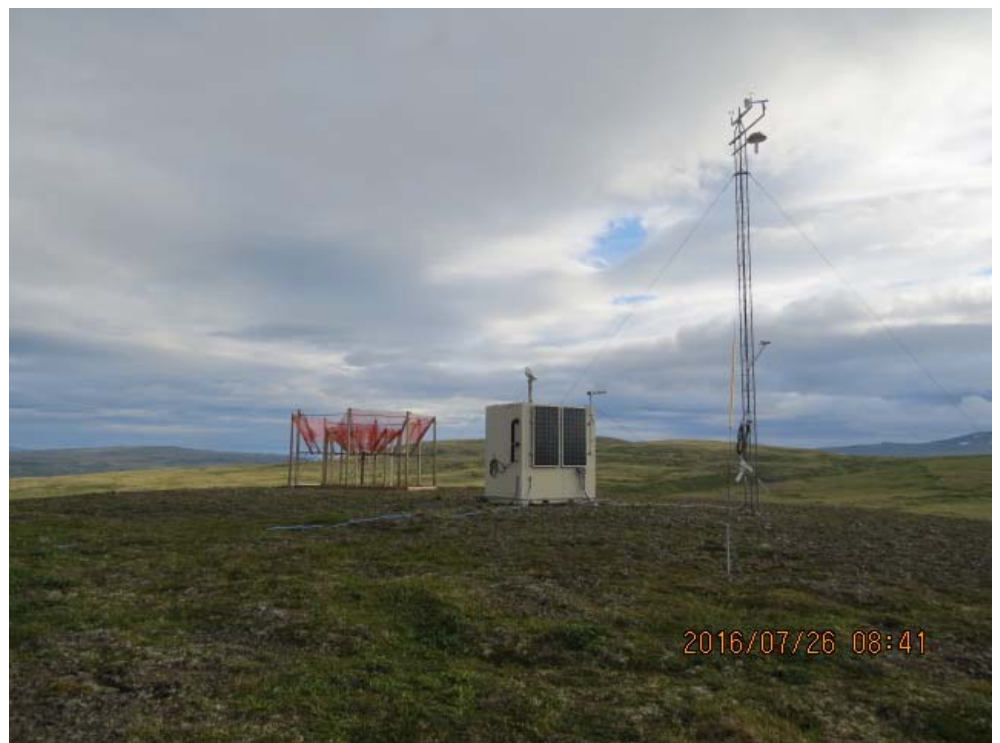
**44. Pebble 1
Meteorological
Observation Station**

The Pebble 1 Meteorological Station is orderly. Relay maintenance at this site has been delayed by several years, however, the station continues to collect data. ADNR requests PLP to identify and report the nature of the liquid in two yellow poly containers kept onsite. All containers are in good condition but the contents are unknown.

Weather station is in stable condition. Technical maintenance on the relay has lapsed, however, the station still collects and records data and is of value considering relatively low density of weather stations in surrounding area.
