Field Inspection Report

-Pebble Copper/Gold Exploration Project-

Inspection Date: June 17-18, 2008

APMA No.: A086118

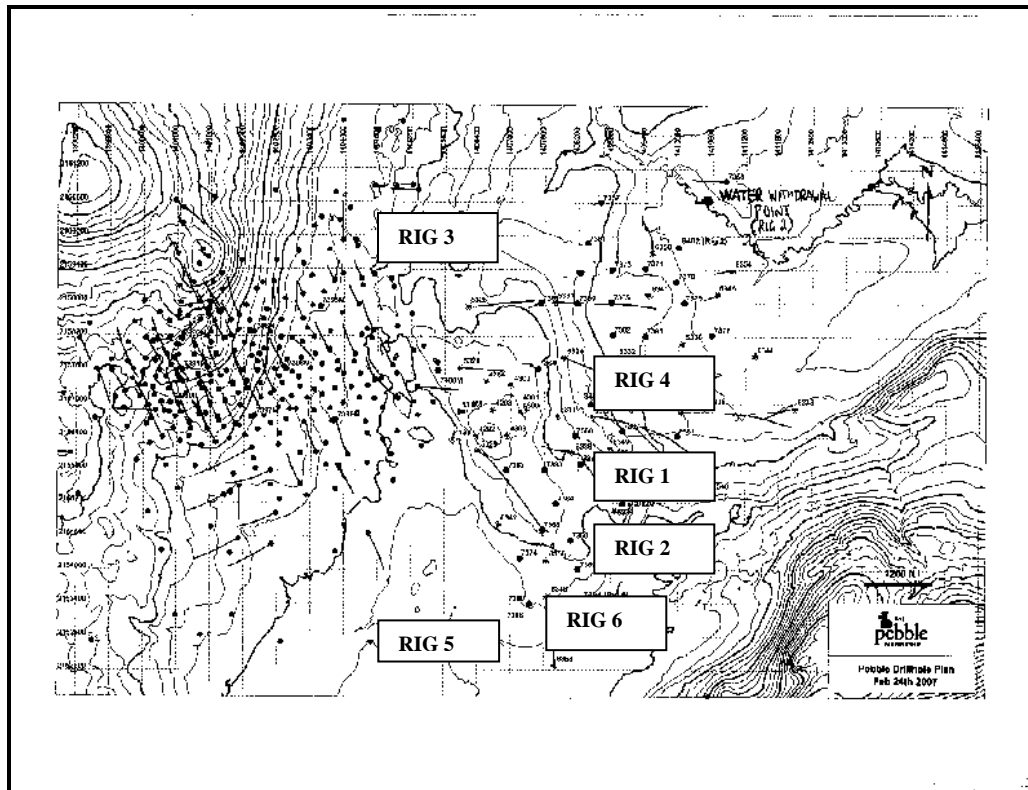
Figure 2. Approximate locations of drilling rigs

| <p><input type="checkbox"/> Inspection Type</p> <p><input type="checkbox"/> Complete: All drill rigs were inspected (Figures 1 and 2)</p> <p><input type="checkbox"/> Follow-up:</p> <p><input type="checkbox"/> Response to complaint:</p> <p><input type="checkbox"/> Weather Conditions</p> <p><input type="checkbox"/> Temperature: Approx 60° F</p> <p><input type="checkbox"/> Wind: S 5 knots</p> <p><input type="checkbox"/> Precipitation and types: None</p> <p><input type="checkbox"/> Visibility: > Unlimited</p> <p><input type="checkbox"/> Sky Conditions: 30 % overcast-scattered</p> <p><input type="checkbox"/> Ground conditions: Clear</p> <p><input type="checkbox"/> Wildlife Observed</p> | <p><input type="checkbox"/> Bear:</p> <p><input type="checkbox"/> Caribou:</p> <p><input type="checkbox"/> Moose:</p> <p><input type="checkbox"/> Waterfowl:</p> <p><input type="checkbox"/> Fish:</p> <p><input type="checkbox"/> Other: Ground squirrels, bald eagle</p> <p><input type="checkbox"/> Water level Frying Pan Lake: Not Observed</p> <p><input type="checkbox"/> Observed inflow: Yes ___ No ___</p> <p><input type="checkbox"/> Observed outflow: Yes ___ No ___</p> |
