## Field Monitoring Report -- Pebble Copper/Gold Exploration Project --

Personnel: Steve McGroarty (ADNR)	Inspection Date: August 27, 2008
David Johnson (ADEC)	Site Contact: Lena Brommeland
	APMA #: A086118
<input checked="" type="checkbox"/> Inspection Type: Routine - Partial	<input checked="" type="checkbox"/> Wildlife Observed:
<input type="checkbox"/> Complete:	<input type="checkbox"/> Bear: None
<input type="checkbox"/> Partial:	<input type="checkbox"/> Caribou: None
<input type="checkbox"/> Follow-up:	<input type="checkbox"/> Moose: None
<input type="checkbox"/> Response to Public Complaint:	<input type="checkbox"/> Waterfowl: None
	<input type="checkbox"/> Fish: None
<input checked="" type="checkbox"/> Weather Conditions:	<input type="checkbox"/> Other: One ground squirrel & one ptarmigan
<input type="checkbox"/> Temperature: 50 f	
<input type="checkbox"/> Wind: Light	<input checked="" type="checkbox"/> Water level at Frying Pan Lake:
<input type="checkbox"/> Precipitation: N/A	<input type="checkbox"/> Observed inflow: not observed

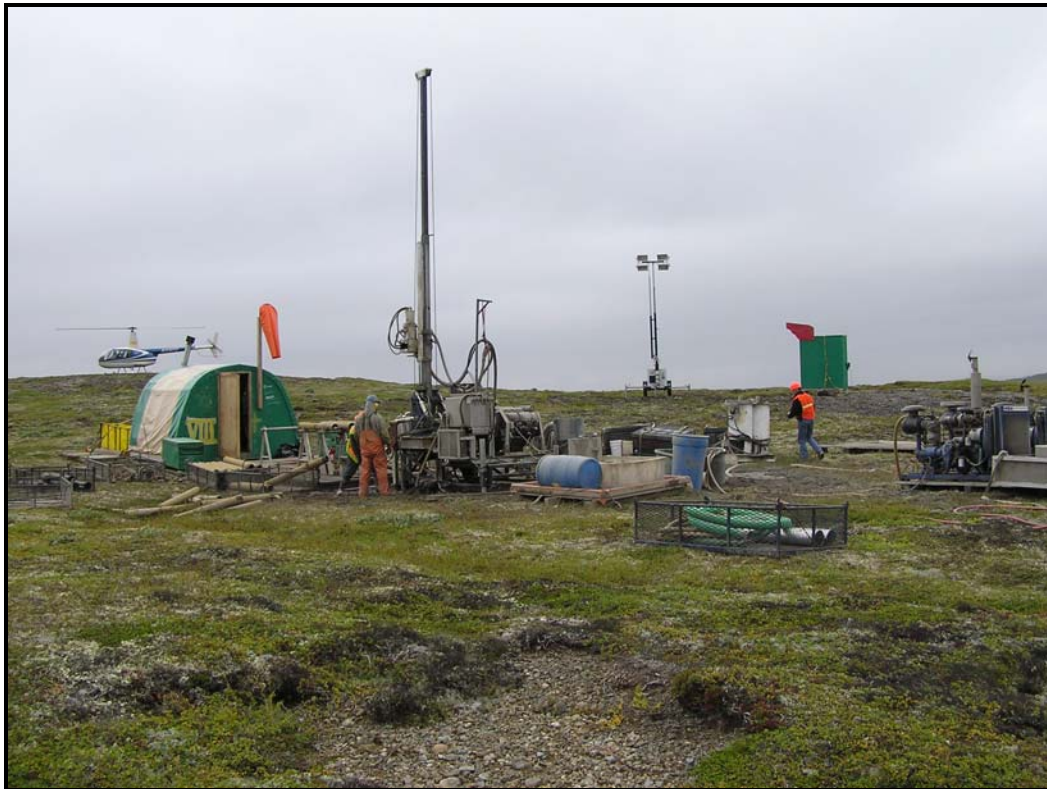
Drill Hole/Site No.: P-08-87	Rig No.: 8
Activity: Active Drilling	Date: 8/27/08
Drilling monitoring well to approx 300'	59 50 39.3/155 09 03.4
<ul style="list-style-type: none"> <li>■ Condition of Drilling Site: No spills noted</li> </ul>	<ul style="list-style-type: none"> <li>■ Sump Pit (continued):</li> </ul>
<ul style="list-style-type: none"> <li>○ Distance from waterbody: &gt; 500-ft (see photo)</li> </ul>	<ul style="list-style-type: none"> <li>○ Location and extent of discharged material: RC drill cuttings were discharged adjacent to drillhole</li> </ul>
<ul style="list-style-type: none"> <li>○ Location of fuel storage: At drill rig; in secondary containment</li> </ul>	<ul style="list-style-type: none"> <li>○ Topsoil, muck, tundra stockpiled: n/a</li> </ul>
<ul style="list-style-type: none"> <li>○ Sorbent pads present: Yes</li> </ul>	<ul style="list-style-type: none"> <li>○ Location of secondary sump pit: n/a - geotechnical drill rig</li> </ul>

**Figure 3: Drill Rig # 8.**

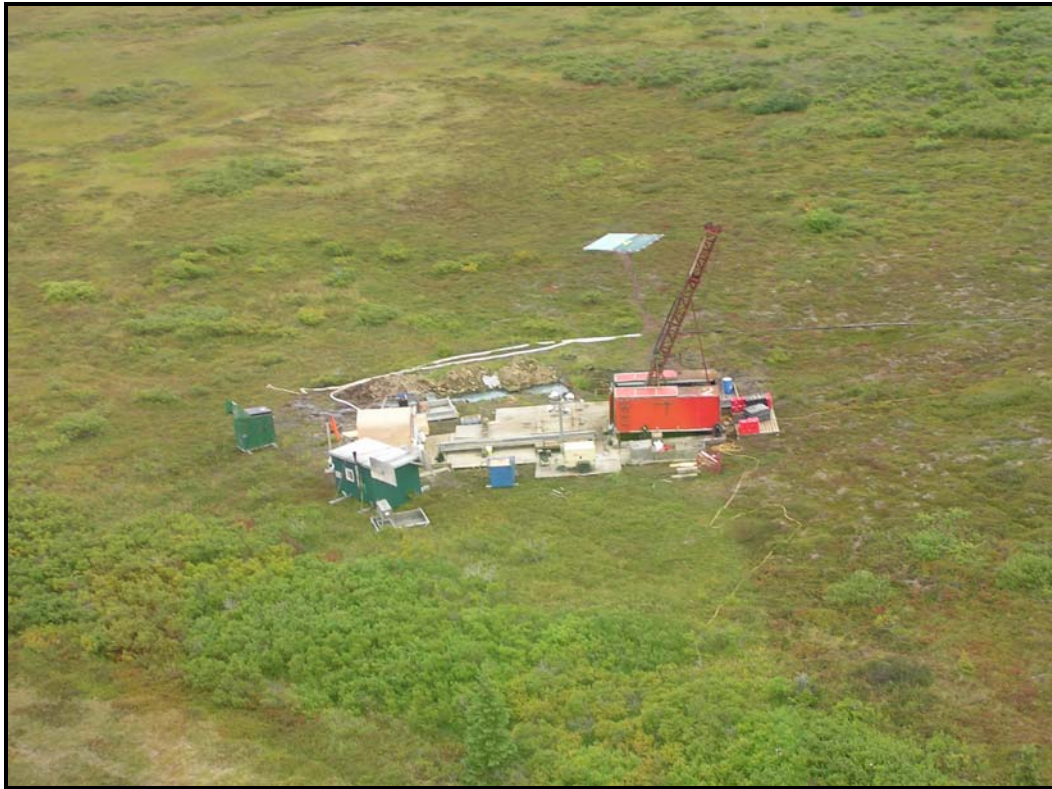
Drill Hole/Site No.: 8423	Rig No.: 2
Activity: Active Drilling	Date: 8/27/08
	59 53 54.3/155 14 37.3
<ul style="list-style-type: none"> <li>■ Condition of Drilling Site: Fuel odor/small stain</li> </ul>	<ul style="list-style-type: none"> <li>■ Sump Pit (continued):</li> </ul>
<ul style="list-style-type: none"> <li>○ Distance from waterbody: See photo</li> </ul>	<ul style="list-style-type: none"> <li>○ Location and extent of discharged material: on ridge near rig - see photo.</li> </ul>
<ul style="list-style-type: none"> <li>○ Location of fuel storage: At drill rig; in secondary containment</li> </ul>	<ul style="list-style-type: none"> <li>○ Topsoil, muck, tundra stockpiled: Yes</li> </ul>
<ul style="list-style-type: none"> <li>○ Sorbent pads present: Yes</li> </ul>	<ul style="list-style-type: none"> <li>○ Location of secondary sump pit: Next to primary sump.</li> </ul>
<ul style="list-style-type: none"> <li>○ Tundra mat: Yes</li> </ul>	<ul style="list-style-type: none"> <li>○ Hose color: Black.</li> </ul>

**Figure 9: Drill Rig # 2 at drill hole number 8423.**

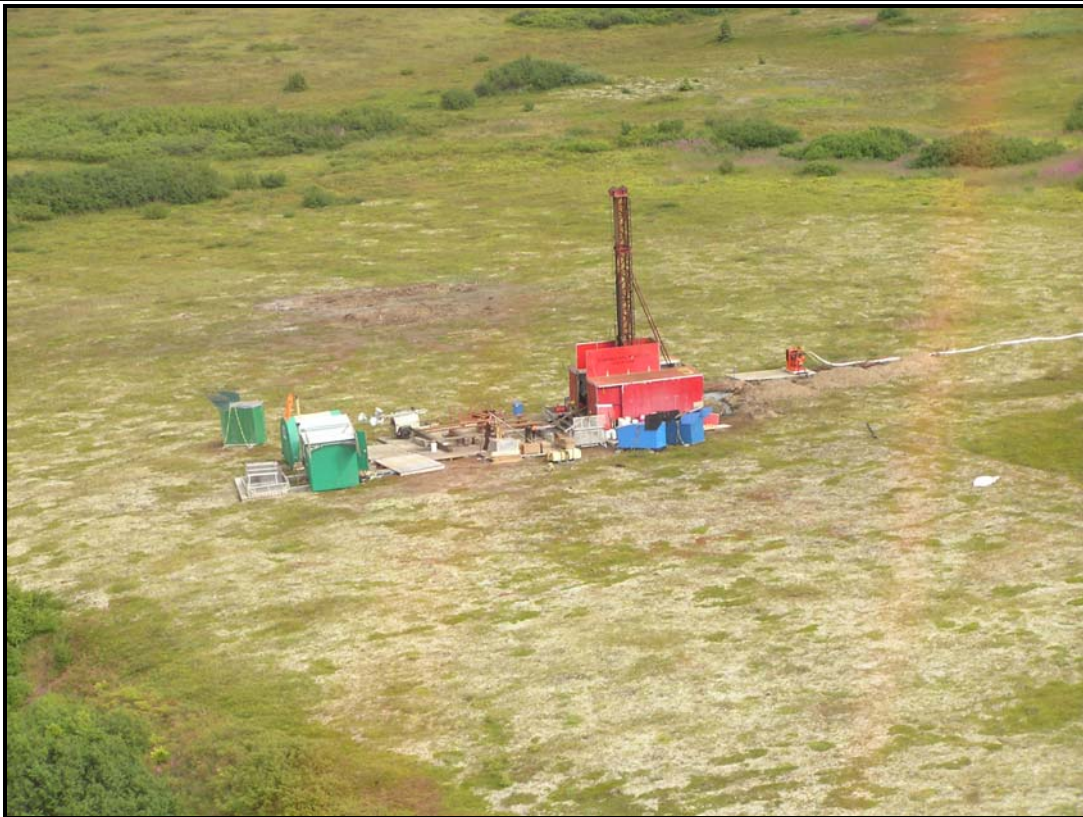
Drill Hole/Site No.: 8420	Rig No.: 5
Activity: Active Drilling @ 4331'	Date: 8/27/08
	59 53 35.5/155 15 24.6
<ul style="list-style-type: none"> <li>■ Condition of Drilling Site: Clean</li> </ul>	<ul style="list-style-type: none"> <li>■ Sump Pit (continued):</li> </ul>
<ul style="list-style-type: none"> <li>○ Distance from waterbody: See photo</li> </ul>	<ul style="list-style-type: none"> <li>○ Location and extent of discharged material: discharge point appears to have been moved periodically; currently to tundra.</li> </ul>
<ul style="list-style-type: none"> <li>○ Location of fuel storage: At drill rig</li> </ul>	<ul style="list-style-type: none"> <li>○ Topsoil, muck, tundra stockpiled: Yes</li> </ul>
<ul style="list-style-type: none"> <li>○ Sorbent pads present: Yes</li> </ul>	<ul style="list-style-type: none"> <li>○ Location of secondary sump pit: See photo.</li> </ul>
<ul style="list-style-type: none"> <li>○ Tundra mat: Yes, plus pallets</li> </ul>	<ul style="list-style-type: none"> <li>○ Hose color: White</li> </ul>

<ul style="list-style-type: none"> <li>○ Pipe off tundra: Most pipe was off the tundra; five sections of pipe were partially on tundra.</li> </ul>	
<ul style="list-style-type: none"> <li>○ Litter: None observed</li> </ul>	<ul style="list-style-type: none"> <li>■ Drill Water Supply:</li> </ul>
<ul style="list-style-type: none"> <li>○ Trash containment: Ok</li> </ul>	<ul style="list-style-type: none"> <li>○ Stream, lake, kettle pond: Pond</li> </ul>
<ul style="list-style-type: none"> <li>○ Sanitary facilities: Ok</li> </ul>	<ul style="list-style-type: none"> <li>○ Location: n/a</li> </ul>
<ul style="list-style-type: none"> <li>○ Any spills or staining: None noted</li> </ul>	<ul style="list-style-type: none"> <li>○ Adequate water flow and depth for fish passage in streams: n/a</li> </ul>
<ul style="list-style-type: none"> <li>○ General impression: clean site</li> </ul>	<ul style="list-style-type: none"> <li>○ Evidence of significant impacts to riparian vegetation or stream banks: None</li> </ul>

**Figure 15: Drill Rig # 5 on drill hole No. 8420.**

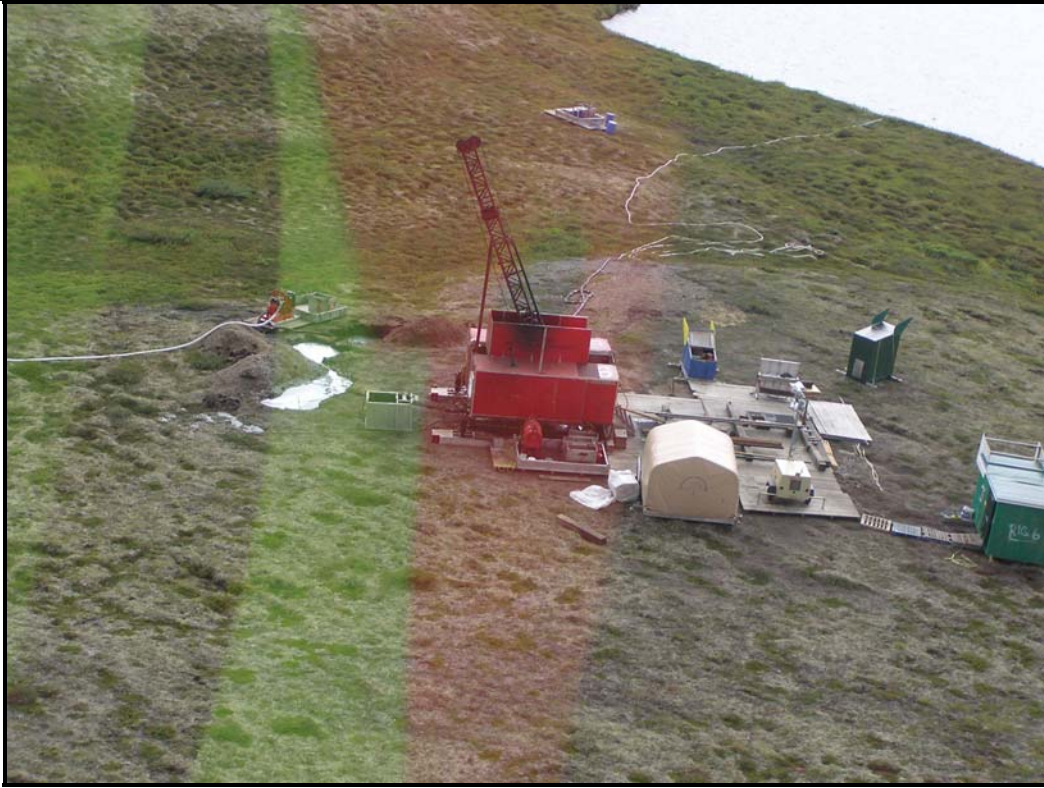
Drill Hole/Site No.: 8418	Rig No.: 6
Activity: Active Drilling @ 2766'	Date: 8/27/08
	59 53 26.6/155 16 12.3
<ul style="list-style-type: none"> <li>■ Condition of Drilling Site: See photo</li> </ul>	<ul style="list-style-type: none"> <li>■ Sump Pit (continued):</li> </ul>
<ul style="list-style-type: none"> <li>○ Distance from waterbody: &gt; 200'</li> </ul>	<ul style="list-style-type: none"> <li>○ Location and extent of discharged material: To tundra.</li> </ul>
<ul style="list-style-type: none"> <li>○ Location of fuel storage: At drill rig</li> </ul>	<ul style="list-style-type: none"> <li>○ Topsoil, muck, tundra stockpiled: Yes</li> </ul>
<ul style="list-style-type: none"> <li>○ Sorbent pads present: Yes</li> </ul>	<ul style="list-style-type: none"> <li>○ Location of secondary sump pit: Adjacent to primary sump.</li> </ul>
<ul style="list-style-type: none"> <li>○ Tundra mat: Yes &amp; pallets.</li> </ul>	<ul style="list-style-type: none"> <li>○ Hose color: White</li> </ul>

**Figure 19: Drill Rig # 6 with water source in background.**

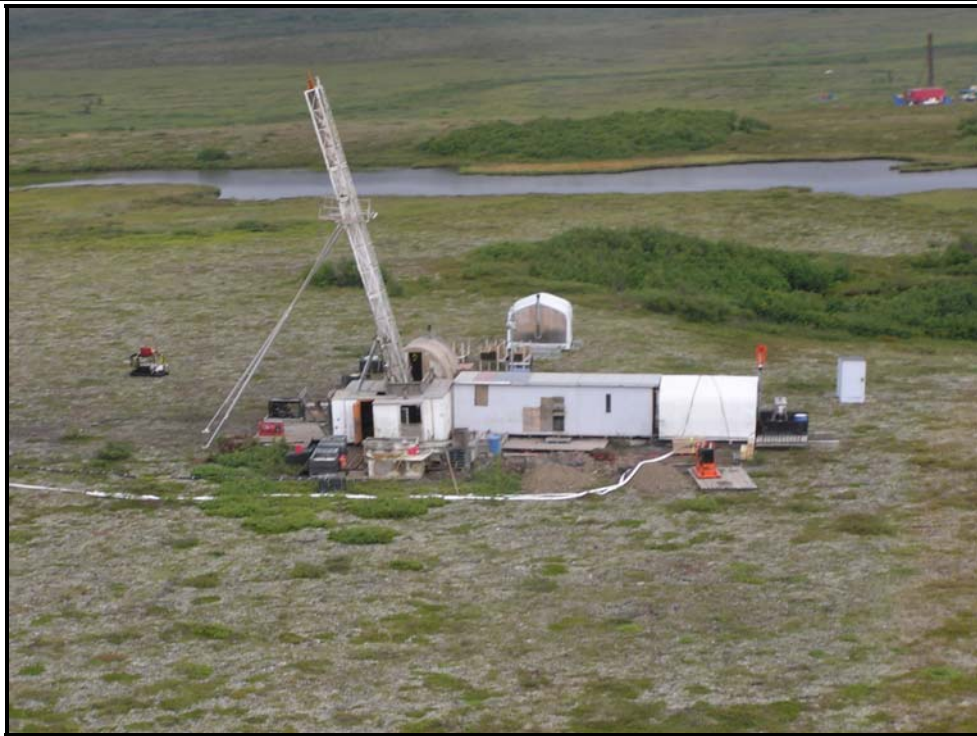
Drill Hole/Site No.: 8422	Rig No.: 1
Activity: Active Drilling @ approx 3244'	Date: 8/27/08
	59 53 36.4\155 15 59.1
<ul style="list-style-type: none"> <li>■ Condition of Drilling Site: Clean <ul style="list-style-type: none"> <li>○ Distance from waterbody: &gt;500'</li> <li>○ Location of fuel storage: At drill rig</li> <li>○ Sorbent pads present: Yes</li> <li>○ Tundra mat: Yes, but some totes were placed directly on ground.</li> <li>○ Pipe off tundra: Yes</li> <li>○ Litter: None observed</li> <li>○ Trash containment: Ok</li> <li>○ Sanitary facilities: Ok</li> <li>○ Any spills or staining: None noted</li> <li>○ General impression: Clean</li> </ul> </li> </ul>	<ul style="list-style-type: none"> <li>■ Sump Pit (continued): <ul style="list-style-type: none"> <li>○ Location and extent of discharged material: On tundra – see photo</li> <li>○ Topsoil, muck, tundra stockpiled: Yes</li> <li>○ Location of secondary sump pit: Adjacent to primary sump.</li> <li>○ Hose color: White</li> </ul> </li> </ul>

**Figure 21: Drill Rig # 1 on drill hole No. 8422.**

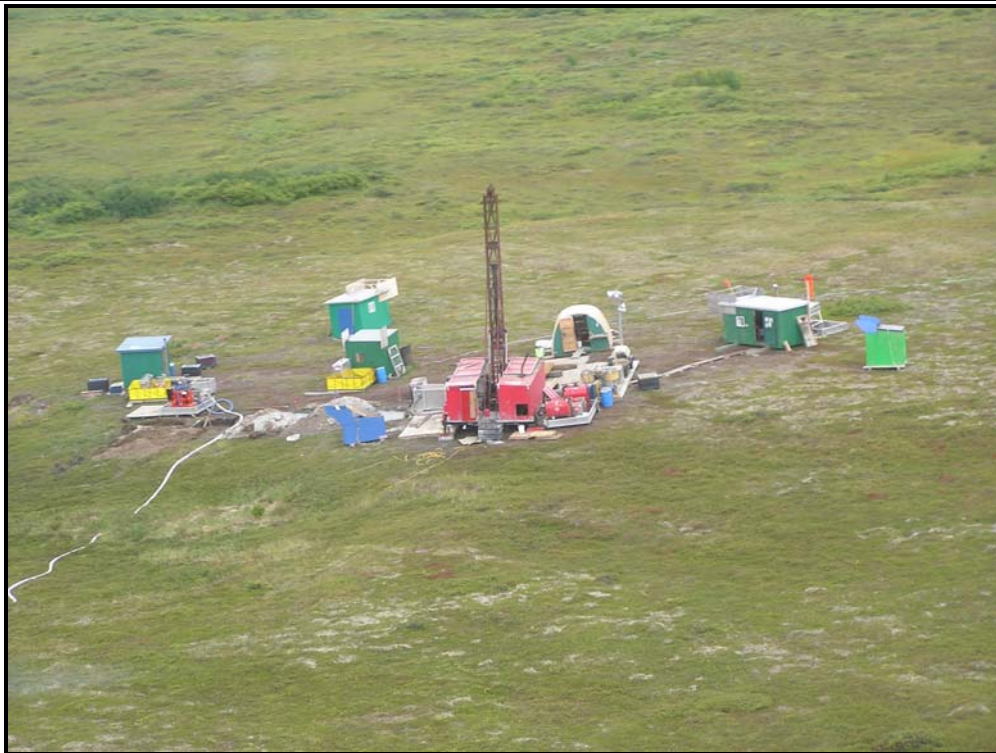
Drill Hole/Site No.: 8417	Rig No.: 4
Activity: Active Drilling @2300'	Date: 8/27/08
	59 53 45.4/155 15 43.8
<ul style="list-style-type: none"> <li>■ Condition of Drilling Site: Reasonably clean <ul style="list-style-type: none"> <li>○ Distance from waterbody: &gt;300' see photo</li> <li>○ Location of fuel storage: At drill rig</li> <li>○ Sorbent pads present: Yes</li> <li>○ Tundra mat: Yes</li> <li>○ Pipe off tundra: Yes</li> <li>○ Litter: None observed</li> <li>○ Trash containment: Ok</li> <li>○ Sanitary facilities: Ok</li> <li>○ Any spills or staining: None noted</li> <li>○ General impression: reasonably clean site</li> </ul> </li> </ul>	<ul style="list-style-type: none"> <li>■ Sump Pit (continued): <ul style="list-style-type: none"> <li>○ Location and extent of discharged material: Not observed</li> <li>○ Topsoil, muck, tundra stockpiled: Yes</li> <li>○ Location of secondary sump pit: Adjacent to primary sump</li> <li>○ Hose color: White</li> </ul> </li> </ul>

**Figure 25: Drill Rig # 4 on hole No. 8417.**

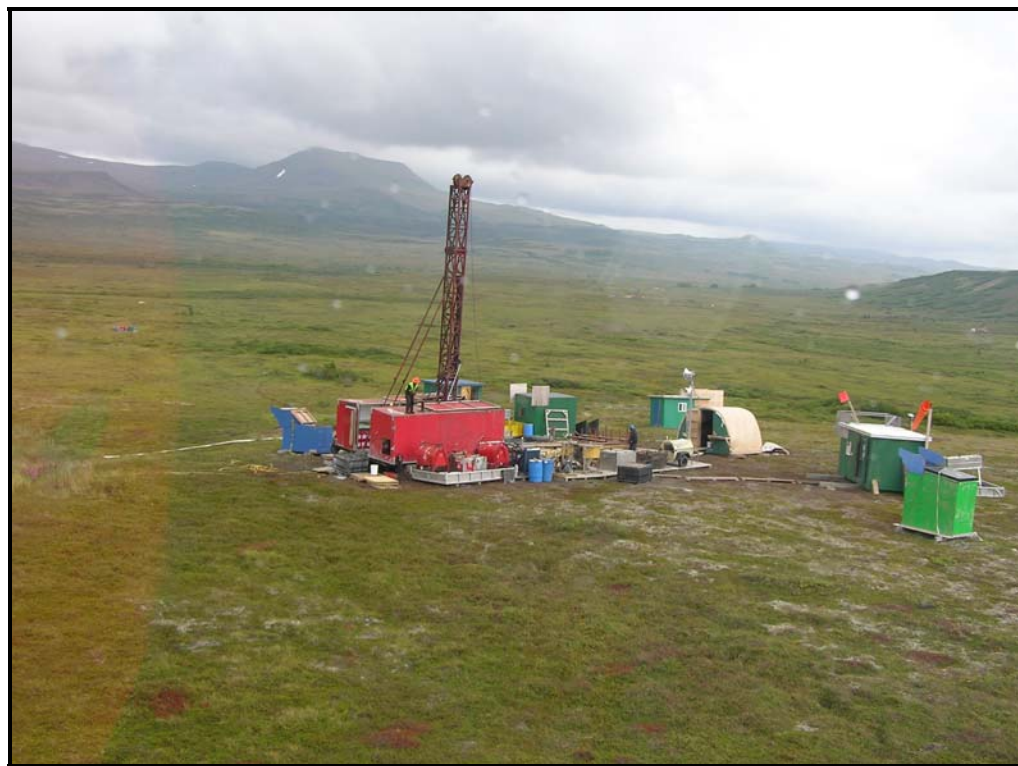
<ul style="list-style-type: none"> <li>■ Drill Water Supply: 59 52 00.6/155 09 45.1 <ul style="list-style-type: none"> <li>○ Stream, lake, kettle pond: see photo</li> <li>○ Location: <ul style="list-style-type: none"> <li>○ Adequate water flow and depth for fish passage in streams: not determined</li> <li>○ Evidence of significant impacts to riparian vegetation or stream banks: None</li> <li>○ Relative water level: not observed</li> <li>○ General impression of water body, i.e. clear, turbid, tannic: not observed</li> </ul> </li> <li>○ Intake structure:</li> <li>○ Structure clear of debris:</li> <li>○ Mesh size:</li> <li>○ Submerged:</li> <li>○ Pump location to source:</li> <li>○ Catch basin for fuel supply:</li> <li>○ Sorbent pads:</li> <li>○ Hose color:</li> </ul> </li> </ul>
<ul style="list-style-type: none"> <li>■ Drilling Activity: <ul style="list-style-type: none"> <li>○ Drill additives in use: yes EZ Mud</li> <li>○ Water recirculation: Not determined.</li> <li>○ Water discharged: Yes</li> <li>○ Artesian zone encountered: Not determined</li> </ul> </li> </ul>

**Figure 28: Drill Rig # 4; assumed water source in background on left.**

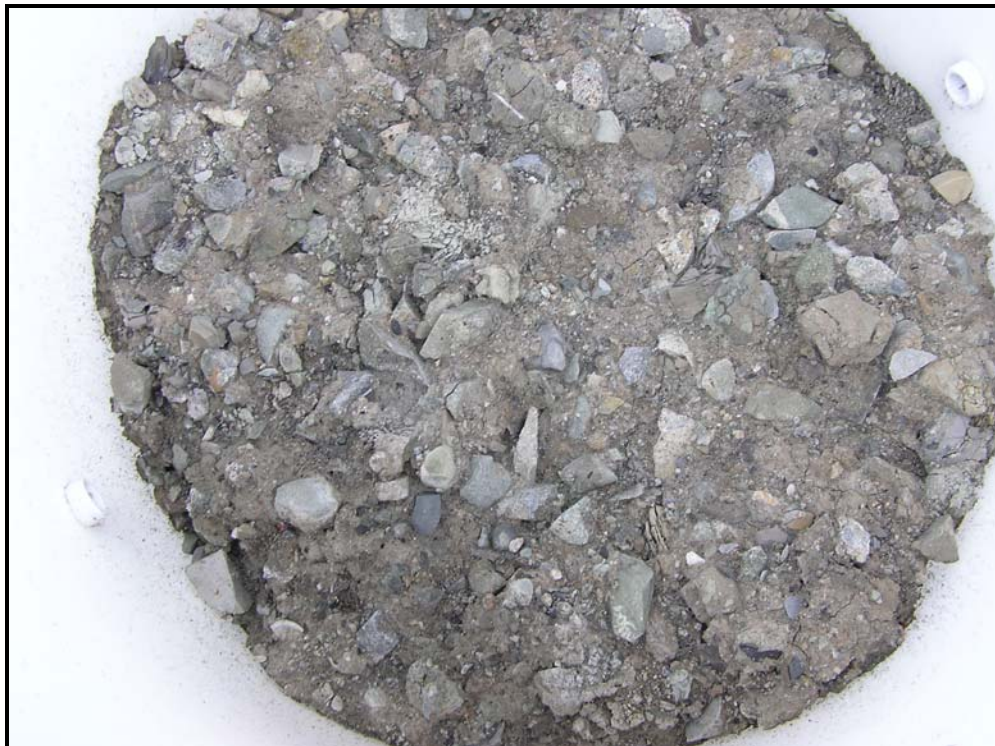
We observed the geochemical barrel testing station.

**Figure 35: Material in geochemical barrel test.**
