Fort Knox

**TAILINGS STORAGE FACILITY
NID ID# AK00212
OPERATIONS & MAINTENANCE MANUAL Rev. 8**

**Fairbanks Gold Mining, Inc.
A Subsidiary of Kinross Gold Corporation
P.O. Box 73726
Fairbanks, Alaska 99707-3726
August 2019**

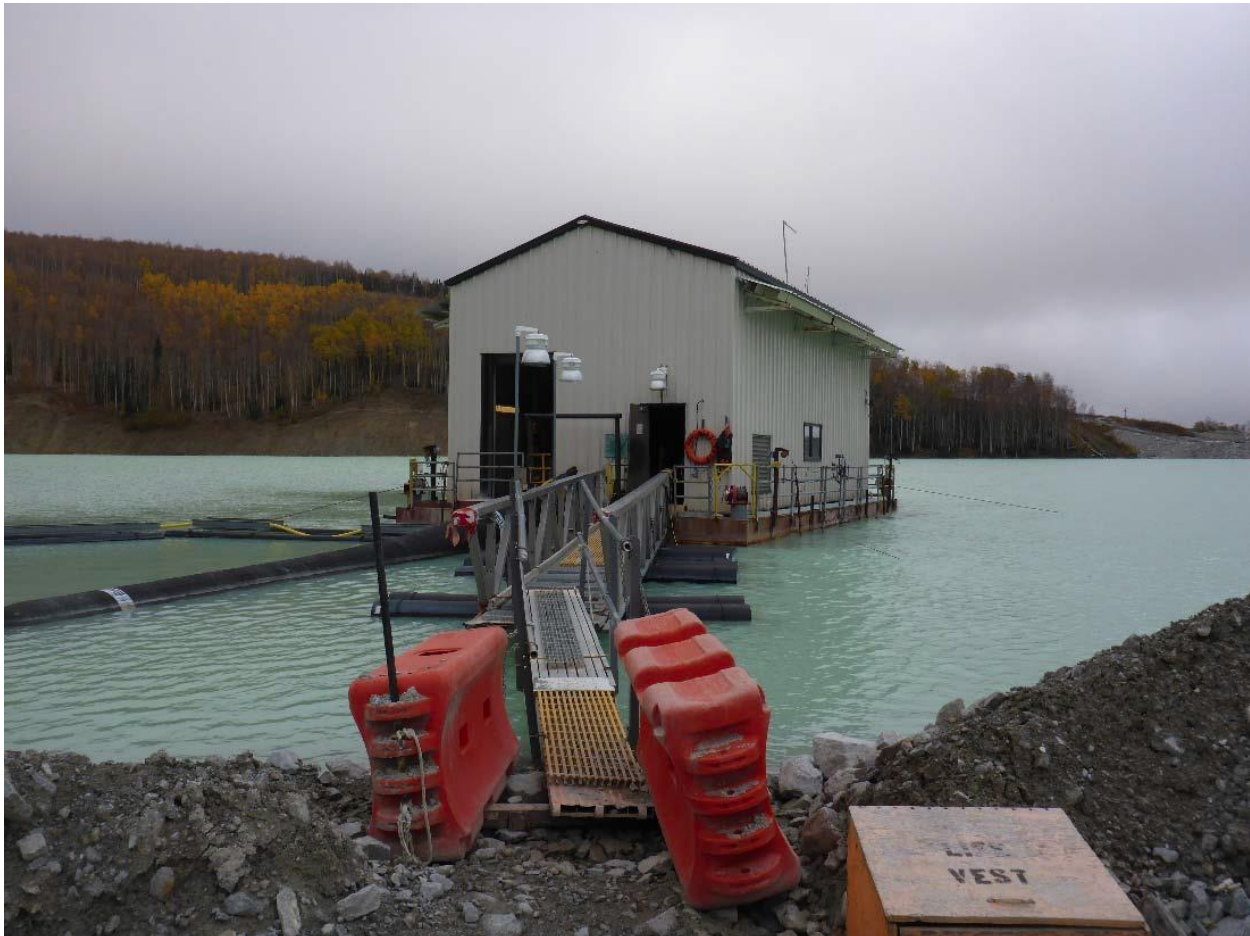
Figure 2-5 - Floating Barge

A floating barge located in the northeast corner of the tailing pond is used to pump water from the tailing pond to the mill (Figure 2-5). The barge is equipped with four 350 to 400 hp pumps with a pumping capacity of approximately 9,000 gpm. Pumping is on an as need basis with the pumping controlled either by radio telemetry from the mill or manually by the pond operator. Additionally, the barge is equipped with a flow meter, pressure gauges, a surge anticipator. It also has deicing system that allows high-pressure water to be released through jets around the barge. The barge is a heated enclosed structure.

Reclaim water is pumped to the process water tank at the mill through a 24-inch HDPE pipeline. Automatic and manual drain valves allow the entire reclaim pipeline to be drained during power outages, maintenance, and barge relocations.

The reclaim water system, including the barge and pipeline, are critical to operation of the mill. Since the barge is a floating vessel, any listing or change in its waterline should be reported to superiors immediately. Such changes will trigger more frequent inspections and a complete investigation to identify and rectify the cause.

Each flotation and ballast compartment on the barge has been fitted with a 2-inch diameter discharge pipe and a 1-inch diameter air inlet fitting so that water can be expelled when necessary. It is critical to limit air pressure to less than 2 psi on these compartments. (Consider that on the 8-foot by 8-foot side of each compartment every 1 psi exerts 9,216 lbs of force pushing the side outwards. This total force must be contained by the compartment bracing and the corner welds. Too much pressure will cause the compartment to bulge and possibly rupture.)

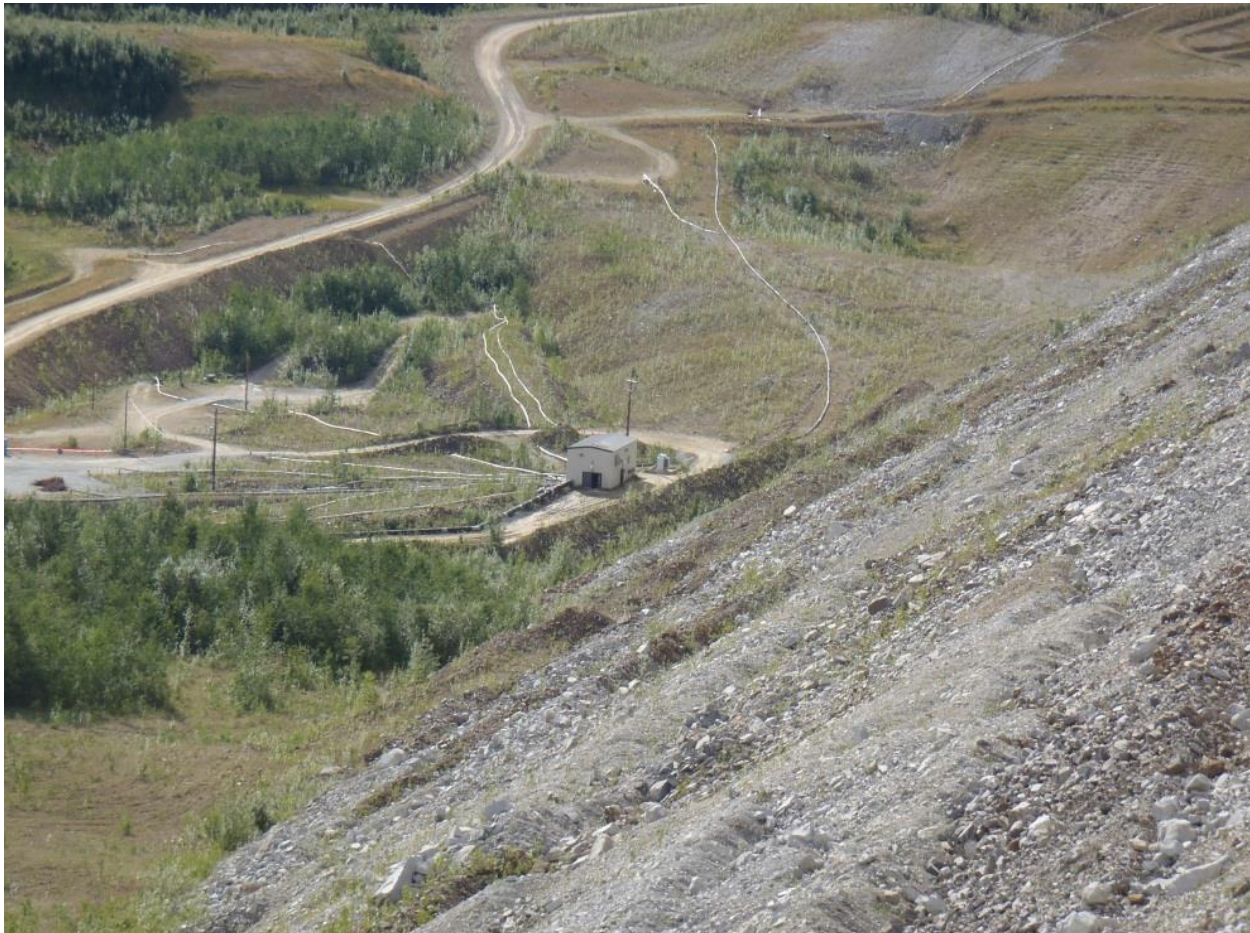
Figure 2-6 - Seepage Reclaim Building

The main TSF embankment has 12-inch diameter, perforated HDPE drain pipes set horizontally in gravel along its toe to collect seepage and divert it to a collection sump. Additionally, water collected from the interceptor wells and the monitoring wells equipped with pumps, is pumped to the collection sump. Water collected in the sump is pumped back to the tailing impoundment. The seepage collection sump is located at the base of the tailings dam and consists of two 63-inch diameter by 50-foot long, perforated HDPE pipes set vertically. A vertical turbine pump is installed to return seepage back to the tailing pond from the sump. The pump is turned on and off by a water level controller. The seepage reclaim building (Figure 2-6) houses the electrical and mechanical components for the seepage collection system.

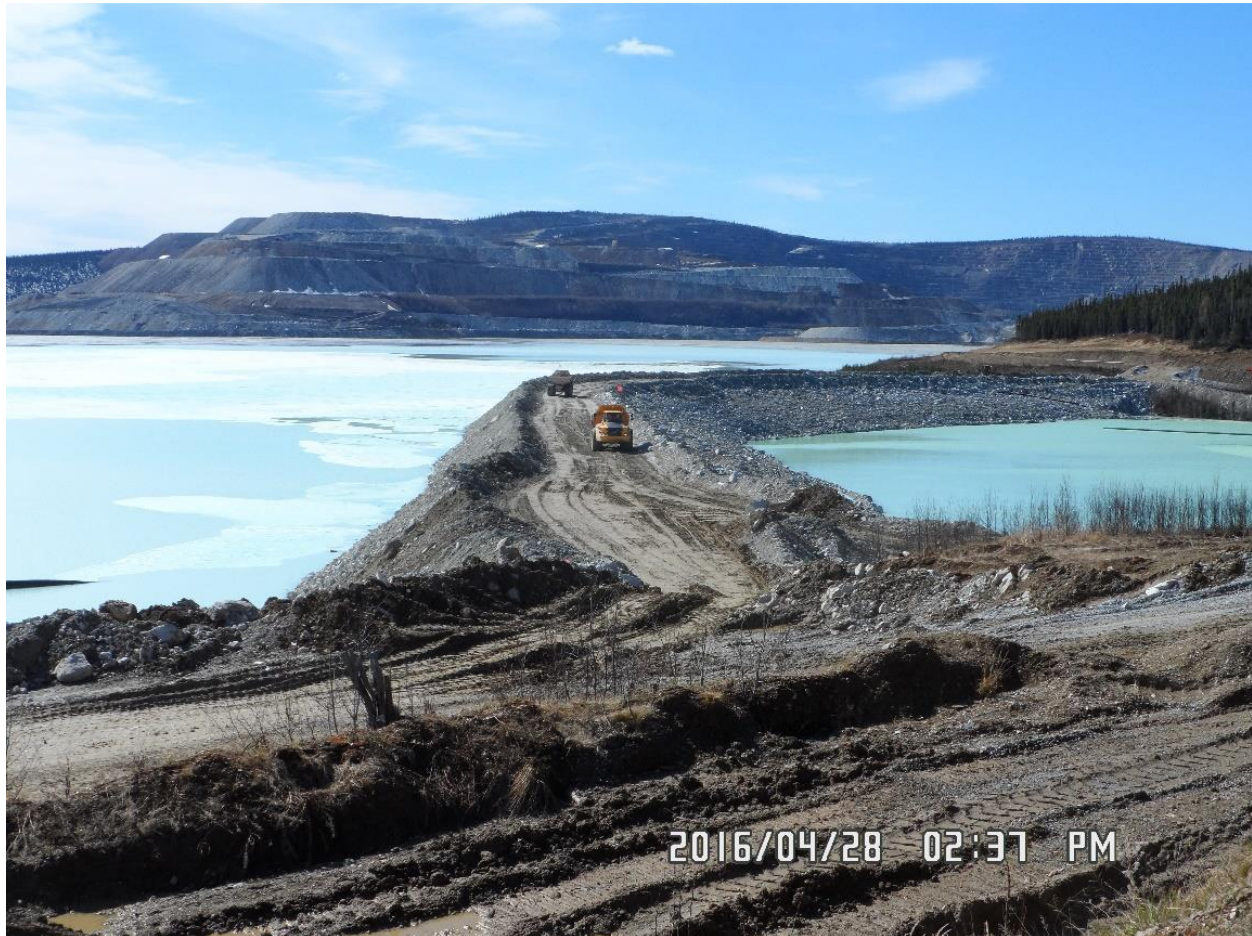
Figure 2-8 - Barge Pond Jetty

The jetty, Figure 2-8, is intended to isolate the barge from areas of active tailing deposition and provide a pool of water that is deep enough to accommodate the barge mounted pumps. Reclaim water will enter the barge pond through the open graded mine waste rock comprising the jetty or be pumped to the barge pond from the south pond via the water transfer system. Should flows through the jetty not provide the 8,500 gpm of reclaim water required, a channel could be excavated at its northwest end at a point furthest from the tailing deposition points along the crest of the raised embankment. The resultant flow path should be long enough to allow for adequate clarification of the reclaim water prior to its return to the mill. At closure, the jetty may need to be breached, to allow flow through the barge pond from the TSF supernatant pond to the closure spillway that will be excavated into the north side of the Fish Creek valley. At that time, it may be necessary to stabilize the surface of the tailing within the barge pond with mine waste to prevent erosion of the tailing surface by storm water flows entering the spillway.

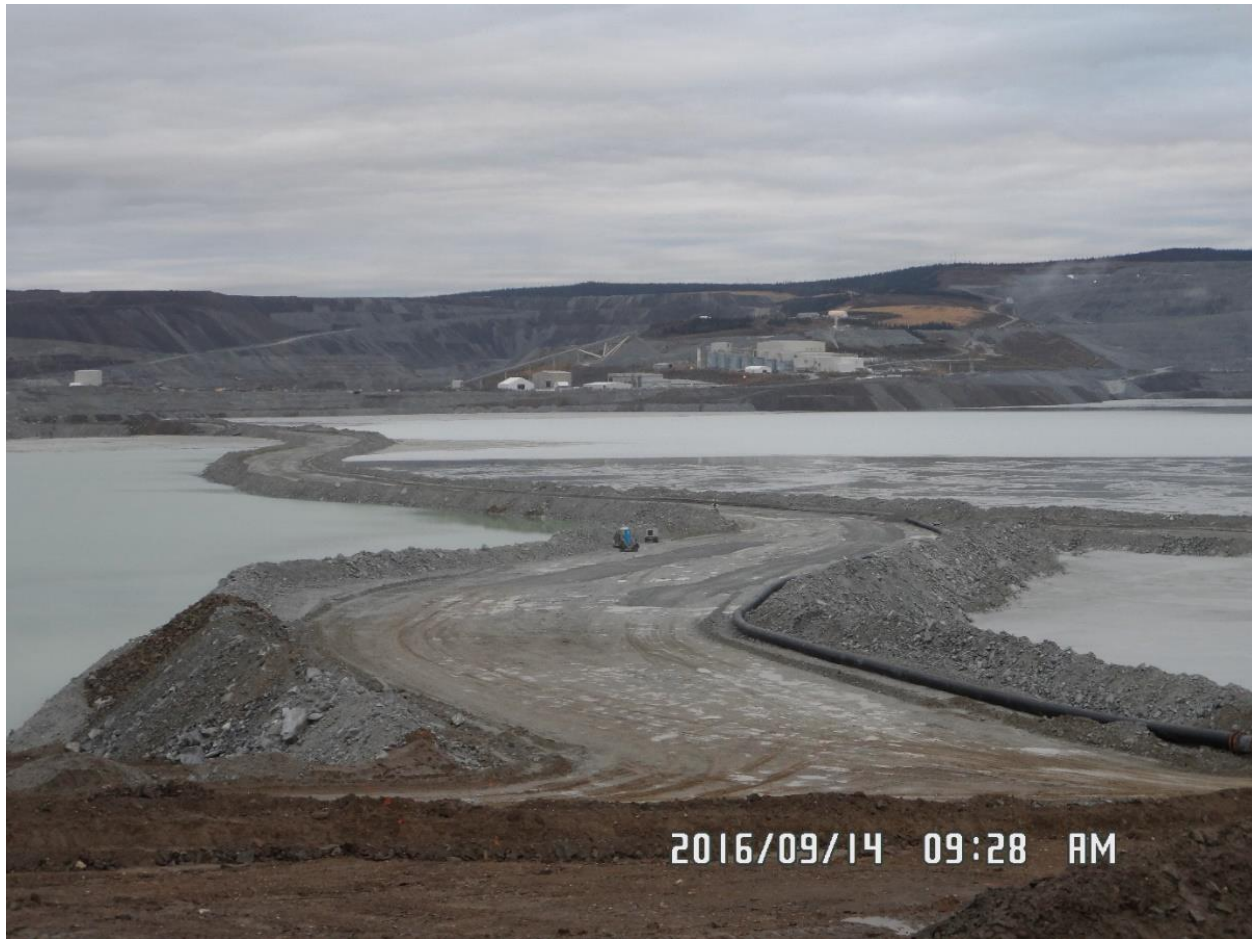
Figure 2-9 - Pearl Creek Causeway Realignment 2016

The pearl creek causeway is a continuous bottom to top vertical rockfill structure. Consequently, it provides a hydraulic connection between the north and south supernatant ponds and the upstream face of the TSF dam when the pond(s) are in contact with the causeway even if the north pond is not in contact with the TSF embankment itself. Although this is not a safety concern since the TSF is designed to withstand full hydraulic loading up to the crest of the embankment. It is considered good practice to isolate the pond(s) from the front face of the dam and the causeway to reduce the head on the dam, the resultant hydraulic gradients and the seepage flow rates through the embankment. The current tailing deposition plan prioritizes the development of beaches in these key areas to facilitate this goal. In addition, FGMI has placed lower permeability rockfill along both sides of the causeway to increase the head loss upstream of the embankment when the pond(s) are in contact of the causeway. In addition, FGMI relocated the current raise to the causeway in 2016 (Figure 2-9) such that it terminates against natural ground at the south abutment rather than the upstream face of the dam. This will have some effect by further increasing the head loss between the supernatant ponds and the upstream face of the embankment. During 2018, the causeway was raised to 1555 in various locations, which is two feet below the engineered zones.

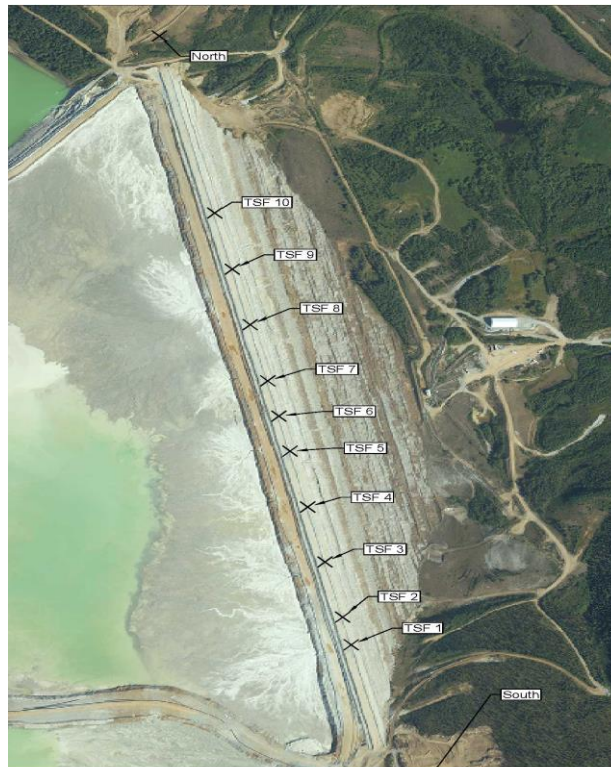
Figure 3-1 - TSF Survey Monuments

Typically, prior to a construction season, the settlement monuments are removed to accommodate construction activities. Settlement monument monitoring is then continued on a monthly basis by the surveyors, once the monuments are reinstalled. Data that is obtained is uploaded to FULCRUM where it is accessible to the engineers and the environmental department. The data is compared to the original location of the monuments as well as the previous months reading. The environmental department reviews the horizontal movement and the vertical settlement data as it is uploaded. The settling monument installation will occur after construction of the seal zone to 1560 fmsl is complete, similar to Figure 3-1.

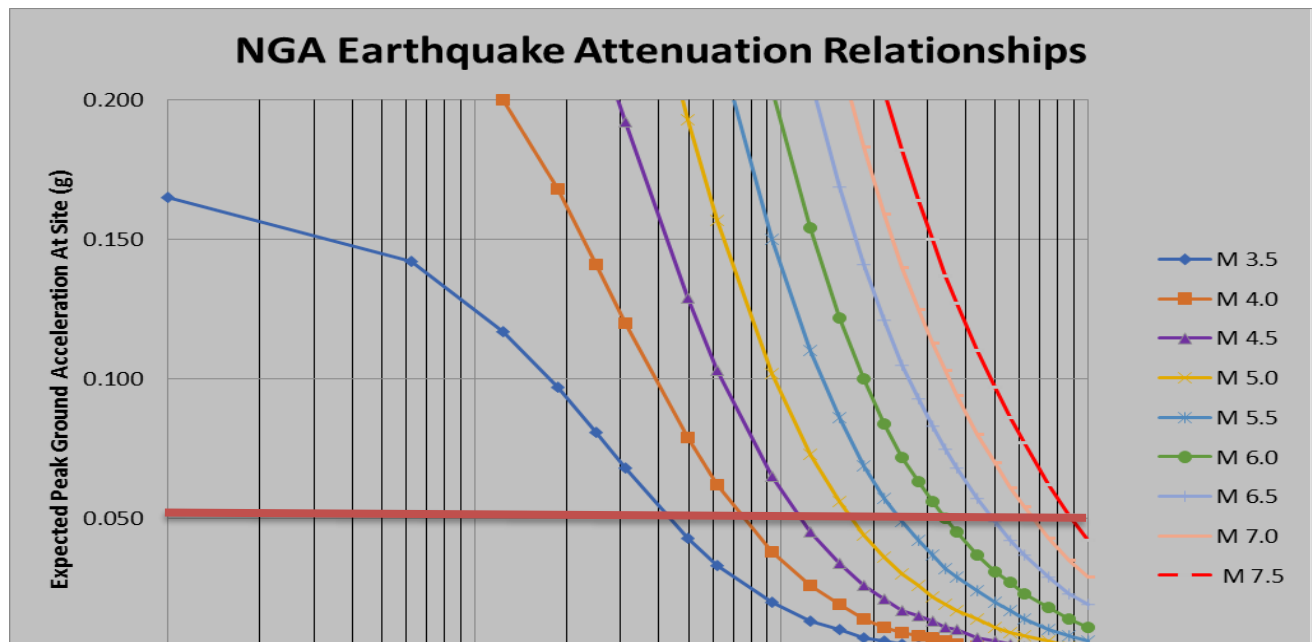
Figure 4-1 - Earthquake Attenuation Plot

In order to provide real-time seismic monitoring and a more effective early warning system, FGMI has installed two accelerometers in the TSF area. These accelerometers were installed along the dam to work in tandem to monitor seismic events and any movement of the TSF dam. One analog triaxial accelerometer, model 147A-01/3, was installed on the crest of the dam while the other a triaxial accelerograph, model 130-SMHR/6, was installed on the north abutment. Both models are made for continuous monitoring of earthquakes and other seismic events. Once the data from the instruments is continuously recorded and sent through the FGMI network to a computer and data storage on-site. In case of major events (PGHA \geq 0.05g) FGMI designated team and EOR are immediately notified via email and above mentioned inspection will be performed. The data can also be downloaded manually then taken back to the office and analyzed. Until this system is fully automated with email notifications Figure 4.1 Earthquake Attenuation Plot and Table 4.3 will continue to be used as the basis for inspections. Once the data from the accelerometer has been manually downloaded or and analyzed the inspections may change in accordance with resulting PGHA.
